# INTERNATIONAL MEETING

On results of the May 13, 1995  
earthquake of West Macedonia:  
One Year After

## **School Buildings and Antiseismic Planning. The example of Grevena - Kozani earthquake(W. Macedonia, Greece) of May 13, 1995.**

**E. L. Lekkas, Ch. D. Kranis, I. G. Fountoulis, S. G. Lozios,  
and E. I. Adamopoulou**

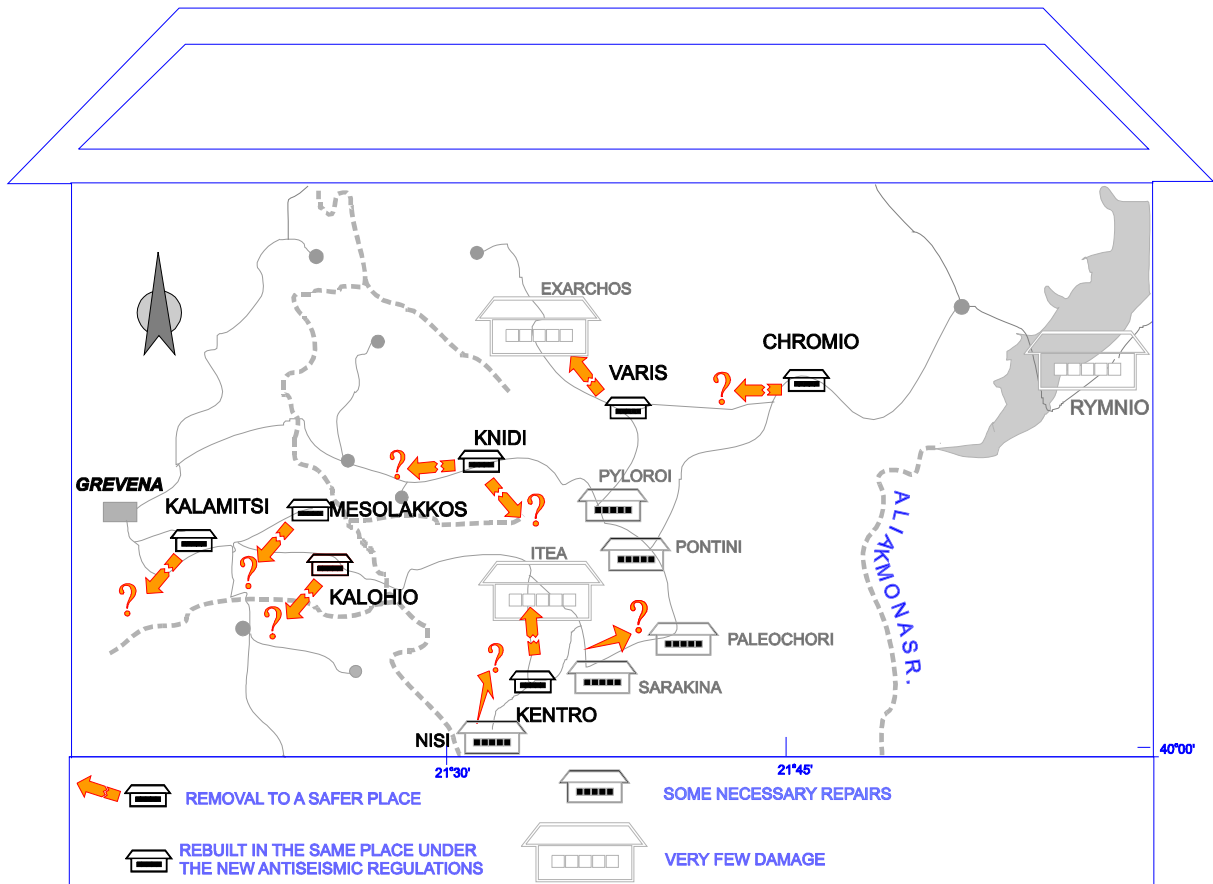
Using this earthquake as the case study, an attempt will be made to determine the factors that played a significant part on the distribution of the damage of school buildings. The pleistoseismal area has numerous small villages and communities, where the school buildings are mainly old constructions, housing one or two classrooms. Most of them collapsed or were seriously damaged (Fig. 1).

It is noted here that the overall distribution of the damage in the school buildings follows that of the other constructions. Thus, out of 30 villages where damage 17, at 6 cases the school buildings collapsed, 3 suffered extensive damage and all the others were lightly damaged (Carydis et al 1995, Lekkas et al 1995).

Fig. 1: The distribution of the school buildings damage and the synoptic proposals.
