## Protection of the Castle of Zakynthos, W. Greece, from landslide destruction phenomena

E.Lekkas

Department of Geology, University of Athens, Athens, Greece

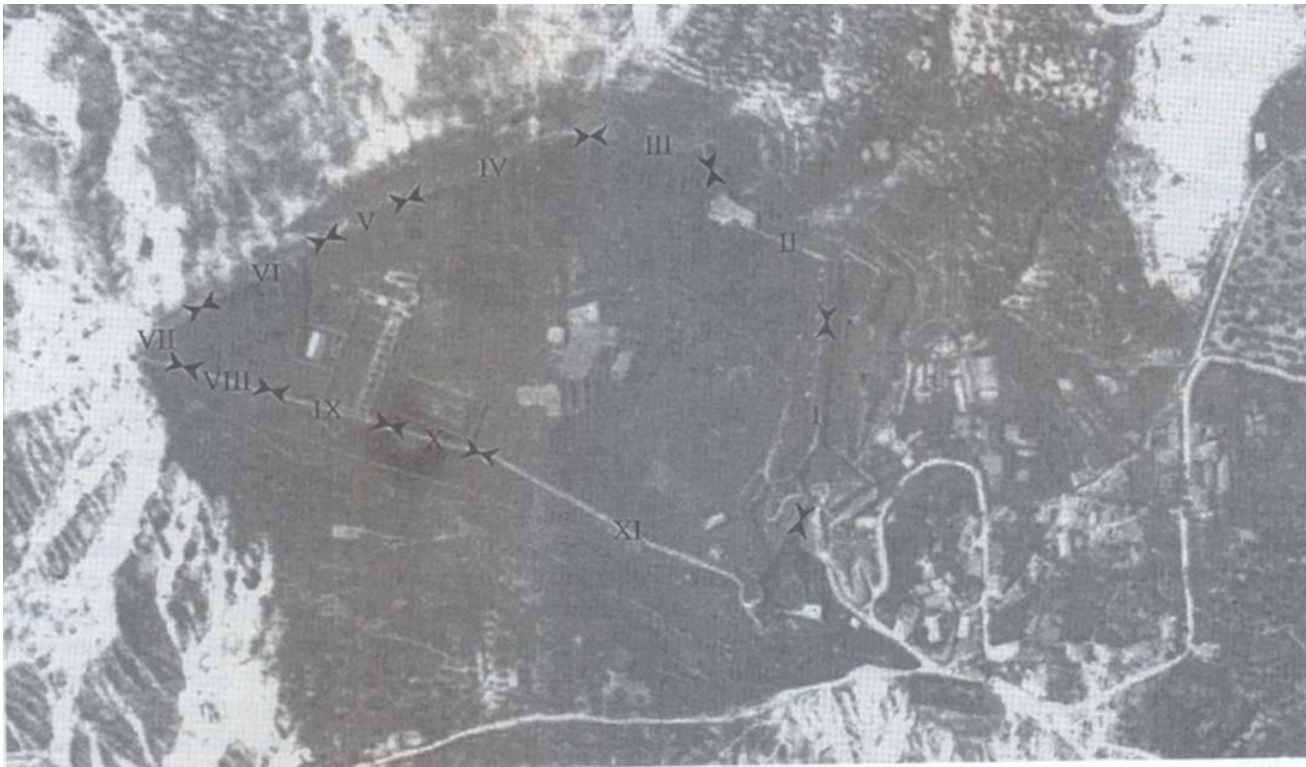
Figure 1. Aerial view of Zakynthos Castle with the distinguished parts.

Alongside the ancient walls of the Castle there were distinguished 11 different sites (Fig. 1) where each one has particular characteristics, like for instance the extent and type of damage, the geotechnical, geological, hydrogeological and geomorphological conditions. In detail:

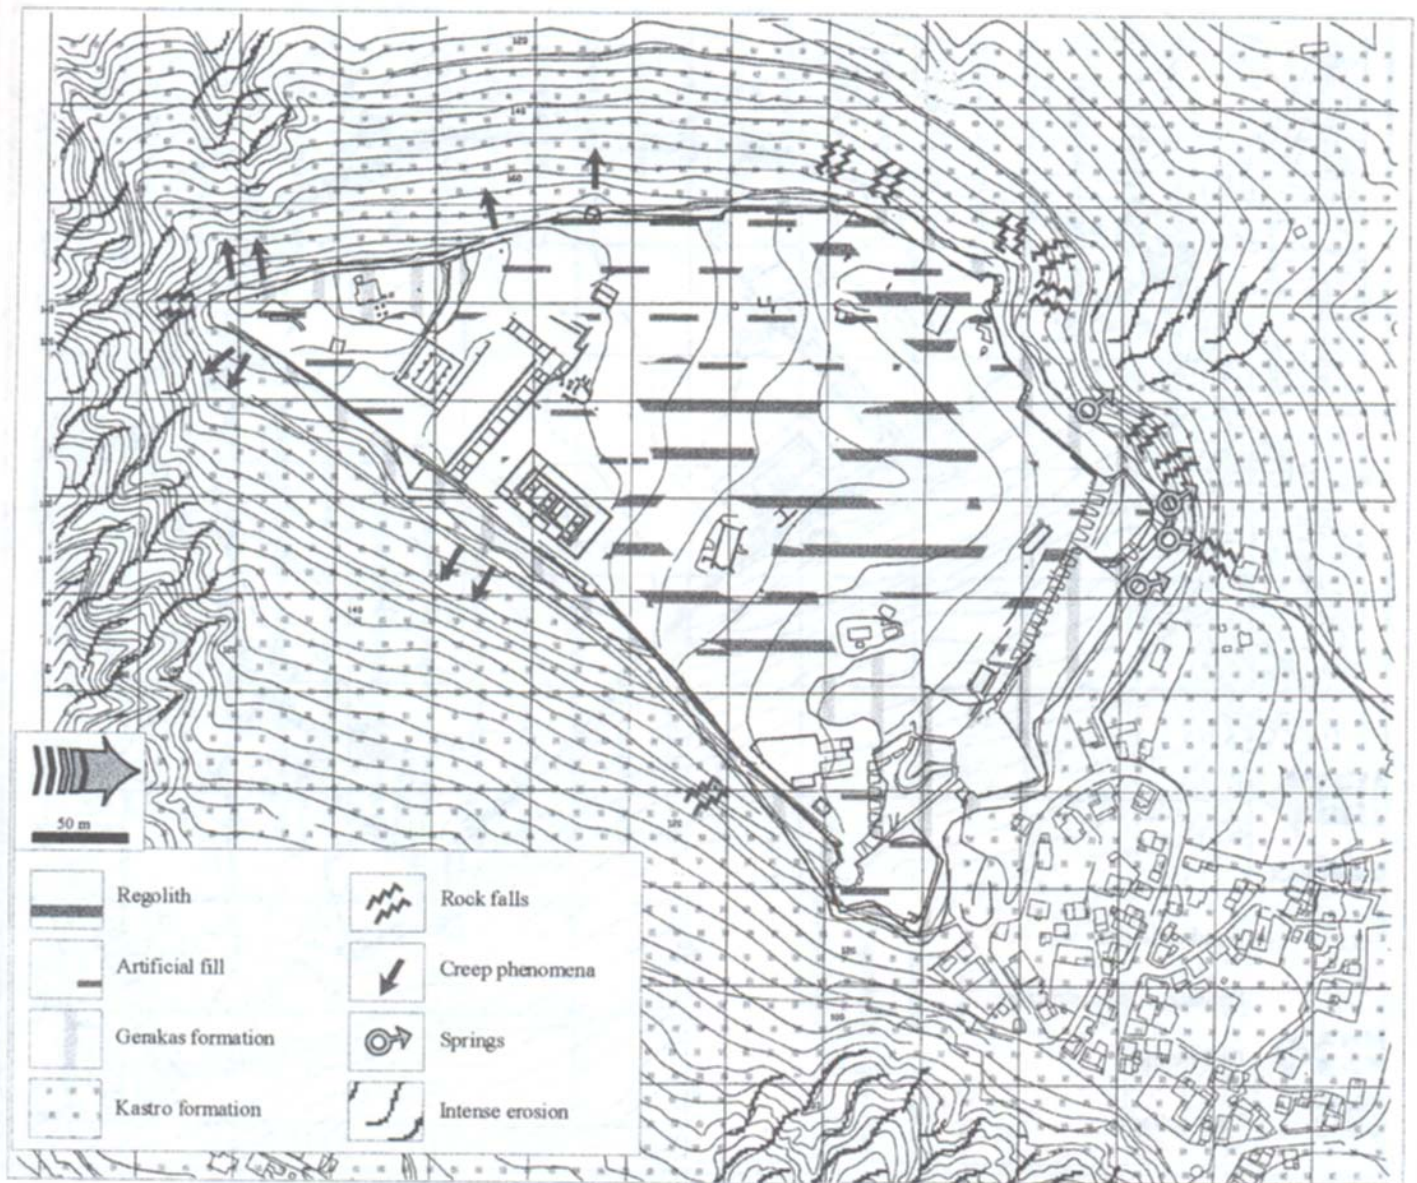
In the hill of the Castle (Fig. 2) the following geological formations outcrop (Kowalczyk et al. 1977, Mariolakos et al. 1989, Lekkas 1993, Lekkas 1996):

Figure 2. Geological – Geotechnical map of the area of the Castle of Zakynthos.

Part V: It is built on calcitic sandstones and marls. The morphological dips of the slope of the outer part exceed 80%. The downslope side is covered by thick vegetation of plants which often show bending due to creeping phenomena. This part of the ancient walls has suffered relatively big damages which were created partly due to the nature of the founding constructions, as well as to the high morphological dips (Fig. 2, 3).

Part X: It is based on weathered calcitic sandstones, of 1-2m thick which are subject to creeping movements. The morphological dips shown in this area are high, with values over 70% (Fig. 2). The downslope side is covered with intermediate density vegetation. The trees show typical bending, due to creeping of the soil (Fig. 3). To cope with the problems, at least for the preserved part of the ancient wall, the following are proposed: (i) earth retaining structures for the ancient wall from the downslope side with a low ancient wall which will be founded on the unweathered basement rock, (ii) reforming the forest in this area by cutting and removing the destroyed plants and plant new ones with deep rooting system (Fig. 4).

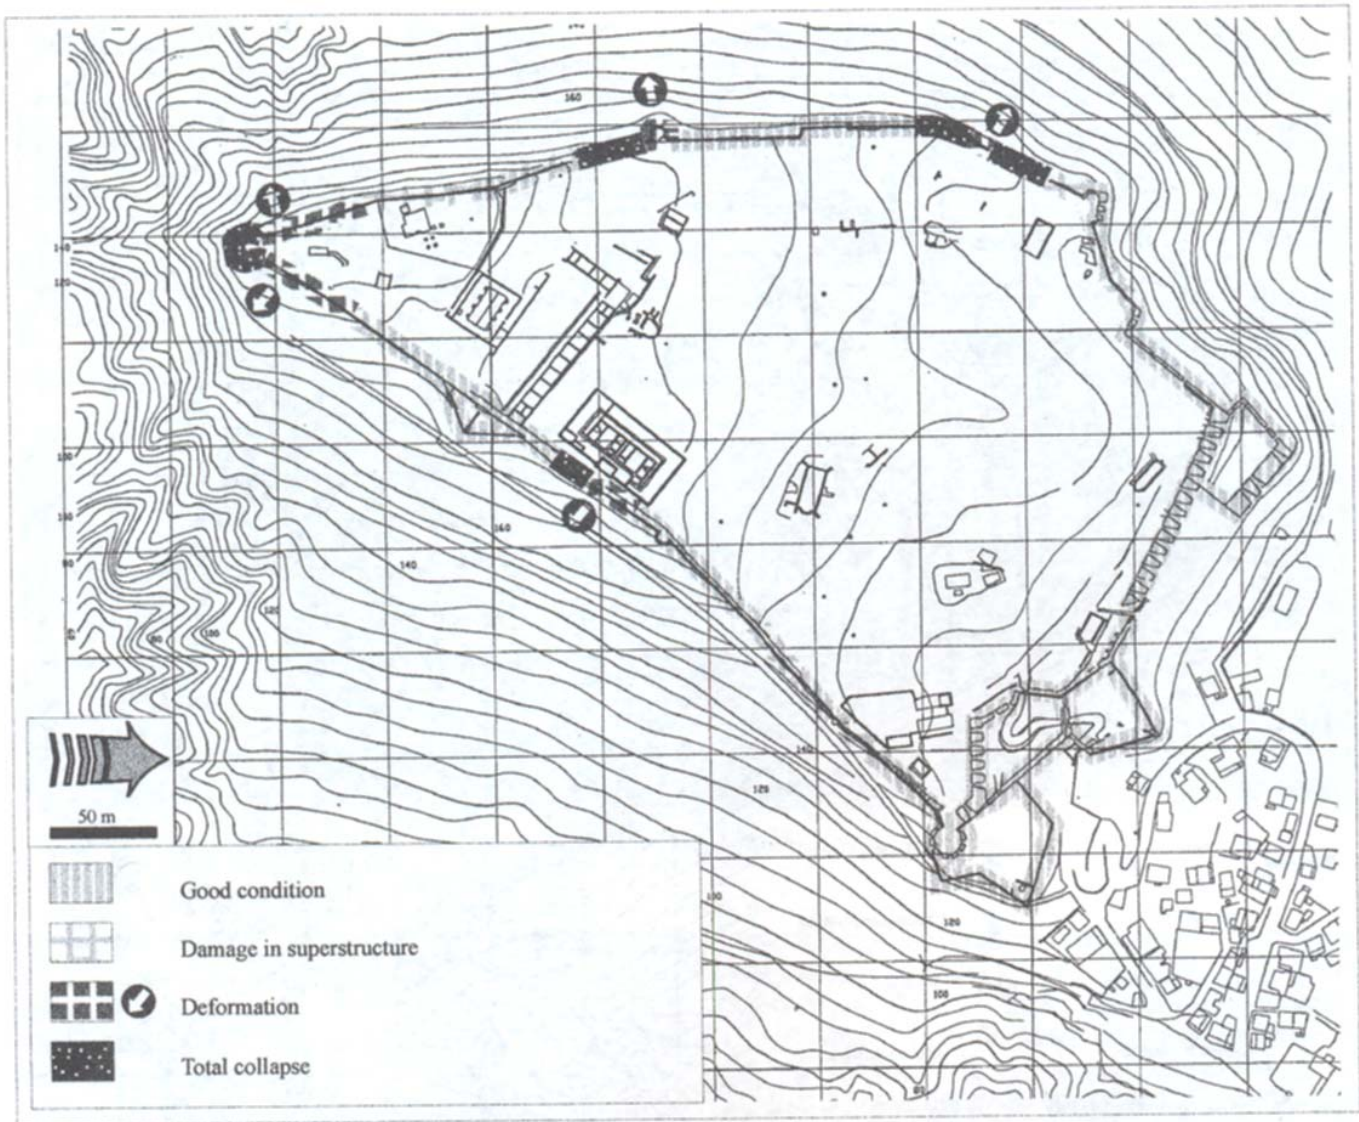
Figure 3. Condition of ancient walls – Problems at the Castle of Zakynthos.

rock mass of the overlying formation which hosts the aquifer and is cut by a dense network of discontinuities. The combination of the above factors creates the instability conditions of the sandstone rock mass which gradually extends towards the inner part of the rock or upwards the slope (Fig. 3).

Part III: The state of the ancient walls is characterised by discontinuous repetition of parts with big and small damages (Fig. 3). This is partly due to the quality of construction of the monument, and also to the geological-geotechnical problems. Especially the downslope side of the slope, which

Part VII: This part is located at the southernmost edge of the Castle and has an overall length of about 70m (Fig. 1). Essentially it is the southernmost corner of the ancient walls which ended in a round rampart. This part was destroyed from landslide due to the earthquakes. About half of the length of the ancient walls has been destroyed, while the remained part is at a marginal stability due to landslide phenomena (Fig. 3). It is noteworthy that in

Part IX: The area as a whole, is characterized by stability which is shown by the good condition of this part of the ancient walls (Fig. 3). For maximum protection of the monument in the short as well as the long term, the following are suggested: (I) embellishment of the entrance rampart area, (ii) works for renewal of the forest (Fig. 4).

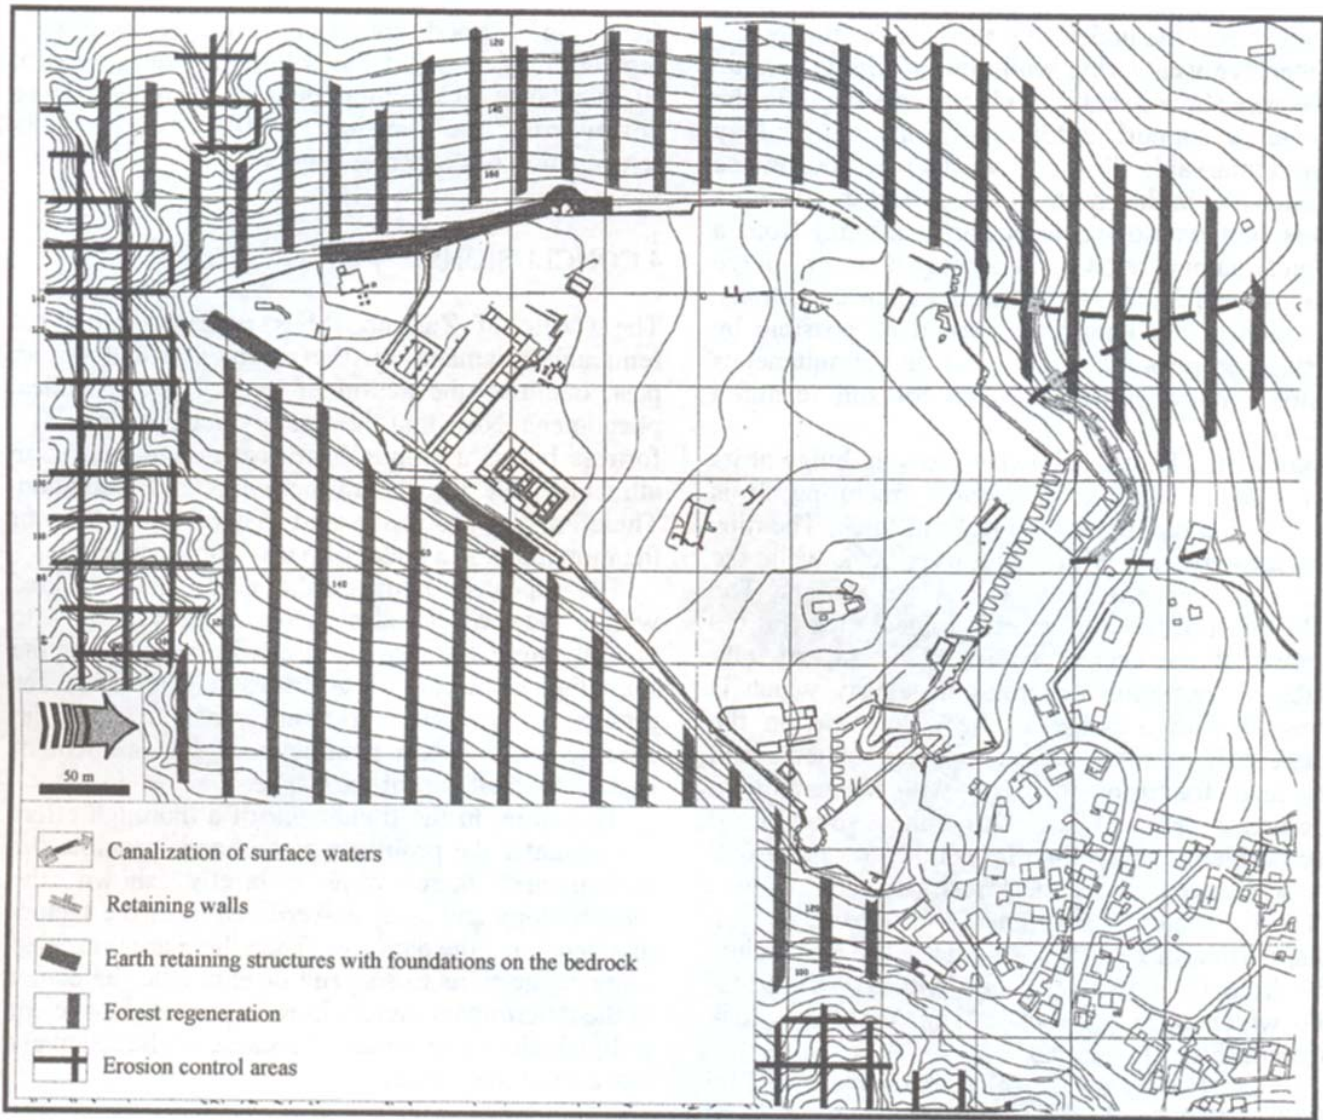
Figure 4. Schematical representation of protection solutions of ancient walls in the Castle of Zakynthos.

the ancient walls there are suggested some works for arranging the rain waters (Fig. 3, 4).

To eliminate the degradation processes which act on the slope, the following measures are suggested: (I) forbid any intervention on the slopes of the road, (ii) works to arrange the superficial waters, (iii) renewal of the forest at the downslope side of the ancient walls, and (iv) earth retaining structures for the rock mass (Fig. 4).

To work out a solution for the observed problems in this location, it is considered necessary to do some works aiming to suspend weathering of the marls. Suspension of weathering can be attained with the renewal of the forest (Fig. 4).

Part IV: The state of the ancient walls is very good without special problems (Fig. 3). For long term protection of this part they are suggested: (i) blockage of the ancient wall openings used for water discharge, (ii) works for forest rejuvenation and (iii) avoid any intervention in the downslope side of the slope (Fig. 4).

To encounter these problems and especially to protect the parts of the ancient walls that have been preserved, the following are suggested: (i) avoidance of extra loading in the inner part of the ancient walls, (ii) works for renewal of the forest (Fig. 4). Further measures for intervention would be of low effectiveness and high cost. These works could be carried out in the framework of a possible rebuilt of parts of the ancient walls, mainly on the direction of: (i) deep founding on the fresh basement rocks, (ii)

Part VI: This part has suffered small damages which are located basically at the top structural levels. To maintain its good state the following suggestions are proposed: (i) avoidance of loading in the inner part of the ancient walls, (ii) gentle interventions in the forest which is situated in the downslope area, by deforesting the old age or destroyed plants and gradually planting new ones with deep-rooting system (Fig. 4).

this particular area the underlying marls are characterised by intensive weathering while the overlying calcitic sandstones show instability phenomena ought to the removal of support. Additionally, the morphology shows remarkable dips, and weathering phenomena are extensive in the southern slope. Any intervention in this part would be particularly difficult from a technical point of view and certainly it requires large outlay, especially due to these particular conditions. Protection in the long term, would be possible by planting deep-rooting trees and by simultaneous construction of specific systems for soil retention (Fig. 4).

Part VIII: This part shows a growing bulge at its outer side, as well as successive fracturing. It is founded on a regolith which is 1.5m thick. The dips in the area are high with values over 50%, while the slopes are covered with sparse vegetation. The combination of the high morphological dips and the founding of the ancient walls on the superficially weathered formation generates instability which is expressed with a bulge at the outer side on the ancient wall as result of creeping movements and subsequent fracturing in places with the maximum deformation (Fig. 3). To work out a solution for these problems, the following actions are proposed: (I) works to rejuvenate the forest, (ii) avoid to load with extra material the inner part of the ancient walls, (iii) earth retaining structures for the ancient walls from the downslope side with a low ancient wall, which will be founded on the fresh rock basement (Fig. 4).

Castle in a good condition. For the long term protection of this part the following are suggested: (i) avoidance of opening new roads on the slope downwards the ancient walls, (ii) careful rejuvenation of the forest (Fig. 4).
