**EARTHQUAKE ENGINEERING
RESEARCH INSTITUTE**

NEWSLETTER

The Dinar, Turkey, Earthquake of October 1, 1995

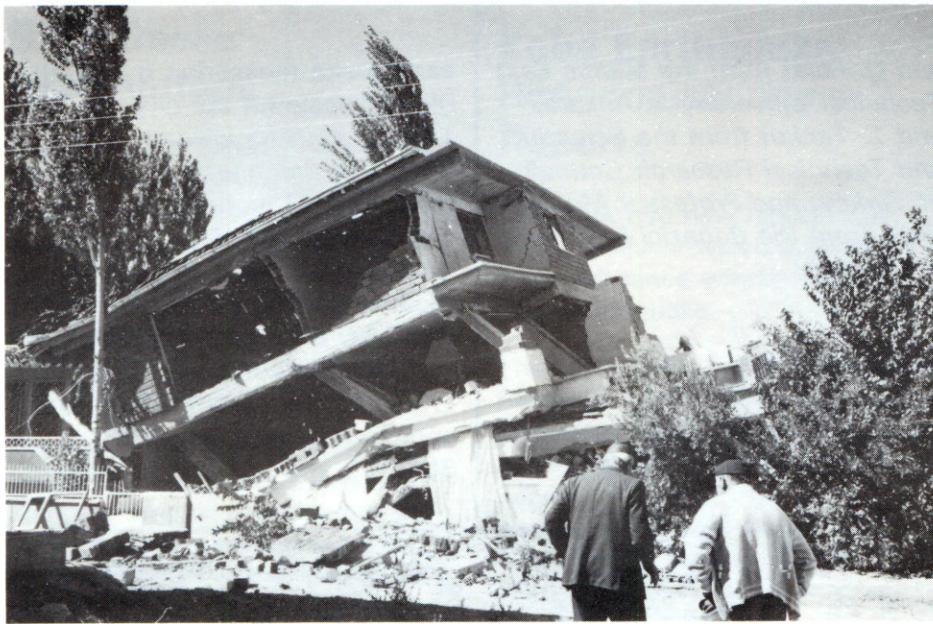
Figure 2 - Typical case of the total collapse of a four-story R/C building.

Most of the four- and five-story reinforced concrete apartment buildings were either heavily damaged or totally collapsed. Some three-story buildings suffered similar damage. One- or two-story building collapses were rare.

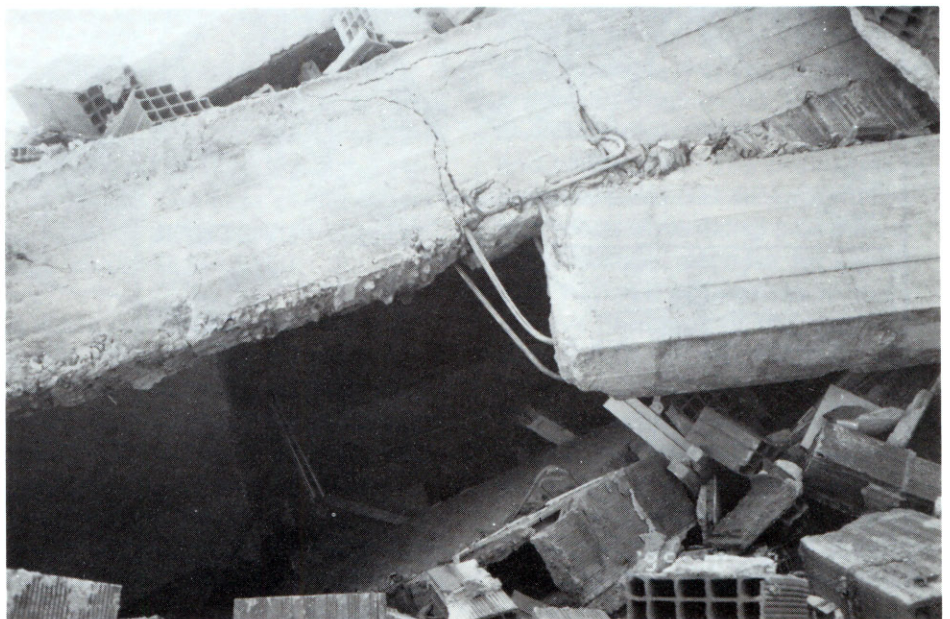
Figure 3 - Typical detail of a beam-to-column joint.

The code provisions and good detailing practice were not followed. Ends of columns were not properly confined. Ends of ties were not anchored into the core. The frames in Dinar could not be classified as ductile frames.

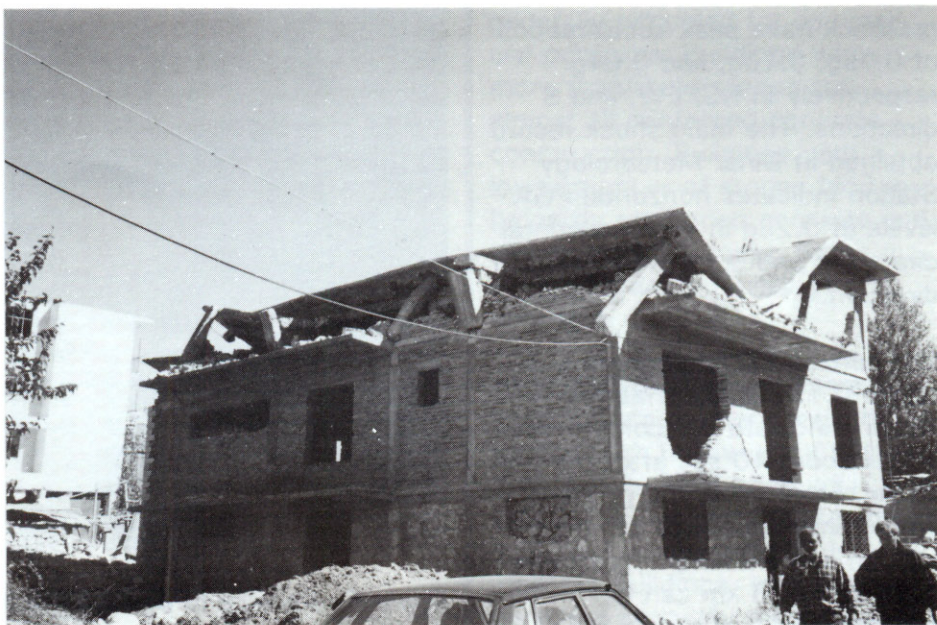
Figure 4 - Collapse of a weak upper story.

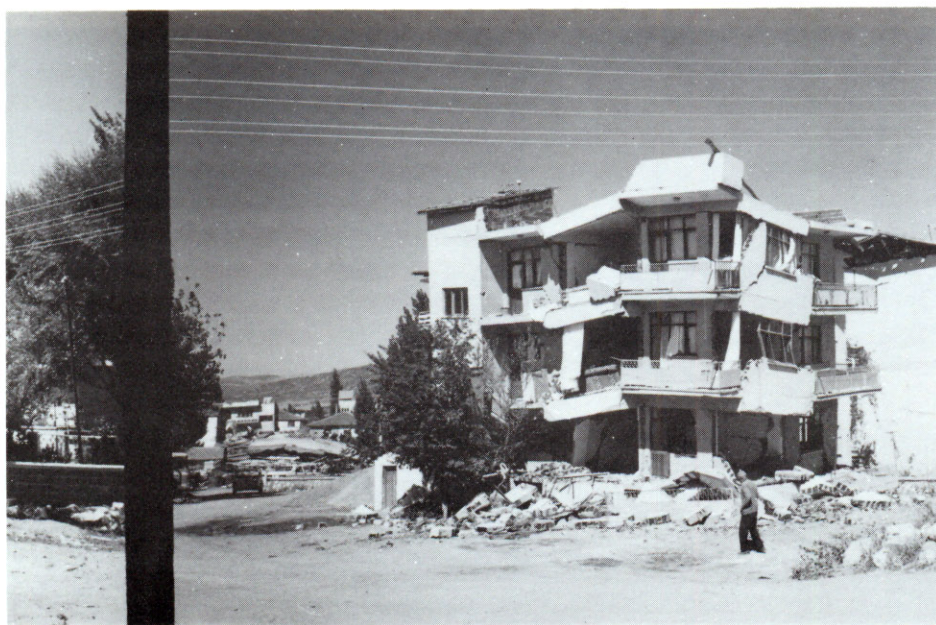
Figure 5 - Most R/C buildings in the downtown area collapsed or were severely damaged.

Most of the buildings located in the downtown area (the sediments) suffered damage. Even the series of preshocks prior to the main event caused light structural and mostly non-structural damage in some buildings in the southwestern part of town.

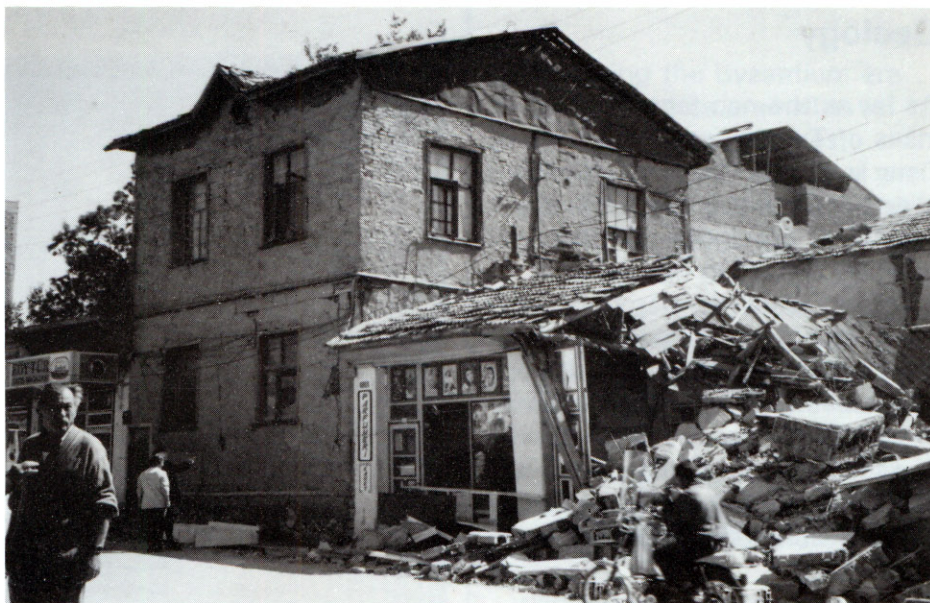
Figure 6 - Damage to an adobe building.

timber frames and some had no framing. Adobe buildings with timber frames suffered little or no damage. Plain adobe buildings suffered medium to heavy damage.

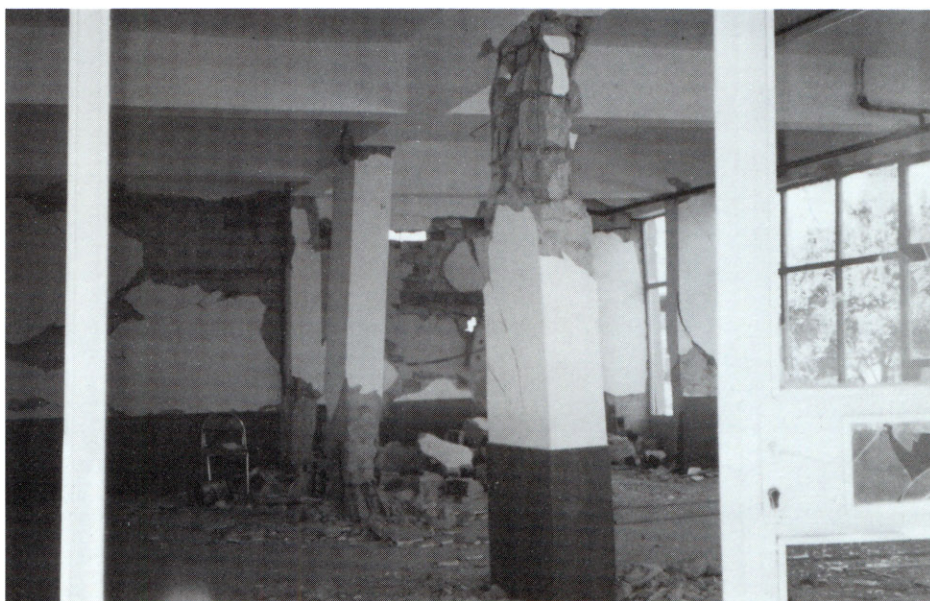
Figure 7 - Damage to soft story columns.

The main causes of damage to reinforced concrete buildings included soft story collapse,

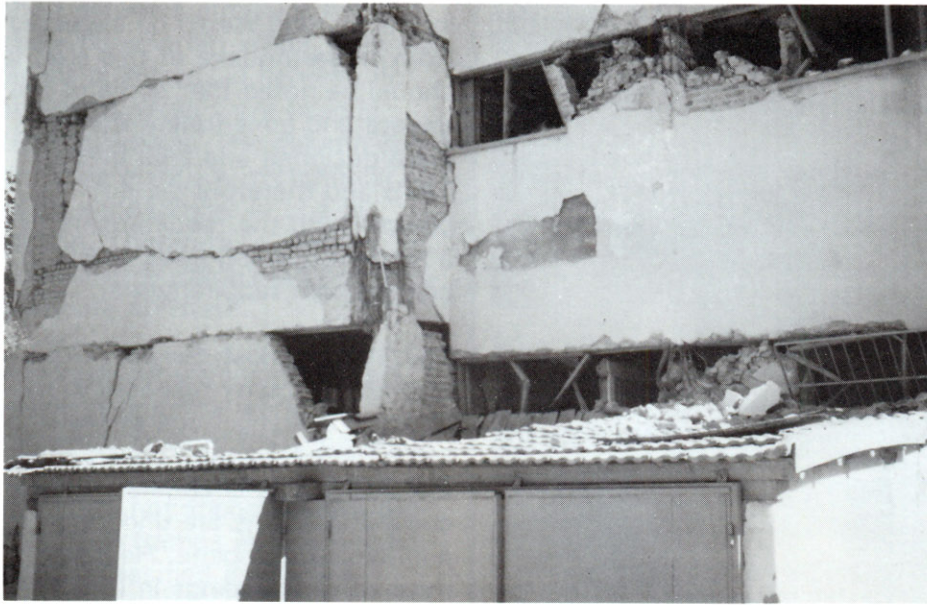
Figure 8 - Short column failure.

short columns, irregular framing, and a hammering effect from adjacent buildings. In general, no structural walls were used in Dinar buildings. The column sections were usually rectangular, being very slender in one direction. Therefore, a great number of buildings did not have adequate stiffness.

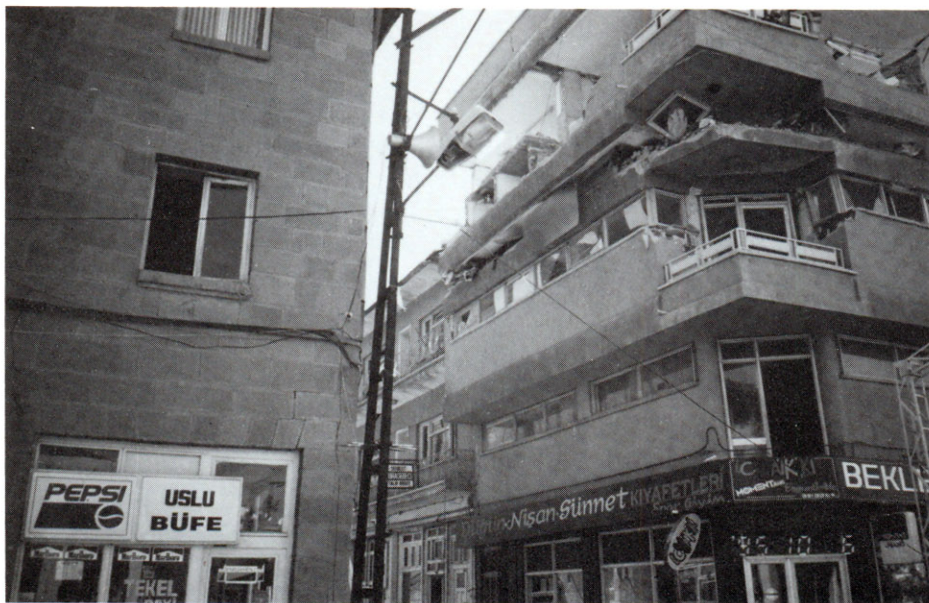
Figure 9 - Failure of middle story due to pounding.

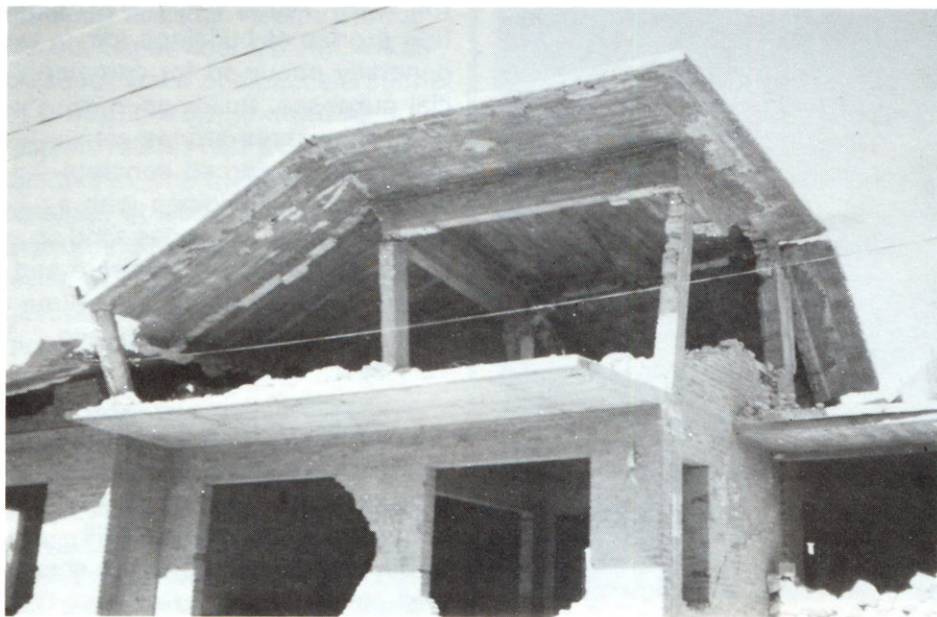
Figure 10 - Inadequate lateral stiffness due to slender columns.

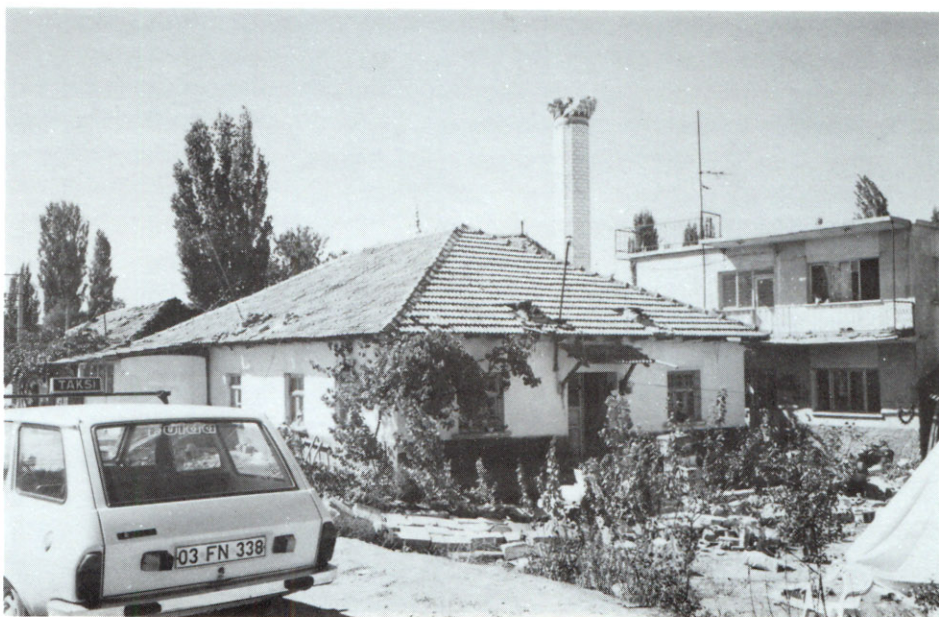
Figure 11 - Chimneys were chopped off in the downtown area.

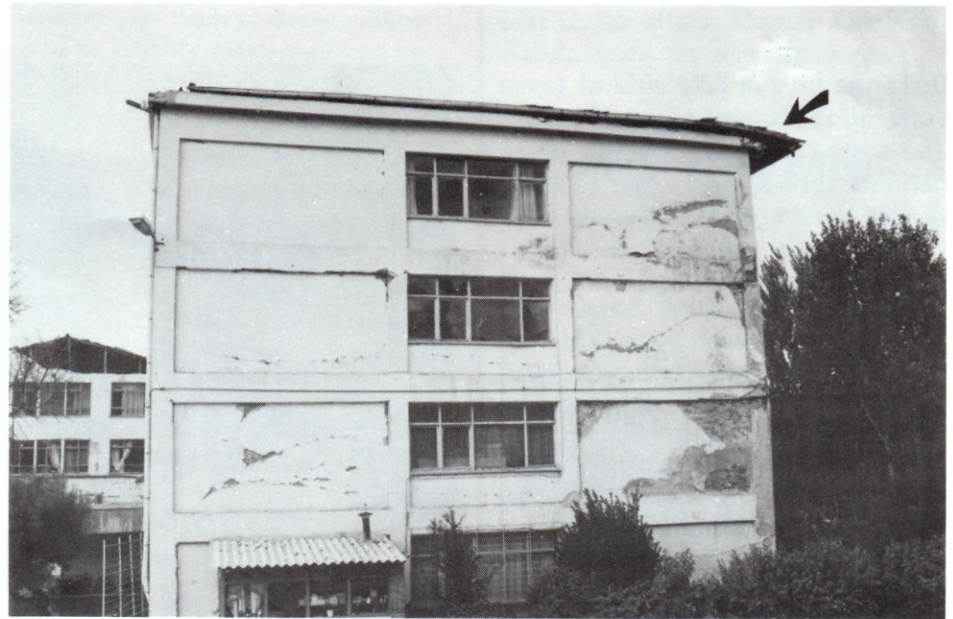
Figure 12 - Many roofs were damaged - this one moved about 1 meter N-E.

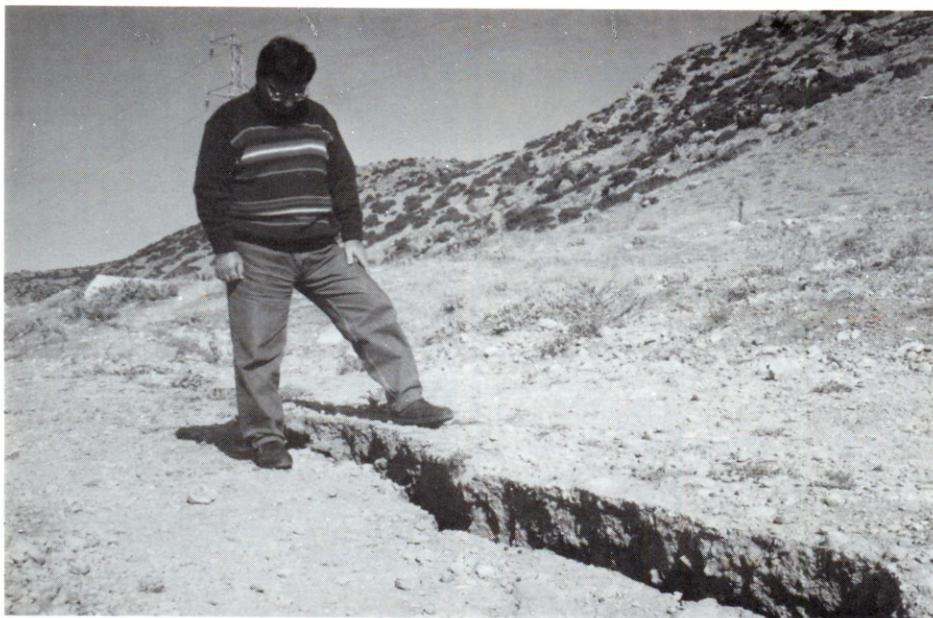
Figure 13 - Ground fracture near Dinar.

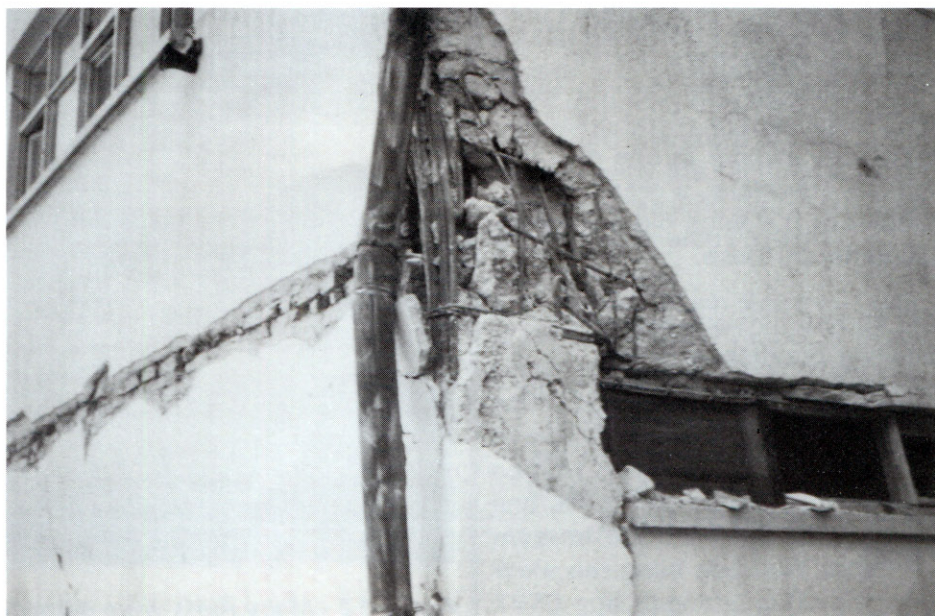
Figure 14 - Inadequate confinement at the joints and at column ends.

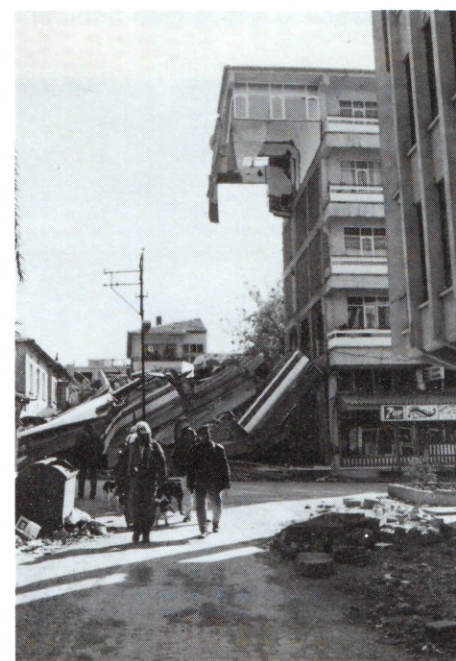
Figure 15 - The unusual collapse of a five-story building.
