Proceedings Eighth International Congress International Association for Engineering Geology and the Environment

Engineering Geological Conditions –Landslide Phenomena in the village of Ropoto Trikala, Greece

ABSTRACT: A detailed investigation and analysis of both the engineering geological – geotechnical conditions and the instability phenomena occurring in the wider area where the village of Ropoto is situated, was carried out. The basic aim of the study was to evaluate the risk of certain zones and the possibility of intervention by the application of both simple and economically feasible measures. The investigation clearly showed that the activation of slopes was caused by the co-ordinated effect of many factors, such as lithological composition, tectonics of pindos sediments covering the area, stratigraphy of both the different phases of flysch and the underlying transition zone, erosion processes, action of water and finally human intervention. Therefore, it was made clear that facing of any of the failures should be based on the detailed analysis of those factors which play a significant role in each case and refer to the wider area.

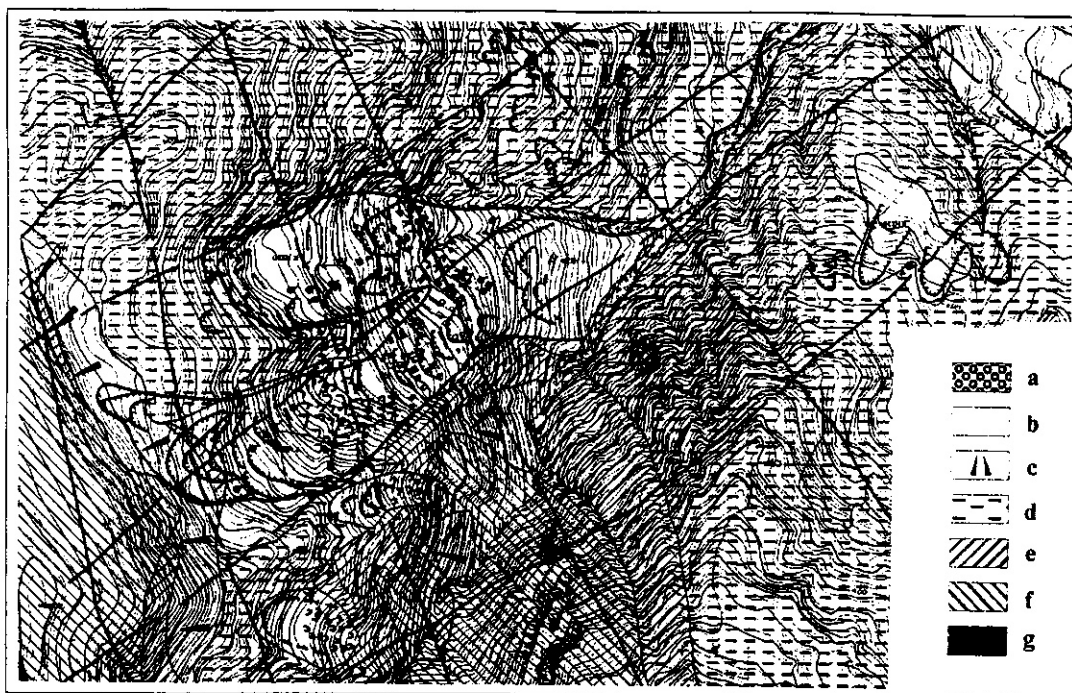
Figure 1. Map showing the geotechnical units of the area.

Ropoto village is geographically located in the North Western part of Trikala, and formations from the Pindos zone take part in its geological structure (Fig. 1).

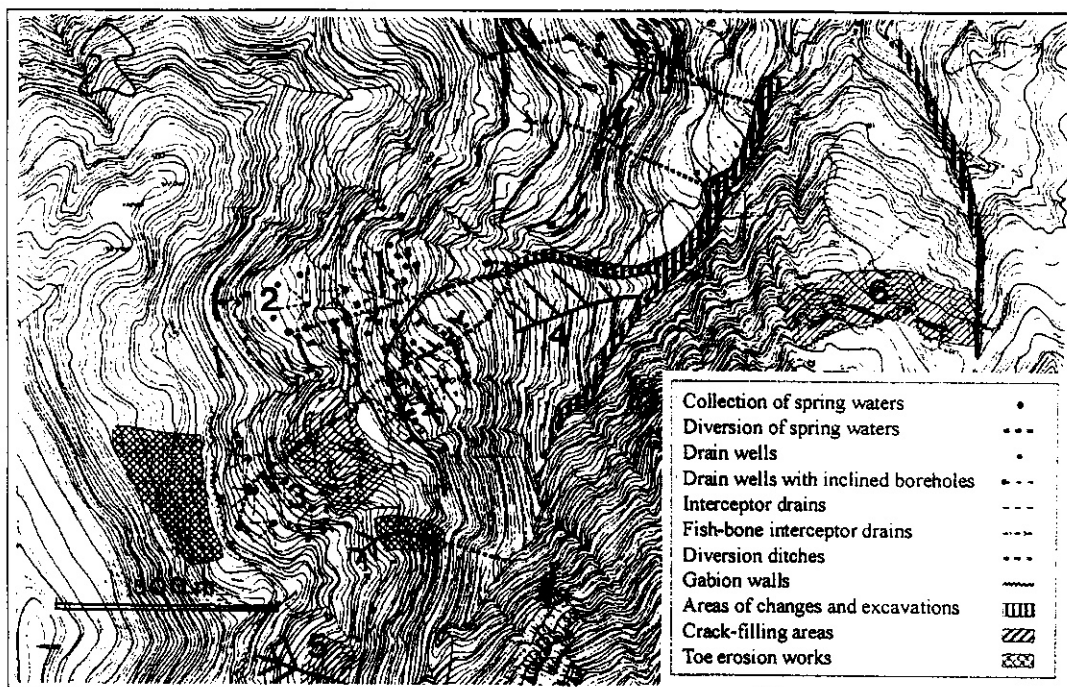
Figure 2. Map showing the suggested works and the observed positions.

In the central part (Fig. 2) of the village (main housing area) landslide phenomena are observed in both depressions (positions 2 and 3). Position 2 constitutes the northern and smaller depression and can be distinguished into two sections. The western section presents smaller dips and includes cultivated areas and a small number of houses. The eastern one presents strongly dipping slopes and is densely build. Basement formations (flysch and transition zone), covered by a thick weathering mantle structure the depression. Water from a number of springs flows into the area. Two landslides of minor importance are observed in the west side of the depression. However, landslides reported in older reports, in the elevation of 780-800m, do not seem to get activated. Today's landslides are observed in the elevation of 740m, acquiring a width of 50-60m and a leap of 10cm. This slide has destroyed a road and the yards of two newly build houses. Downward (elevation of 700-710m) these failures extend to cover all the depression. Successive fractures and slides, causing damages to houses, roads, etc. are observed in this area. Regarding the geometry of this slide, its confinement downwards and the formation of its toe in the area of the county road seems to be caused by the presence, in a small depth from the surface, of the formations of the transition zone. These formations, which form the previously mentioned anticline, prevent the sliding surface from reaching deeper horizons and act in a confined manner thus prohibiting the quick development of the phenomena. In addition, the tectonic structure of the area supports the manifestation of springs of significant discharge.

However, the most serious of the landslide phenomena are located in the southern, larger depression, where the largest part of both housing and agricultural activity also takes place.

Two extensive failure zones are encountered in this depression. The first, which starts from the forested area and reaches the cultivated area and the second, which immediately follows, and affects constructions, destroys houses and roads as it is developed in successive ruptures and slides.

The other large landsliding zone includes all the individual fractures located just underneath the toe of the previous slide. These fractures create serious damages to a number of houses and/or shops, the main church of the village, as well as to a number of auxiliary buildings. This zone seems to be formed in the downward side of the anticlinal structure and acquires a greater mobility, since, in addition to the permeating water, also accepts the loading of the toe materials of the previous slide.

Landslide phenomena of a smaller importance (as far as safety of the village inhabitants is concerned) also occur in other places, around the main housing area (Fig. 2) and they affect agricultural roads (position 5), smaller housing areas (position 6) and finally the main county road (position 1).

- retention of slopes by the construction of gabion walls,
- drainage networks and arrangement of surface waters in order to lead them out of the slopes,
- unloading the displaced deformed material, line and grade control for the formation of gentler slopes,
- development of drains in disturbed areas,
- local arrangement of the bed of both the main and secondary currents,
- dense plantation of both the unstable masses and the formed technical slopes,
- an extensive network of large diameter wells in both depressions, combined with inclined boreholes for the decrease of the water horizon and
- extensive water collection of any type of springs and outlets in both depressions.
