## TYPE AND DISTRIBUTION OF DAMAGE IN THE DINAR (TURKEY) EARTHQUAKE (OCTOBER 1, 1995)

Prof. P. Carydis\* & Assist. Prof. E. Lekkas\*\*

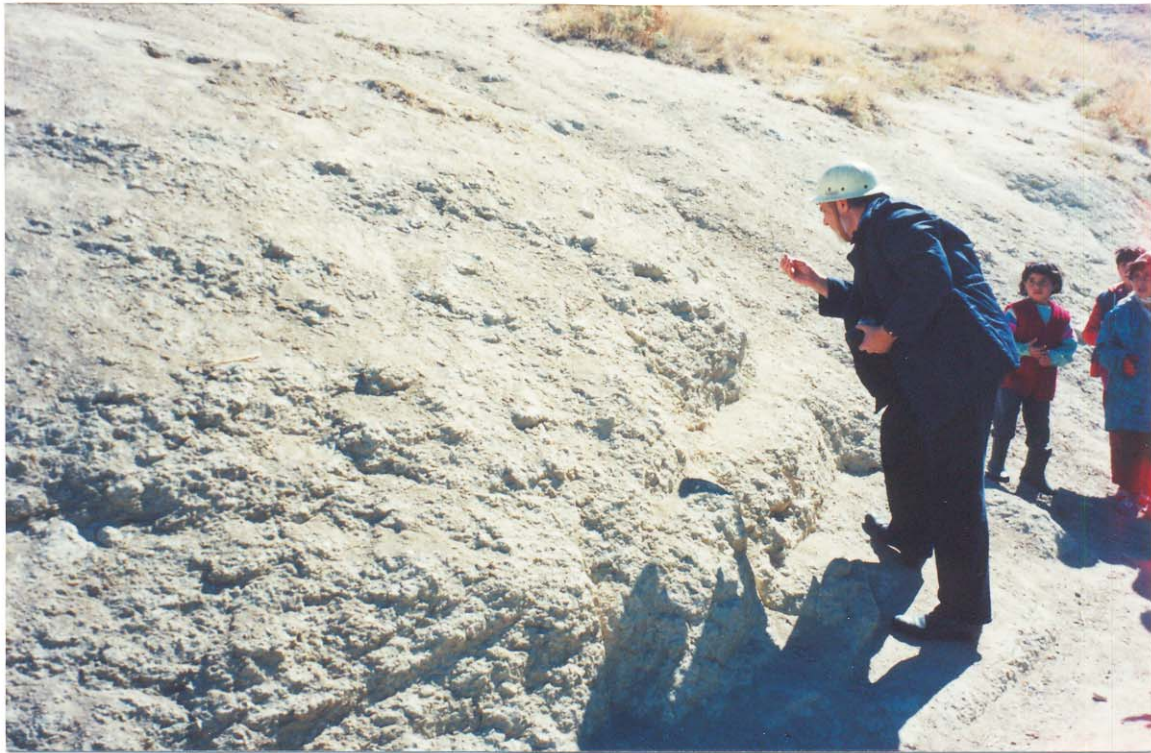
The surficial geology of the hills to the east of town consists of Cretaceous and Eocene limestones and Oligocene marly limestones (Fig. 1). The plateau is covered with Quaternary alluvium containing sand, gravel and clay (M.T.A., 1973). The transition areas at the foot of the hills are covered by continental deposits (Fig. 2). Reports indicate that NW-SE trending fault ruptures have been observed at Dinar city and at about 5 km northeast of the city following the earthquake.

**Fig. 1** Marly limestone that outcrops at the east part of Dinar city.

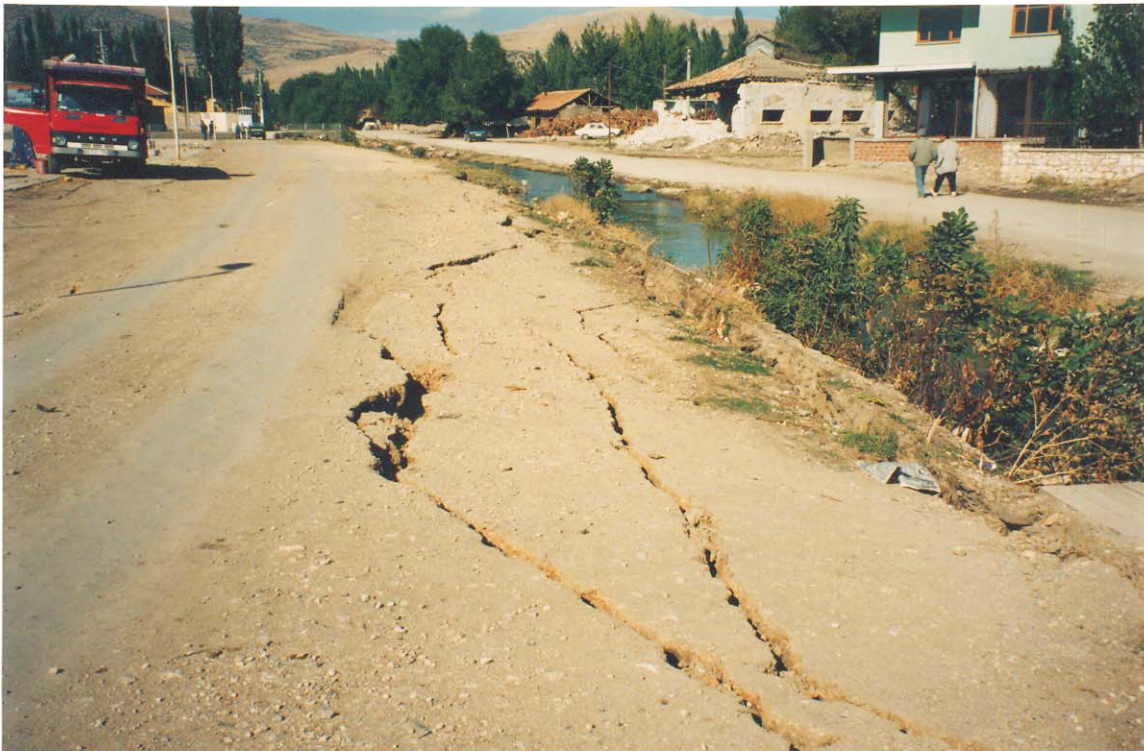
**Fig. 2** View of the west, flat section of Dinar city that is covered by recent (Holocene) sand, gravel and clay deposits.

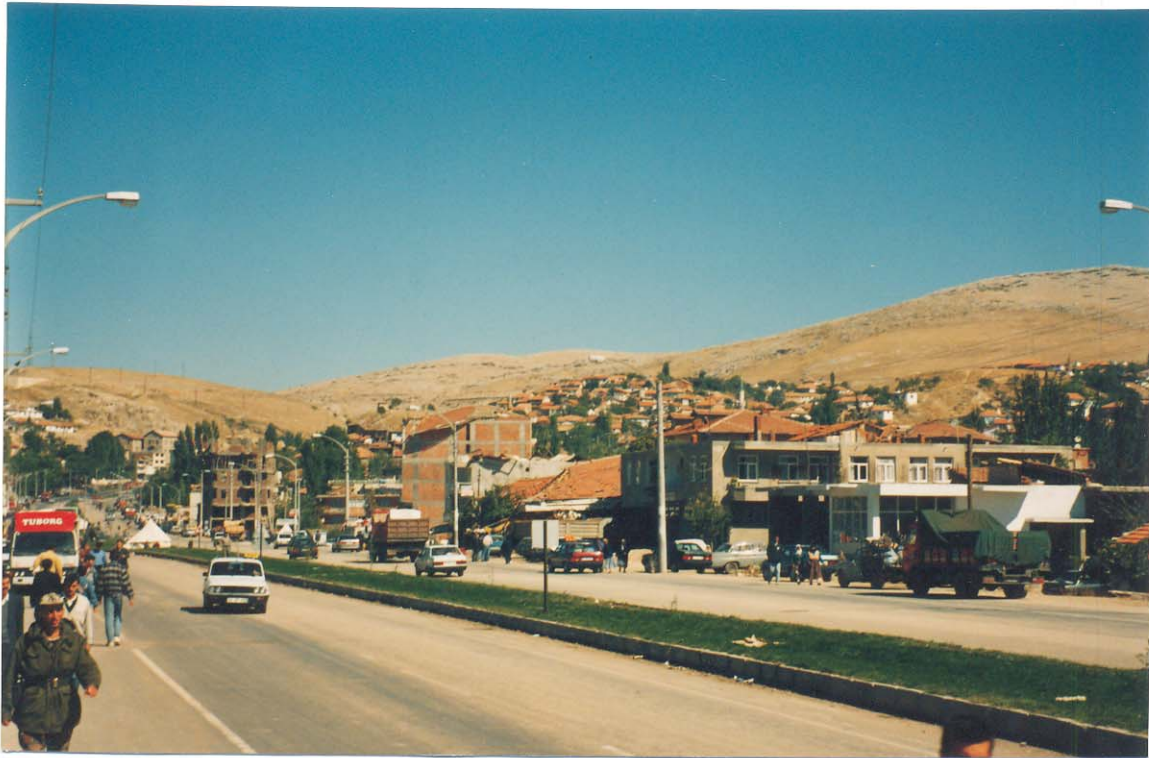
**Fig. 3** View looking east at the part built on bedrock outcrops (limestone and marly limestone). At this particular section of the city, damage was limited.

The damage in Dinar is localised in some sections of the city. In the higher parts of Dinar, where the foundations were on bedrock, the effects of the earthquake on buildings were small or non-existent (Fig. 3). Here the buildings, their chimneys and the minarets were untouched. The damage starts gradually (fractures in chimneys, breaking off of top part of minarets, damage to buildings), as one proceeds towards the lower parts of the city (Fig. 4). Damage reaches a peak in the center of the city and then starts to decrease. The last phenomena occur on thick alluvial deposits (Fig. 5, 6).

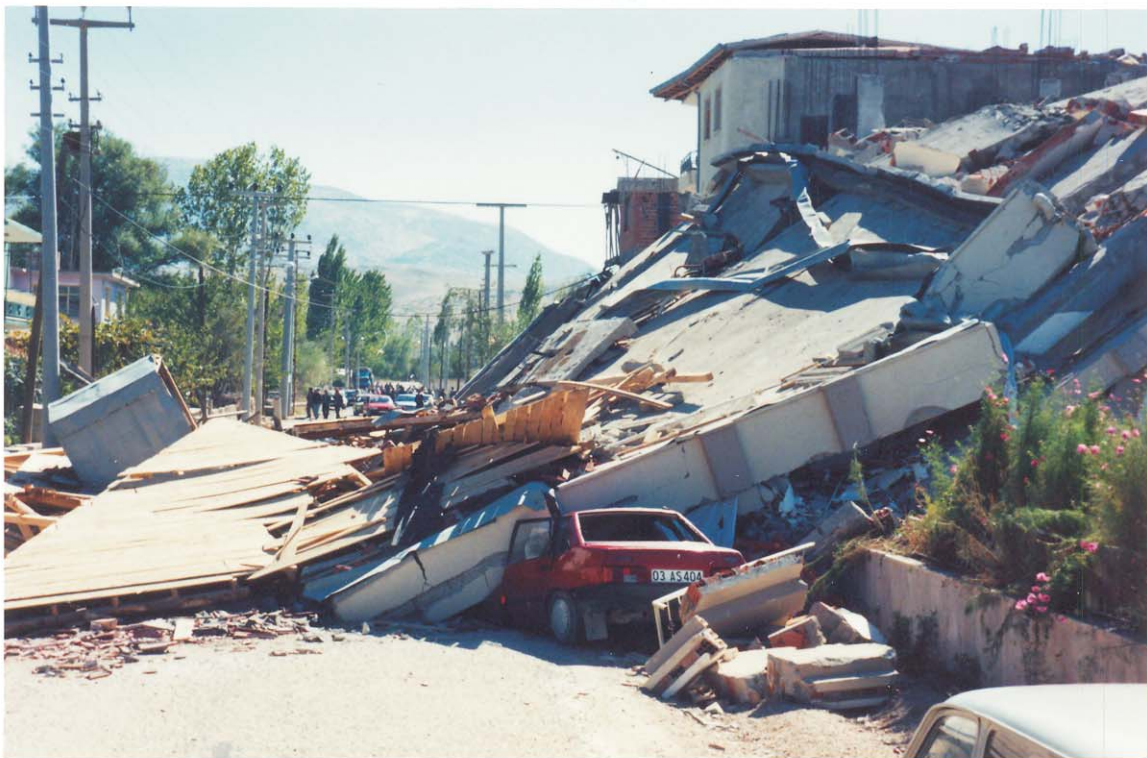
Most of the four- and five-story reinforced concrete apartment buildings were either heavily damaged or totally collapsed. Some three-story buildings suffered similar damage. One- or two-story building collapses were rare. Initial estimates based on preliminary walking surveys indicate that approximately 30 buildings totally

**Fig. 4** Collapse of a multistorey R/C building at central Dinar where thin, loose formations are present.

collapsed and around 50 to 60 buildings experienced first-story and occasionally an intermediate story failure.

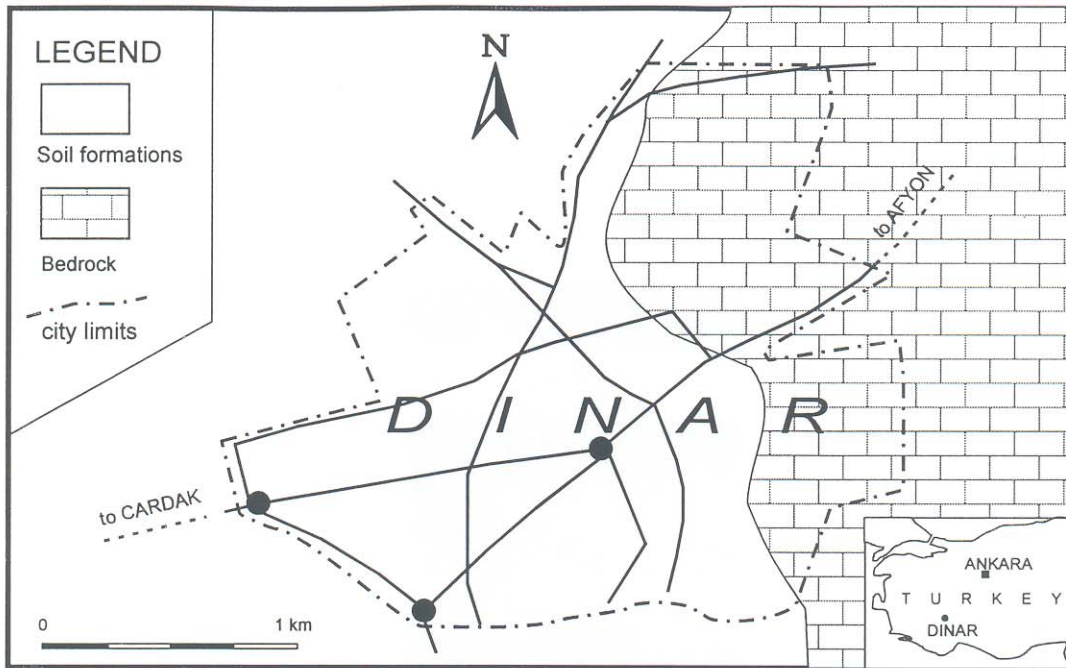
**Fig. 5** Geologic sketch map of Dinar city (1. Cretaceous - Eocene limestone and Oligocene marly limestone, 2. Holocene sand gravel and clay deposits).

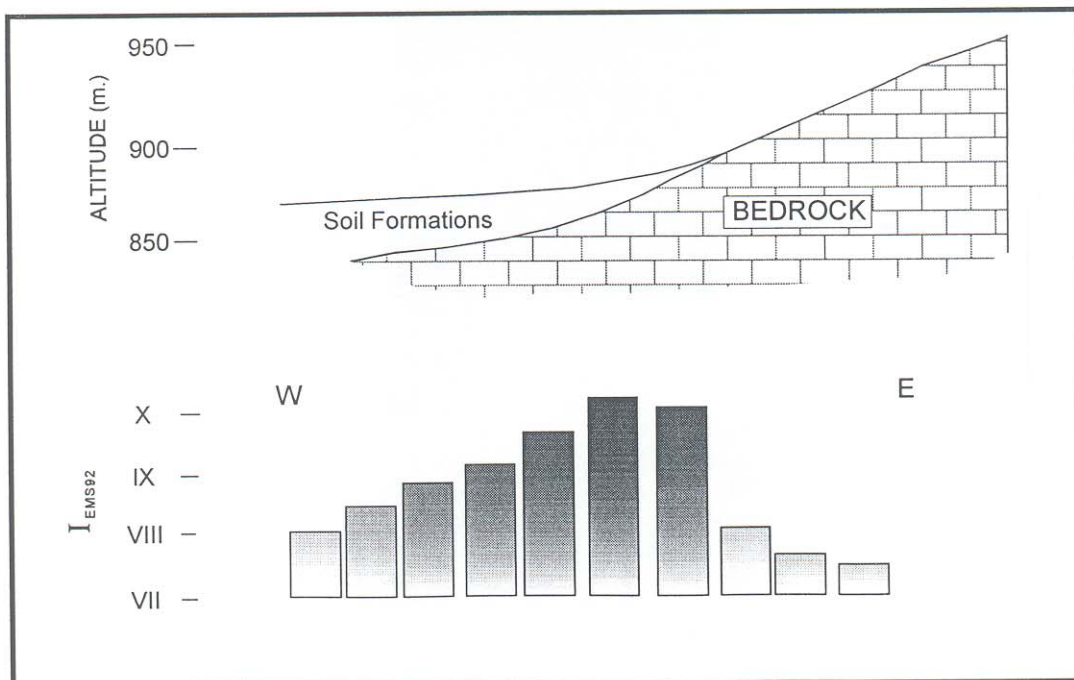
**Fig. 6** E-W cross section showing intensity distribution. Note that intensity is getting higher at the city center formed by loose and thin soil formations.
