Earthquake Resistant Engineering Structures

Linear damage distribution and seismic fractures at the Egio earthquake (15 June 1995, Greece)

E. Lekkas, S. Lozios, H. Kranis & E. Skourtsos

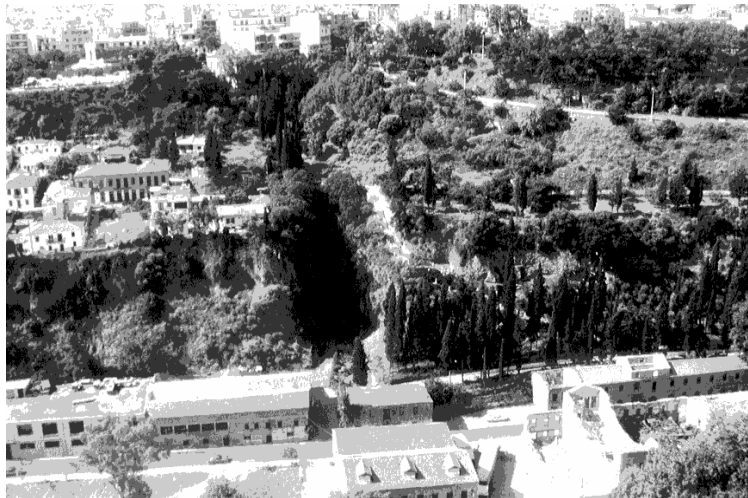
Figure 2. The Egio fault scarp. View to the south

The fractures occurs at the base of a 100 m.-high, E-W trending escarpment, whose height decreases heading eastwards. To the north of the scarp there is a flat area with a mean altitude of 30 m., while to the south we meet hilly terrain with altitudes of more than 120 m. The scarp must have been created by a (?)normal fault (Egio fault, Fig. 2), the hanging wall of which consists of loose alluvial and fluvial deposits and its footwall comprises Late Pleistocene-Holocene consolidated conglomerates.

The seismic fractures occur along the foot of the scarp and display a small vertical offset of 1-2 cm (north side downthrown). They are visible at the western end of the fault, from the western outskirts of Egio up to Rododafni.

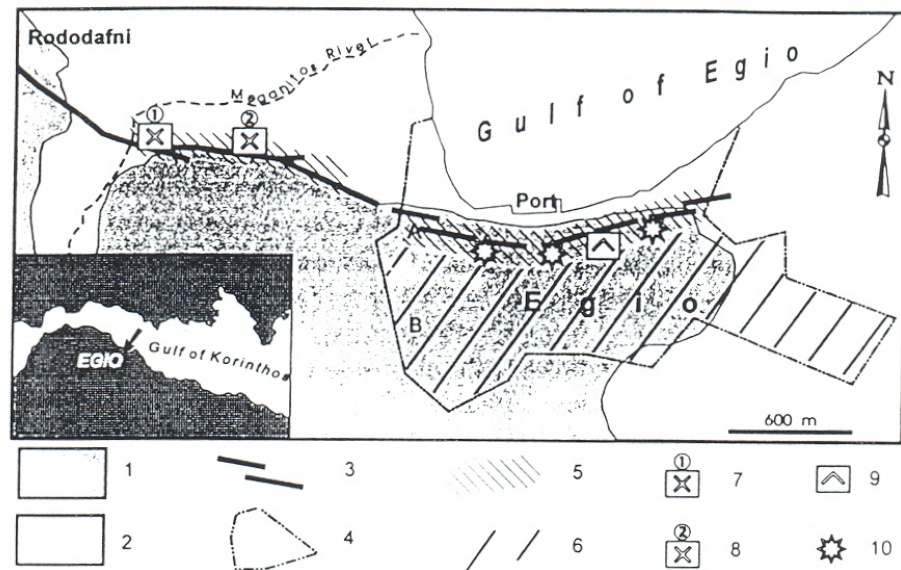
In the following sections the distribution of damage will be discussed in detail, together with the prevailing geological factors. The town of Egio was divided into two zones (A and B) depending on the intensity of damage (Fig. 3). These two zones strike roughly E-W; zone A is characterised by intense damage, while in zone B the damage is less and mostly non-structural. More specifically:

It covers the northern part of the town that develops parallel to the coast and lies at the footwall of the Egio fault, adjacent the fault trace. The most severe damage was located there, with R/C, and stone-built houses having suffered structural damage. A considerable number of houses was rendered demolishable.

It should be noted that all over zone A most of R/C constructions suffered extensive damage. In Fig. 3 four cases of destroyed houses built to meet the 1984 Earthquake-Resistance Regulation are shown. Besides, the apartment block that collapsed lay in this zone..

Figure 3. Damage distribution sketch. 1: Egio formation, 2. Holocene formation, 3. Seismic fractures, 4. Town limits, 5. Zone A, 6. Zone B, 7. Hellenic Weapon Industry, 8. Kouniniotis factory, 9. Collapsed apartment block, 10. Demolishable apartment blocks

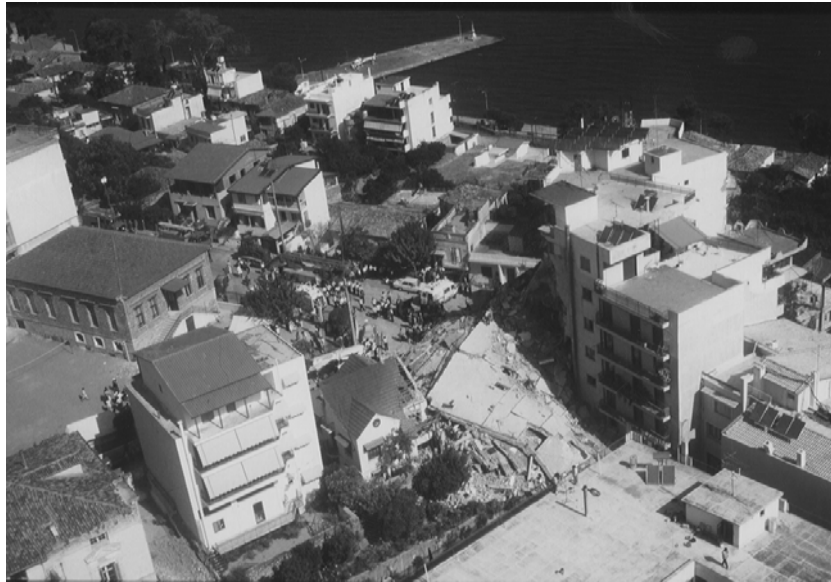
The collapsed building was next to the possible trace of the seismic fracture (Figs 3, 4), on the footwall of Egio fault. It was built adjacent to the fringe of the escarpment, where the topographic gradient exceeds 70%. The foundation soil has relatively good quality, while no subsidiary effects (local subsidence, liquefaction, etc.) were observed.

Similar are the conditions for the other 3 modern buildings that were damaged beyond repair in zone A.

Figure 4. Aerial view of the collapsed apartment block. The port of Egio can be seen in the background. The Egio fault scarp runs from the top left to the middle right of the photo, directly beneath the row of buildings

3. At the eastern part of the zone, which is mostly inside the town, severe and irreparable damage was observed at modern buildings (as the collapsed apartment block). Damage here is believed to be mainly related to the occurrence of seismic fractures. The morphological conditions were negative, but played a secondary part, while the foundation conditions are quite good.

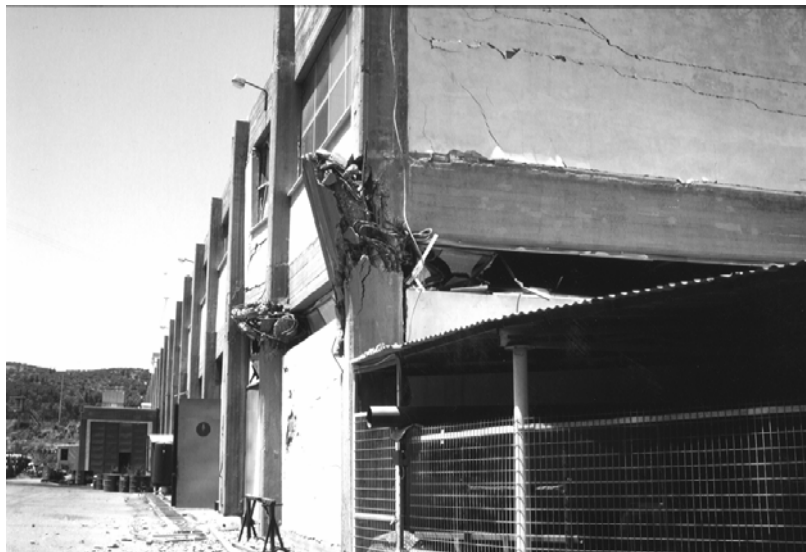
Figure 5. Severe structural damage at the building of Hellenic Weapon Industry.

foot of the escarpment (hanging wall of Egio fault) are several buildings with increased anti-seismic properties, as the HWI and Kouniniotis factories. Despite the fact that these buildings were built to meet high earthquake-design standards, they suffered severe structural and non-structural damage (certain parts collapsed, deformed beams and columns, destroyed masonry) (Fig 5).

The foundation soil has poor geotechnical parameters (Table 1), since it comprises loose conglomerates and sands of Meganeitos river terrace. The thickness of these deposits is 50 m. and overlies the consolidated conglomerates of Egio.

The trace of the seismic fracture has an overall WNW-ESE trend and coincides with the foot of the escarpment of Egio fault. It is traceable from Egio to Rododafni and can be seen cutting not only the soil but also the constructions (walls, columns, floors, etc.) founded on it. Traces of the fracture were found all over the destroyed or collapsed part of the HWI building. Besides, two liquefied sites were located, along the seismic fracture and inside the southern part of the premises. However, the deformation of the ground floors at other places suggests that liquefaction was more widespread and affected the majority of constructions.

4. At the western part the zone, extending from the west of Egio to the industrial area there was considerable damage to high-standard buildings, and is attributed to a combination of negative factors, that is the occurrence of the seismic fracture and liquefaction of foundation soils, which have poor geotechnical parameters and were suitable for liquefaction.
