International conference
EngeoPro-2011

THE MW=9.0 TOHOKU JAPAN EARTHQUAKE (MARCH 11, 2011) TSUNAMI IMPACT ON STRUCTURES AND INFRASTRUCTURE

E. Lekkas, E. Andreidakis, V. Alexoudi, E. Kapourani, I. Kostaki

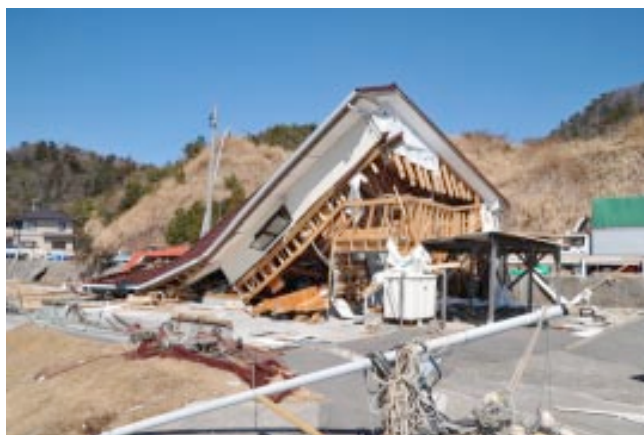
On the contrary, the tsunami impact was devastating. More specifically, they were totally swept by the wave forces and by the impact of objects carried by the water. They were broken to small pieces of debris,

which were deposited in the inundated areas, or were carried to the cost-line or the open sea, when the water receded. A great number of this particular type of constructions were swept by their footings and were carried, practically unchanged, to great distances (Fig. 2, 3, 4).

Fig.2. Collapse of a wood frame house in Iwaki area. Tsunami height of about 5 m

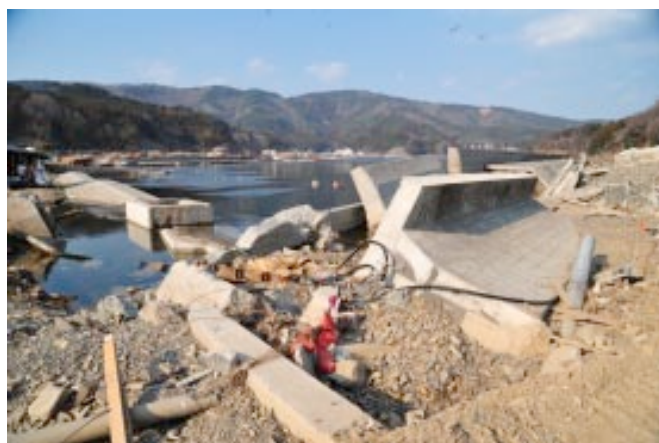
Specifically, failing and deformation of quay walls was observed, caused either by the hydrodynamic forces of the waves, or the impact of objects such as boats and containers.

In many cases the quay walls and the accompanying supporting constructions collapsed or were overturned, due to the intense scour of the foundation materials. Moreover, the seaport constructions proved to be especially vulnerable to receding waters, which caused intense deformation and overturning.

Finally, the piers constructed in order to protect against tsunami waves, could not cope with the observed tsunami, either because of inadequate or underestimated structural design, or because of collapse, resulting in devastating effects on inland areas. In addition, severe failures because of intense erosion were observed in levees and coastal river regulation constructions (Fig. 8, 9).

Fig.8. Destroyed port facilities and general alteration of the shoreline in Mizuhama town

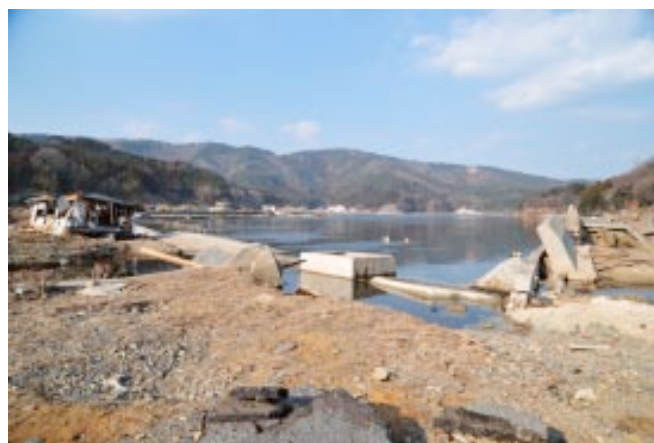
Fig.9. Destroyed port facilities and general alteration of the shoreline in Mizuhama town
