# The October 23 ( $M_w = 7.2$ ) and November 9 ( $M_w = 5.7$ ), 2011 Van, Turkey earthquakes. A geoscientific and engineering report

Panayotis Carydis\*, Efthymis Lekkas\*\*, Christos Papaioannou\*\*\*, Andreas Tsokos\*\*\*\*, John Delakouridis\*\*\*\*\*

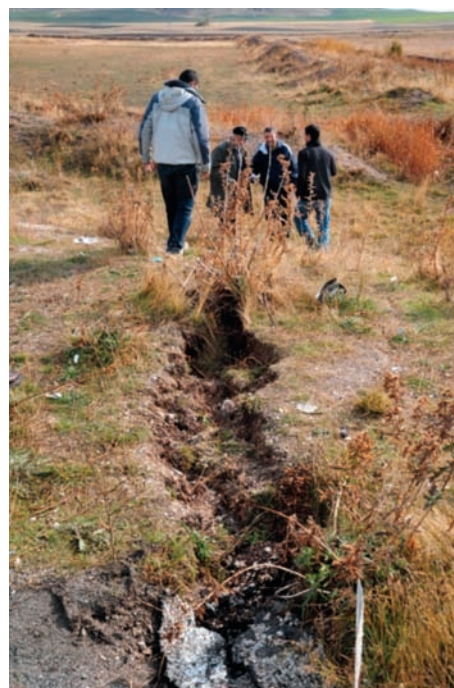
Fig. 2. The seismic rupture, crossing the main road of Van-Ercis, is very close to epicenter, which is associated with the October 23<sup>rd</sup>, 2011 earthquake, see Fig. 5.

cessive lakes and ground elevations, as a result of the pop-up and pop-down structures Fig. 2.

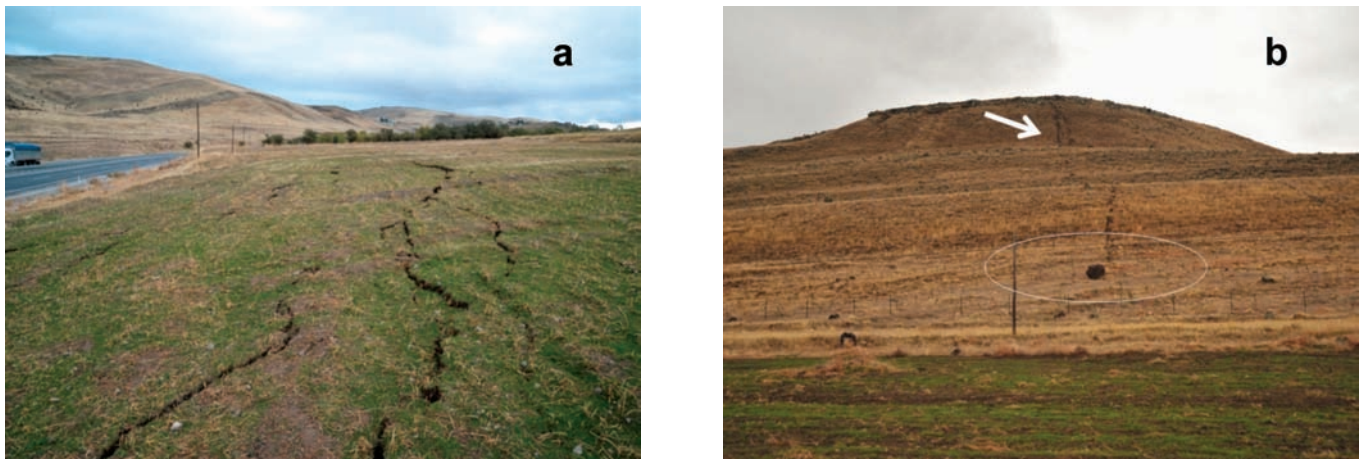
Fig. 4. (a) Landslides and (b) rockfalls at the north of the epicentral area (hanging wall).

of adverse soil dynamic conditions and the reflection of the seismic waves at the rock basement. Finally, several landslides and rockfalls were observed at the north block, whereas at the south block they are absent, Fig. 4.

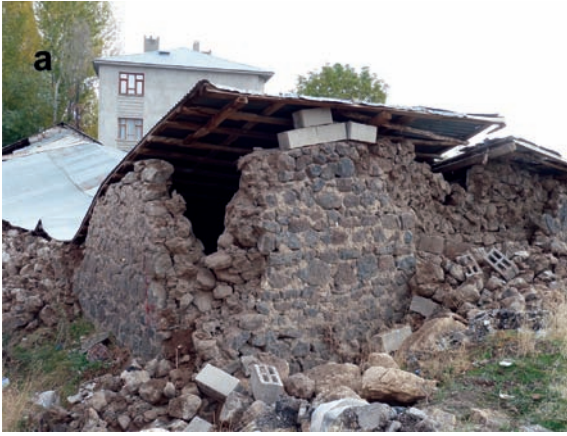
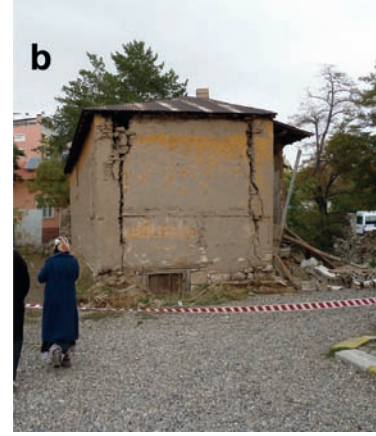
Fig. 16a, b. This manner of damage of simple houses indicates the dominance of vertical seismic component.

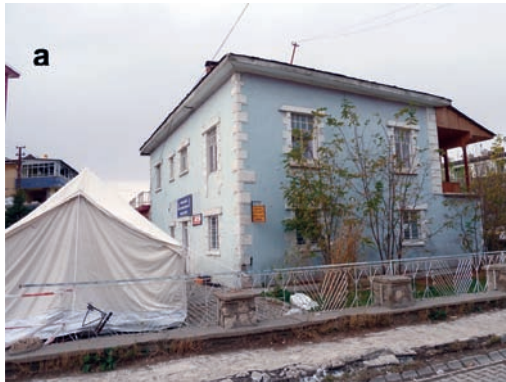
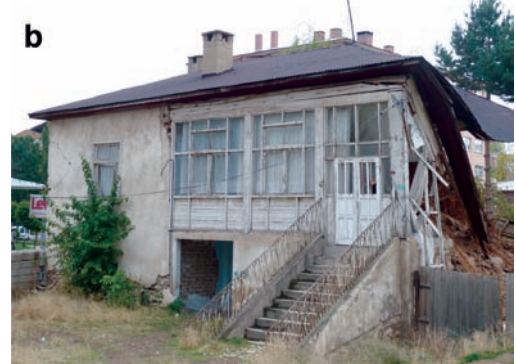
Fig. 17a, b. Traditional masonry buildings survived the main shock with minor or no damage.

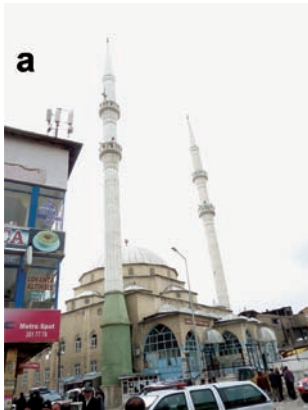
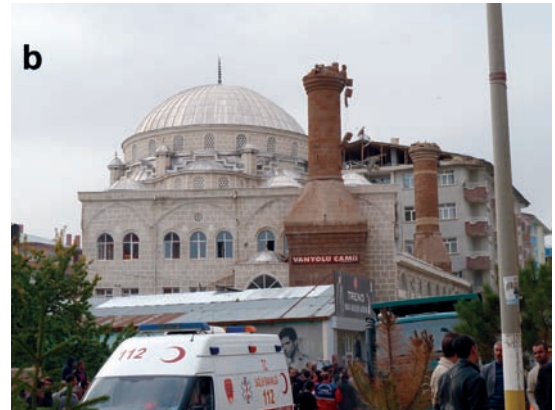
Nevertheless, it must be stated that in some locations the final damage could be attributed to the dominance of the horizontal seismic component too. This is depicted, for example, in the damage of a minaret, while many others remained intact.

Fig. 18a, b. Most of the mosques with their minarets weathered the main shock without any damage. In a limited number of cases parts of minarets toppled.

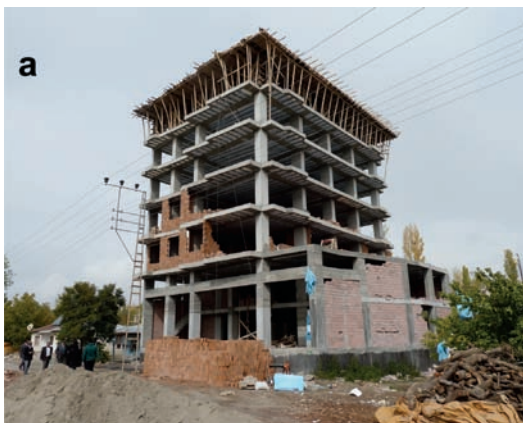
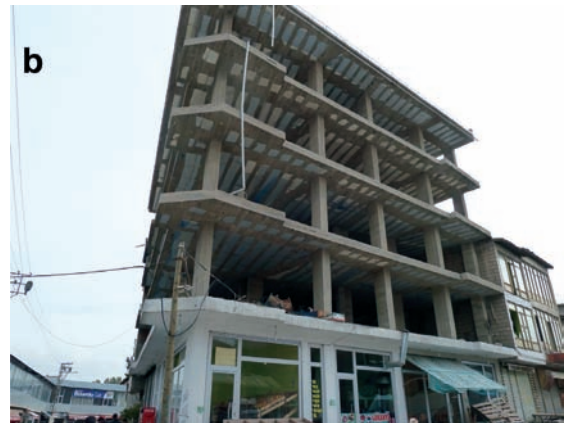
Fig. 19a, b. Flexible buildings with rather large openings and without shear walls, as well as those with a one way flat-slab construction system are prevalent in new structures.

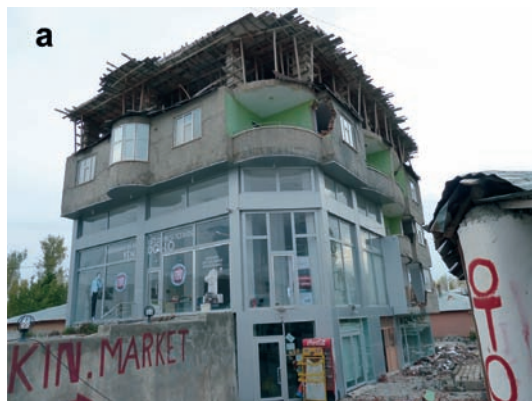
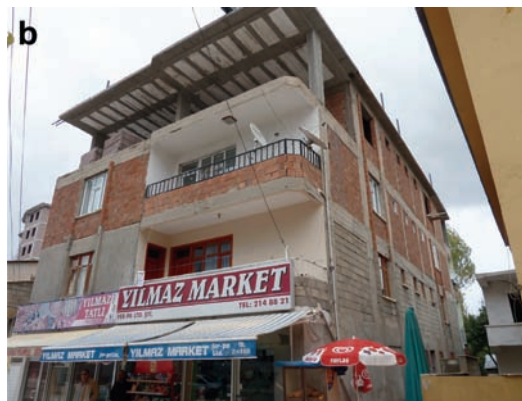
Fig. 20a, b. Usually, one or two storeys are added at the top and the balconies are externally closed with masonry partitions.

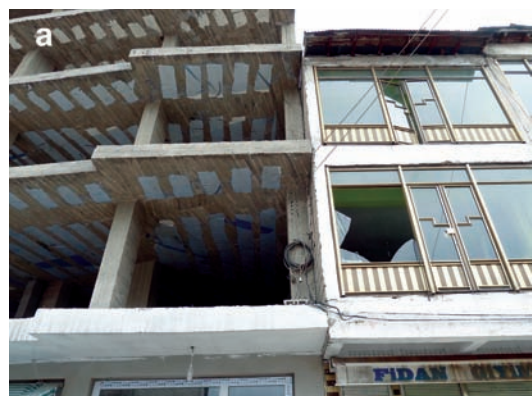
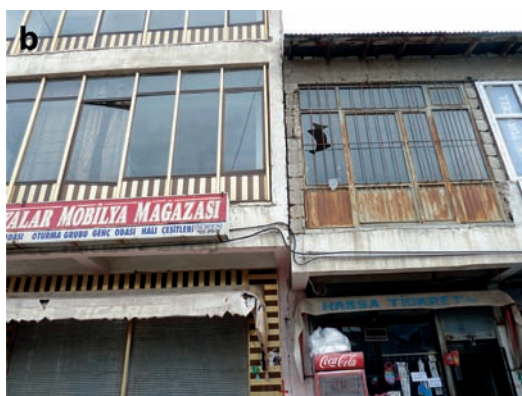
Fig. 21a, b. No evident horizontal motion, or breaking of glass panels, or pounding between adjacent buildings was observed.

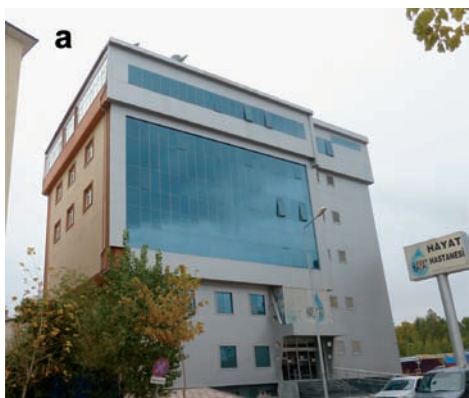
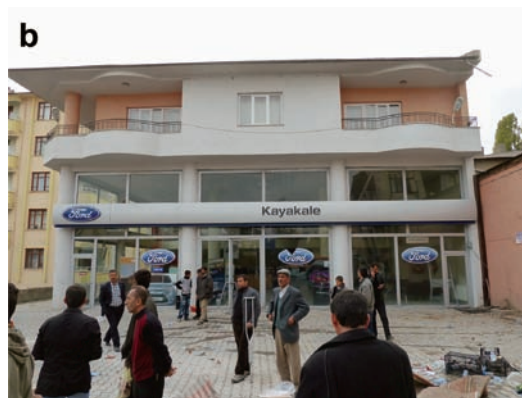
Fig. 22a, b. Externally, some well designed and constructed strong modern buildings, did not present any damage. Internally, the secondary elements and the content suffered extensive damage.

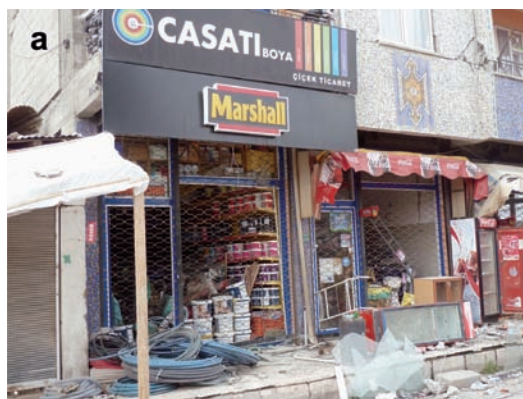
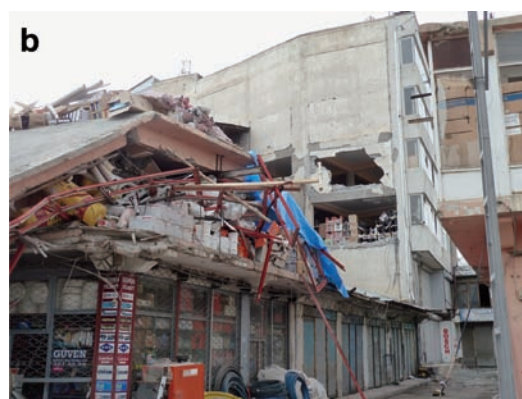
Fig. 23a, b. The content and appendages in old / flexible / soft buildings weathered the events with rather limited losses.

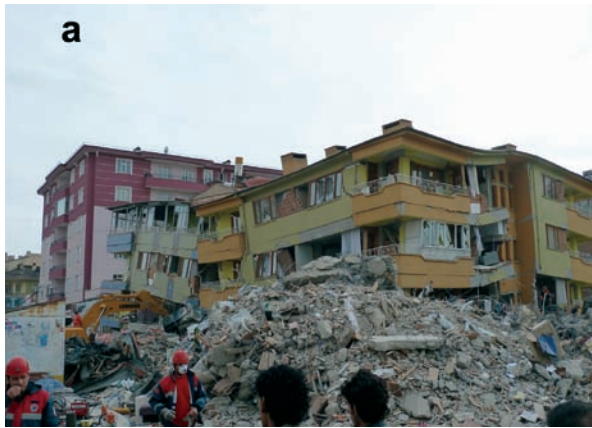
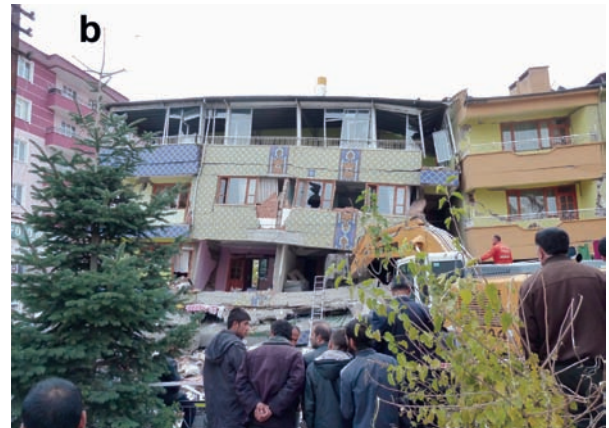
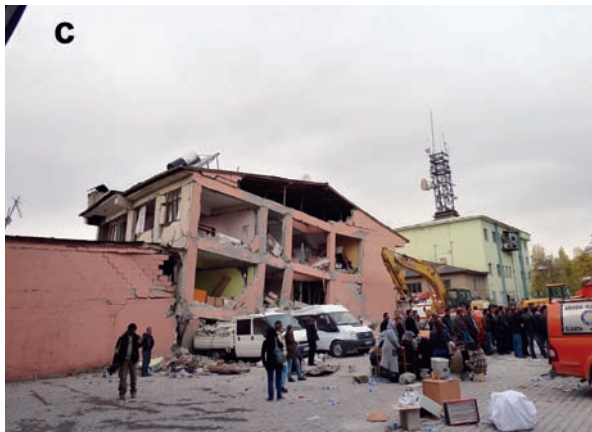
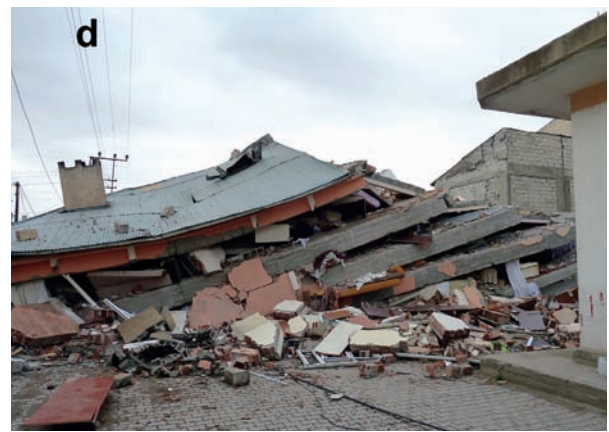
Fig. 24a-d. An agglomerate of collapsed buildings in the city center of Ercis. Note, that some chimneys are standing upwards.

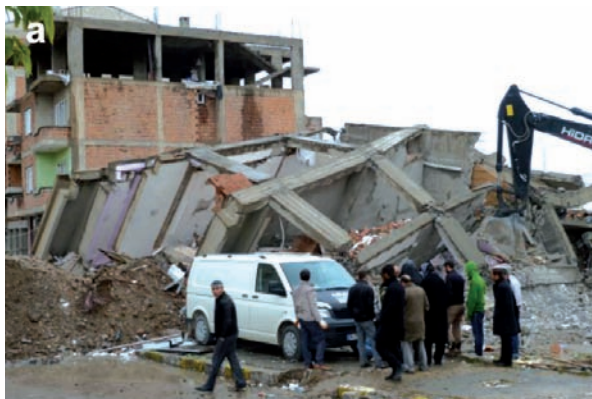
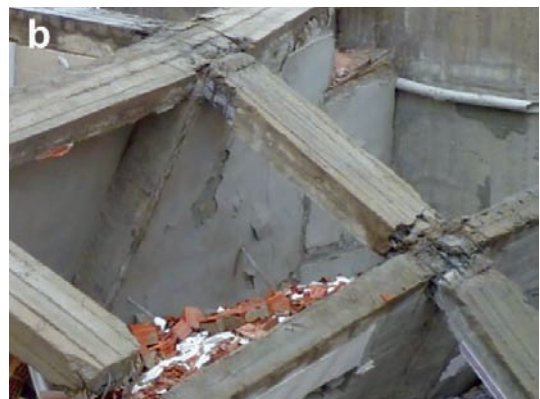
Fig. 25a, b. A technically interesting collapse. The reinforcement detailing is acceptable. Perhaps the concrete quality might have a problem or the concreting.

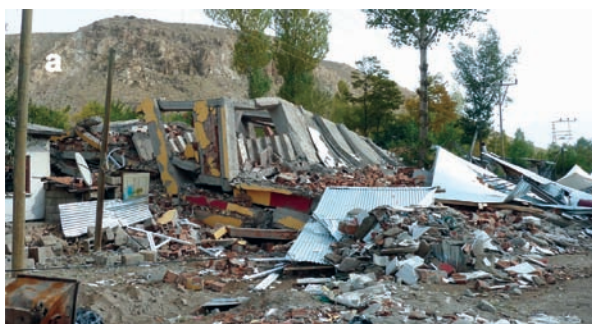
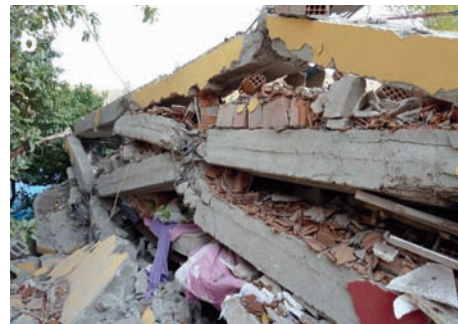
Fig. 26a, b. An other technically interesting collapse: a) In the fore-ground is the roof and the roofing corrugated iron-sheet; b) The top is the back column. The other columns are shaken off. Note that a flat-slab construction system does not allow any space for protection during collapse. The owner was describing that during the main shock he was staying on the ground. He felt two extremely violent upwards jolts, the one followed by the second making him to jump-up. At that time the building was jumping-up too. It was balancing, at the first cycle it stood on the front columns in parallel to the street. Next, the building stood on the back columns and then in the front ones with a stronger stroke when it toppled over.

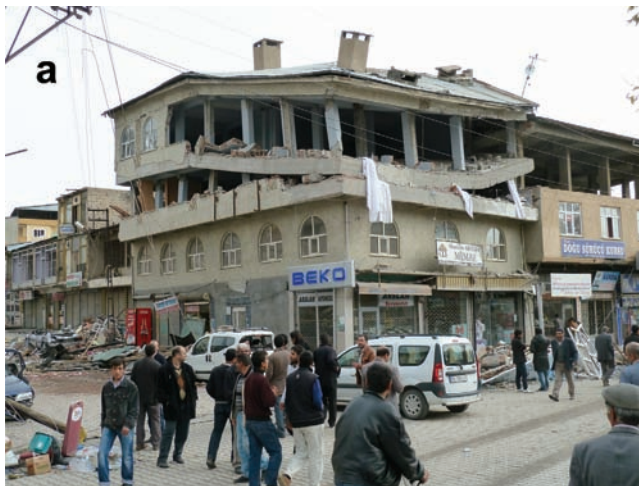
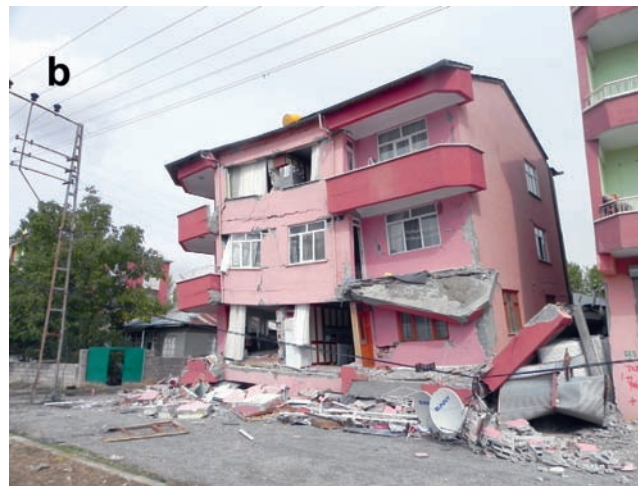
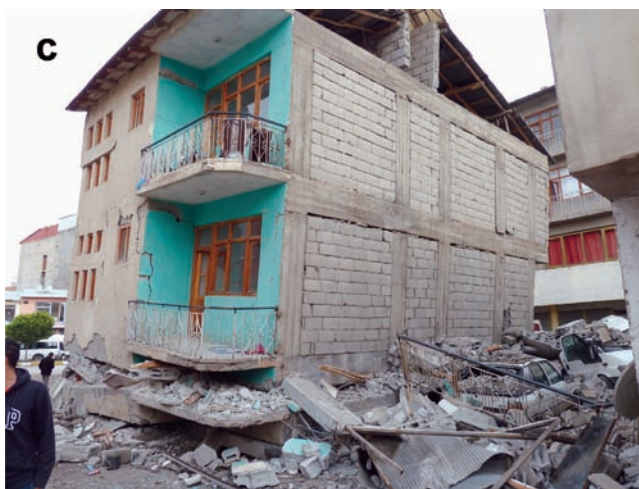
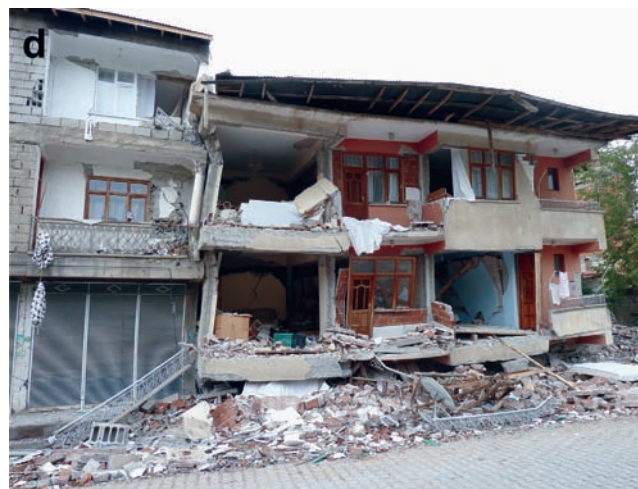
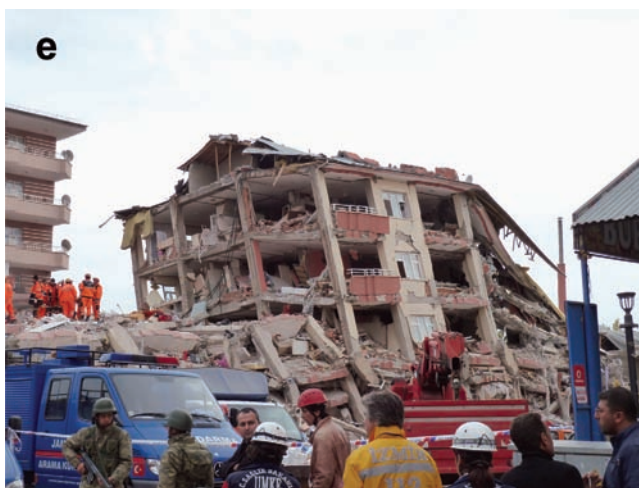
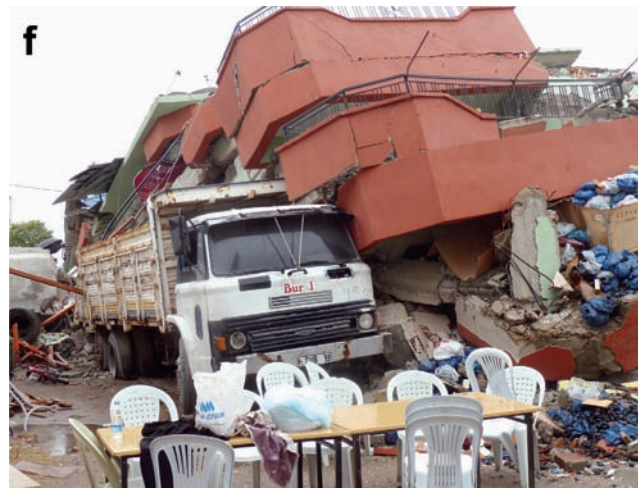
Fig. 27a-f. Heavily damaged and collapsed buildings in Ercis city.

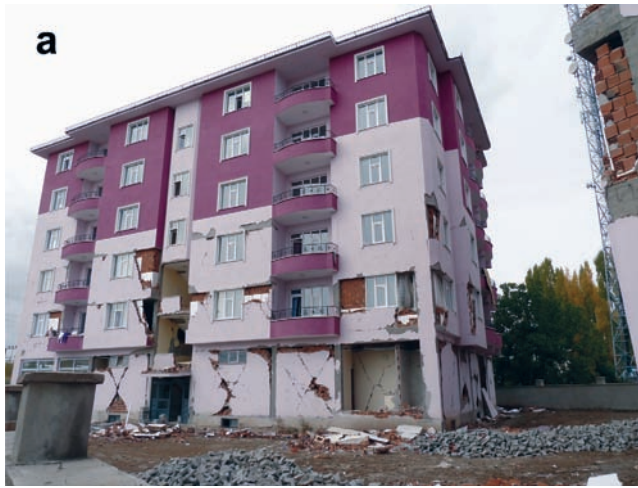
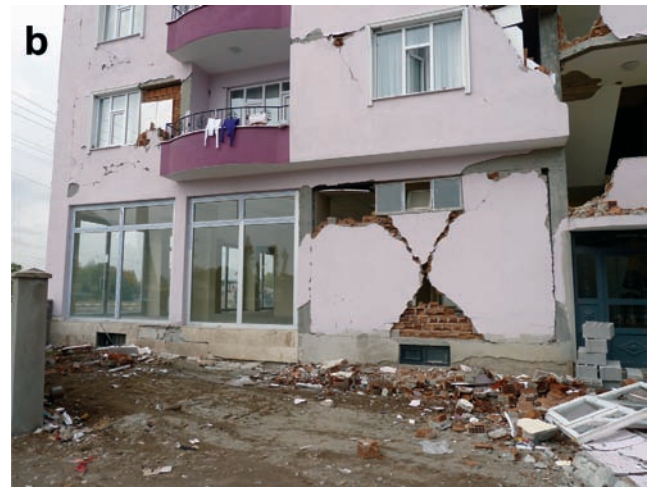
Fig. 28a, b. Note that the glass panels are intact while the walls are damaged especially at the lower levels. This is the case for almost the majority of the damaged-not collapsed multi-storeyed buildings, in Ercis city.

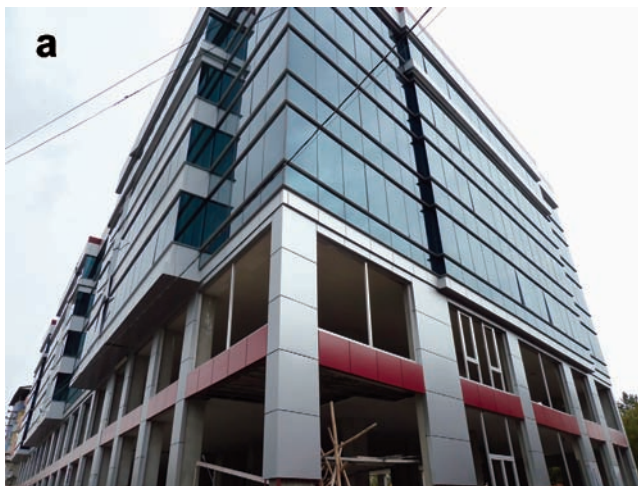
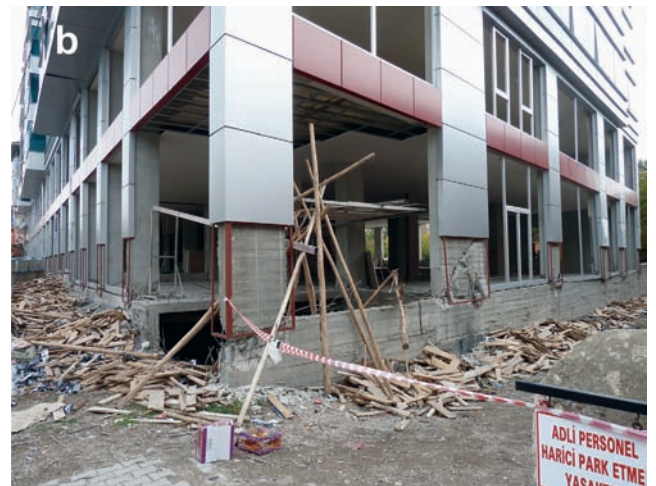
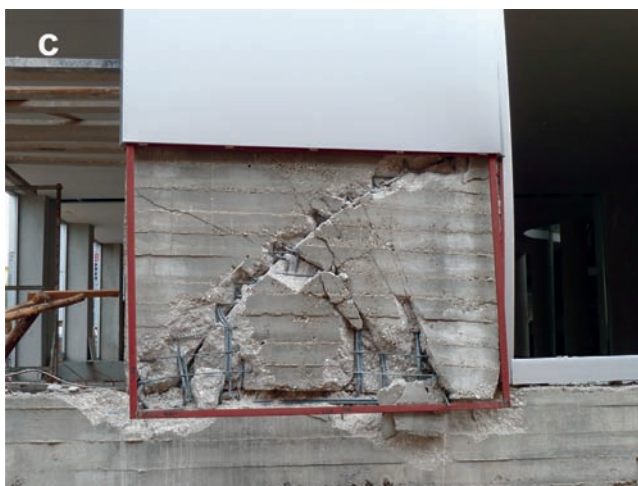
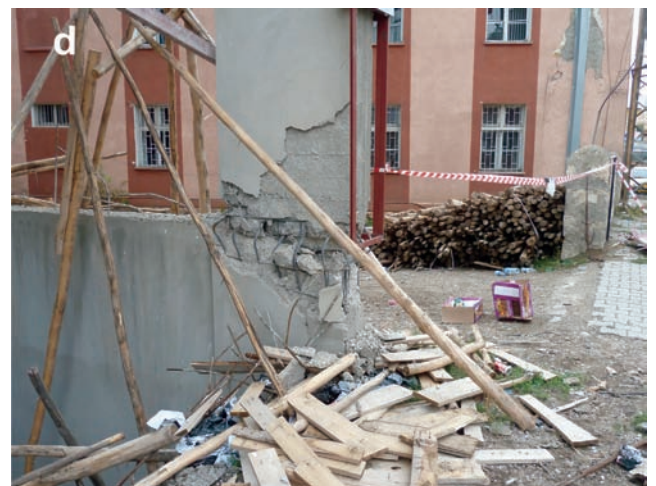
Fig. 29a-d. A just erected building with acceptable reinforcement detailing. The majority of the columns in the ground floor suffered mainly compression damages. There are no noticeable horizontal displacements.

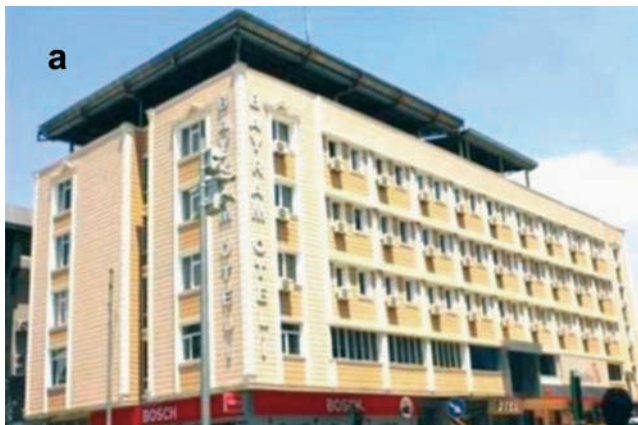
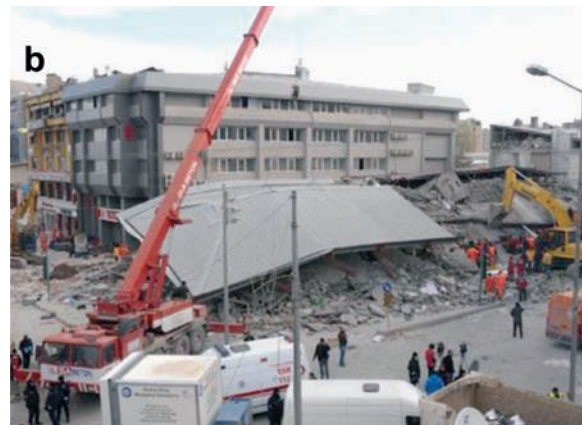
Fig. 30. a) The free standing Bayram Hotel before the earthquake and after the addition of a floor with a light weight roof. b) The collapsed roof is covering the plan, of the collapsed building in a parallel way to the pavements.
