Adana Earthquake: Peculiar damage distribution and seismotectonic characteristics

Lekkas E. & Vassilakis E.

Abstract

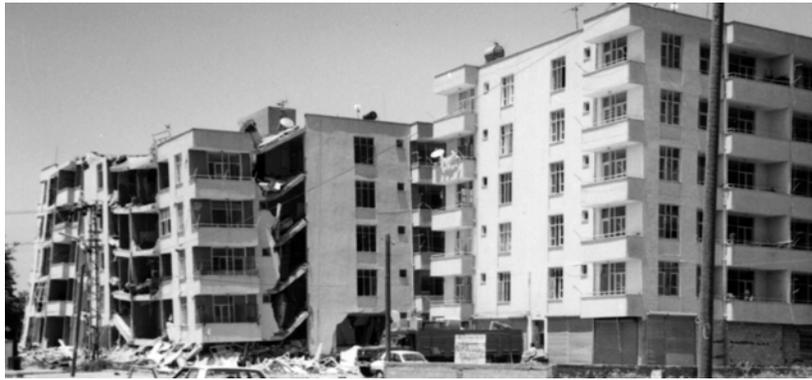
In the city of Ceyhan, only a small percentage of damages occurred in small old type structures, while the majority of these structures remained essentially undamaged. On the contrary, a significant number of multi-story buildings collapsed. They were of older age and located in the centre and the outskirts. Additionally, more than 30 modern buildings of 6-8 stories with earthquake-design standards collapsed or suffered significant damages (Figure 4).

Figure 4. Aspect of the damages on modern constructions at the eastern sector of Ceyhan.

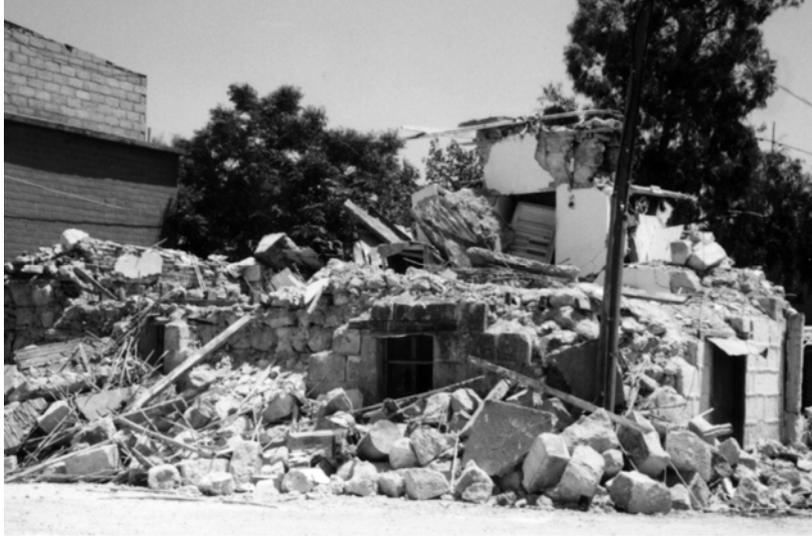
The damages in the village of Misis were very extensive. The village was the typical picture of an earthquake-hit epicentral area. More than 70% of the structures collapsed while structures reinforced with armed concrete suffered significant damages. Only a small percentage of the buildings was not damaged (Figure 5).

Figure 5. Collapse of older residential structures at the village Misis.

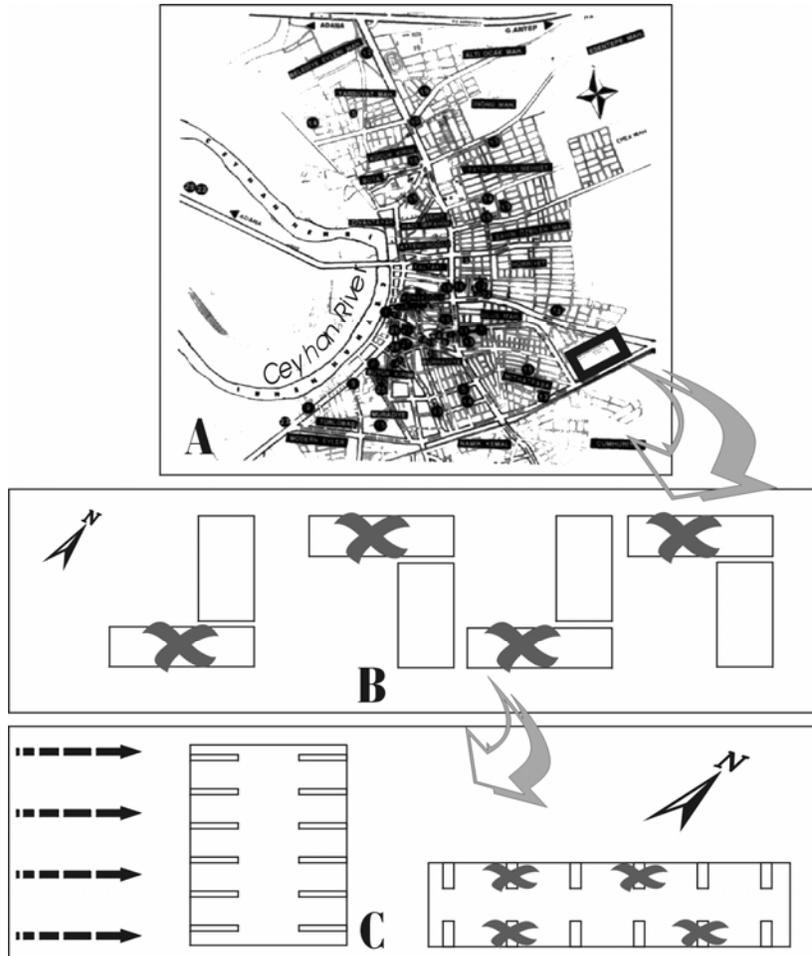
In the eastern part of Ceyhan, multi-story residential buildings have been constructed, which have a different orientation, although identical regarding the ground plans and the construction in general. In particular, two perpendicular orientations can be identified in the oblong ground plan: one running NE-SW and the second running NW-SE. The main characteristic of the aforementioned buildings is that almost all pillars had an oblong direction perpendicular to the oblong direction of the greater dimension of the ground plan, namely NW-SE and NE-SW respectively (Figure 6).

The collapses occurred in the above structures, which had the oblong direction parallel to the NE-SW direction, which is the direction towards the epicenter. Evidently, the oblong pillars (NW-SE) were of a direction

Figure 6. Map of Ceyhan town centre (A) and the exact place of the collapsed multi-story structures having NE-SW orientation (B). As shown at the schematic representation of the failures at the pillars (C) the collapse happened due to the perpendicular direction of the seismic waves.

perpendicular to the direction of propagation of the seismic waves and consequently of a lower resistance to loading. On the contrary, no collapses occurred in those of the specific structures, which had the oblong direction of the pillars (NE-SW) parallel to the direction of propagation of the seismic motion. The deformation suffered by the

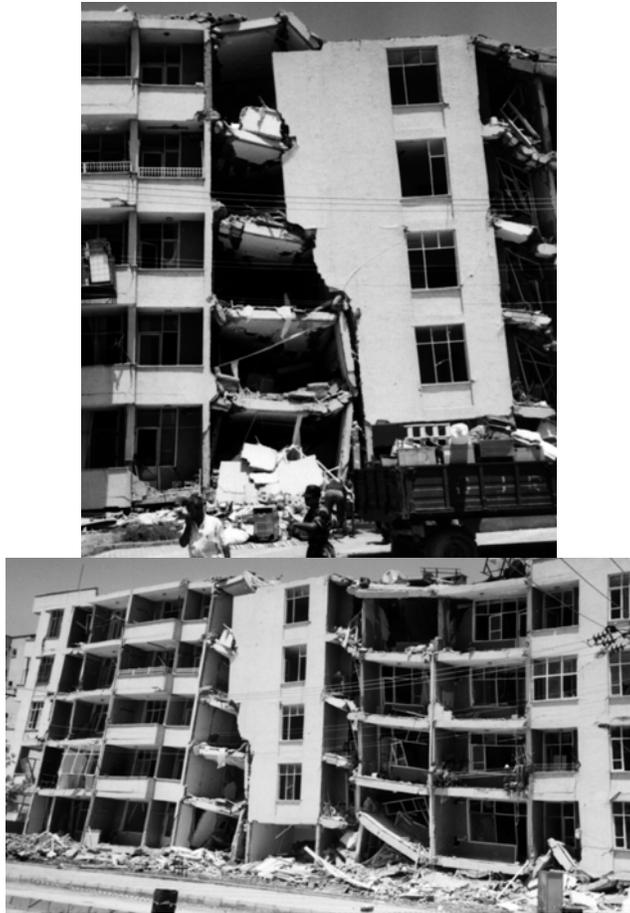
structure shown in Figure 7 from west to east is very characteristic, with collapse, compression, deformation etc of structural elements.

Figure 7. Aspects of a modern multi-story construction of NE-SW orientation, which collapsed totally.

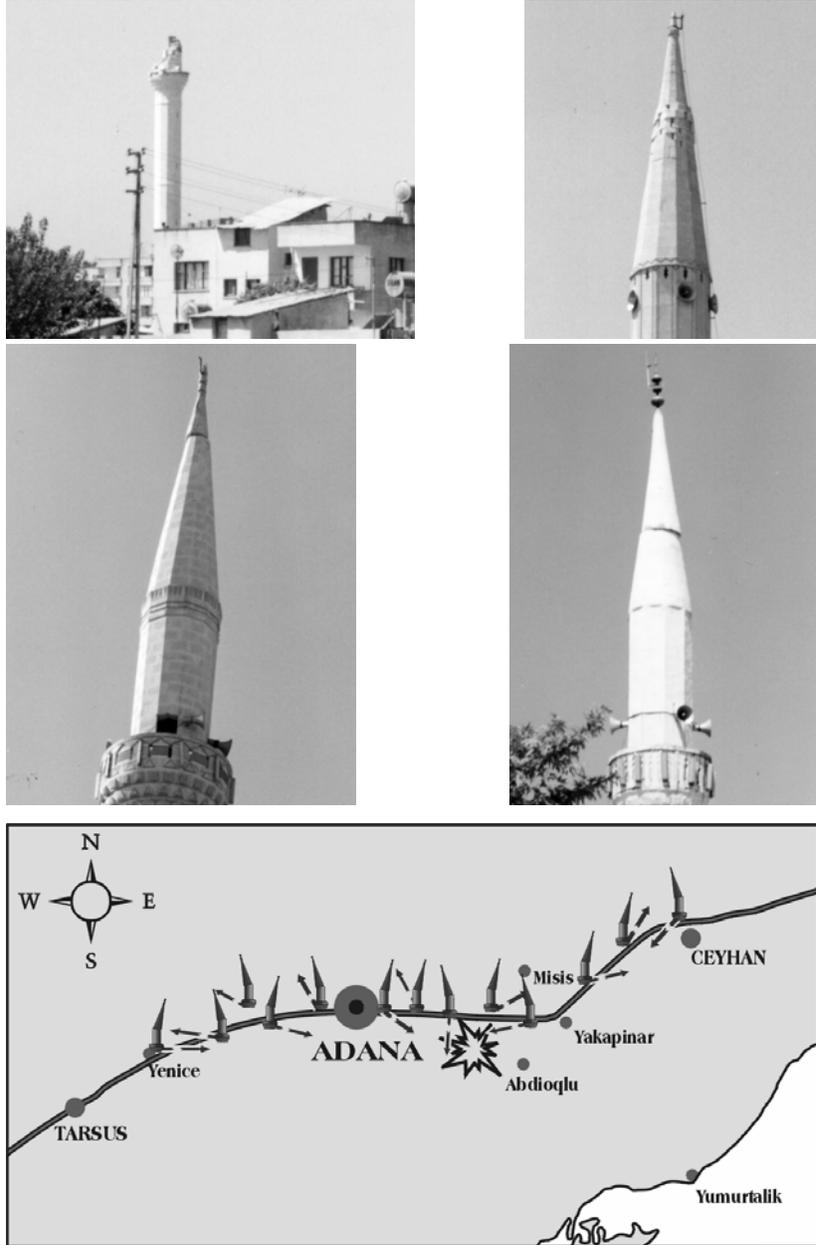
Except for the selective distribution of damages in the city of Ceyhan, the deformations and collapses of the top parts of the minarets were very interesting, too. The transpositions, rakes and collapses of the top parts of the minarets, which took place in the broader region, were recorded, as can be seen in Figure 8. It is concluded that the phenomena were focused in the broader area of the Tarsus-Adana-Ceyhan axis and the vectors of the movements indicate the approximate location of the epicentre.

Figure 8. Aspect of minarets' collapse and their geographic distribution along with the direction of the collapse.
