# Engineering Geology for Society and Territory – Volume 8

Preservation of Cultural Heritage

Andreas Antoniou, Efthymis Lekkas, and Nikitas Chiotinis

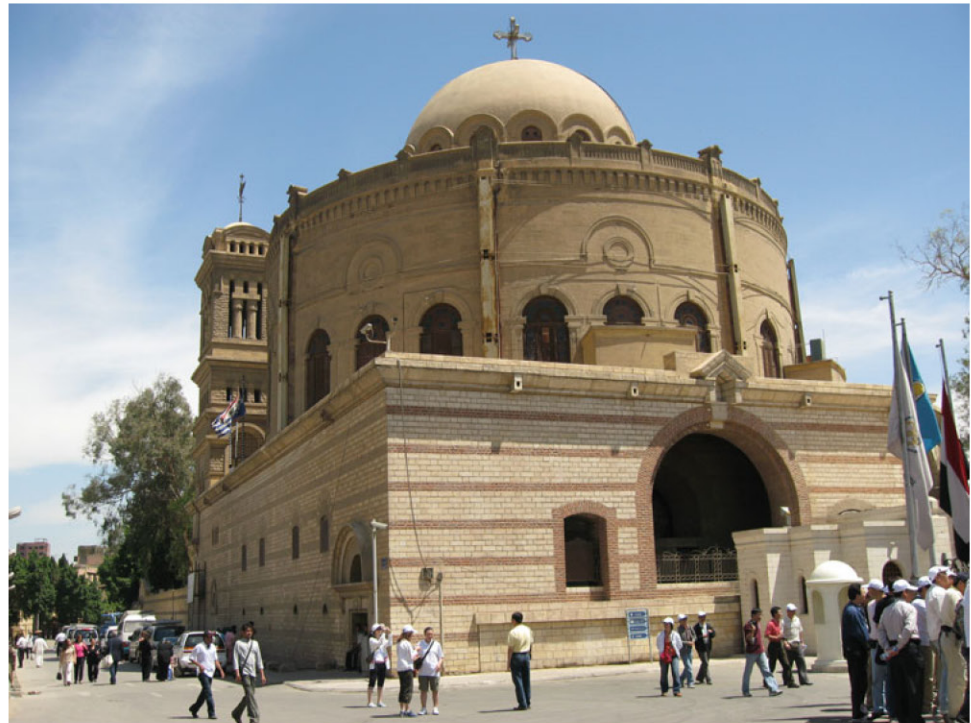
**Fig. 13.1** View of the Saint George Church at Mar Girgis area, Cairo, Egypt

- The cupola window arches which are cracked through the entire thickness of the masonry arches.
- The ceiling of the hollow clay block vaulted roof is cracked around the peak of the vaults.
- The bases of six central columns have unsupported areas underneath them.

- The interior central core colonnade of masonry arches supporting the main sanctuary floor are slightly cracked due to stress concentrations.
- The eight cracked marble columns in the central well area that are supporting the intermediate period masonry above give the appearance of instability.

The internal ancient Roman stairway is suffering from deterioration and degradation.

Before the beginning of the renovation of the church, another monitoring program with additional Elevation Reference Points (ERPs) at the inner columns and walls of the outer circle of the Roman Tower and the 1941s additional structures should be performed. Readings should be taken

weekly for a period not less than six months. In case of no additional movements the works of renovation will commence.

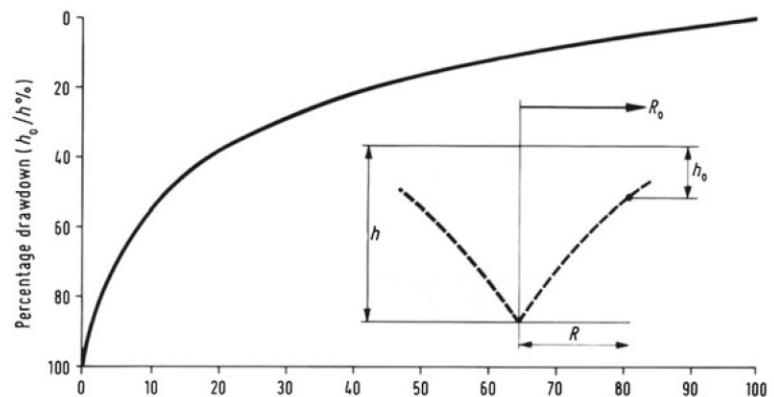
**Fig. 13.2** Relation of drawdown to distance from centre of cone of depression (CIRIA 1986)

Based on various theories for the estimation of settlements and calculate Young's modulus equal to 9 MPa for fill materials, while in a conservative approach the preconsolidation of fill material was not taken into account, the authors calculated settlements up to 9 mm at the areas of filter wall and perforated shaft. In certain distances from shaft and wall, various diagrams (Fig. 13.2, Ciria 1986), which relate the drawdown to distance from center of cone of depression, can be used.
