## **Analysis of damage parameters of the Chi-Chi Taiwan earthquake**

E. Lekkas

### **Abstract**

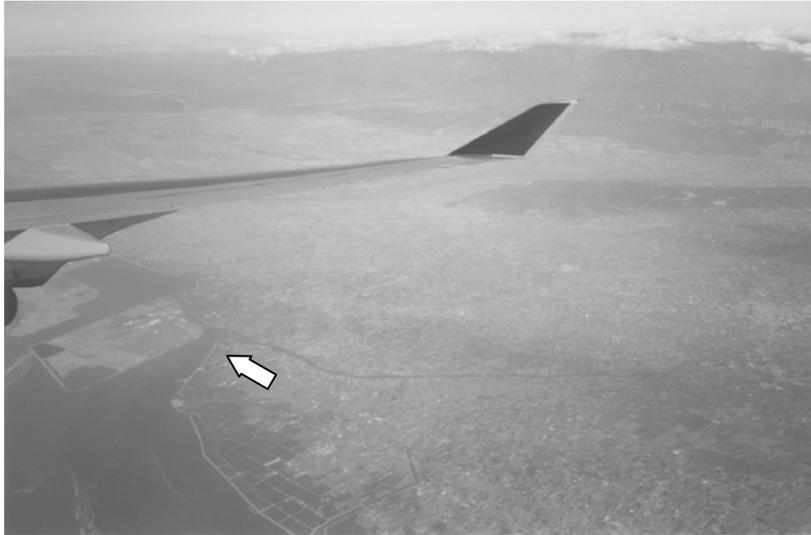
**Liquefaction.** Liquefaction occurred at a number of sites, causing considerable damage. It was significant at Yuan-lin- there was widespread settlement of building foundations, and water wells were completely filled by sand from sand boils. Liquefaction also led to settlement, failure and lateral spread of levees, and movements at bridge abutments at river crossings. However, despite signs of liquefaction and lateral spread close to the bridge foundations. Taichung port, located some 45 km from the epicenter, experienced liquefaction-induced damage at the quays, port facilities and storage locations. More than twenty sites in the meizoseismal area were also affected by liquefaction, which damaged the road network, infrastructure and other facilities (Fig. 9).

Figure 9: Partial view of the affected area. The port facilities (arrow), which were damaged by liquefaction, are visible.

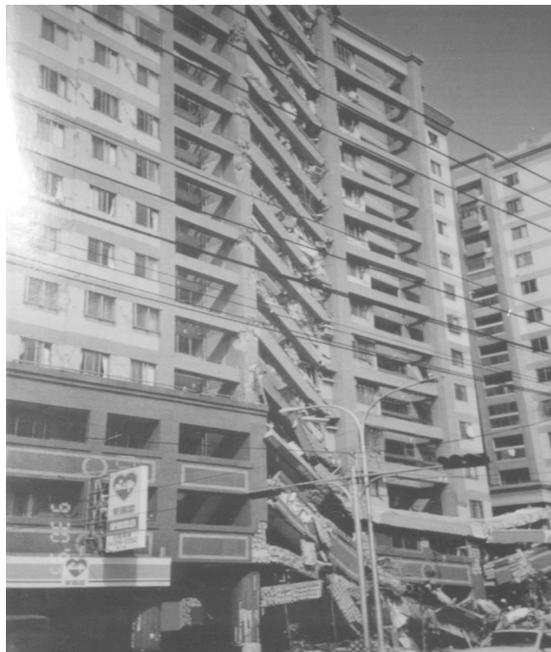
**Mid-Rise Buildings.** In urban areas, a substantial percentage of the residential units are in reinforced apartments of 12-15 stories. A number of these buildings collapsed in special Taichung City, Feng-Yuan, Dali and Taipei County. Typically, they are cast-in-place, special moment frame structures utilizing all frame lines in both directions. They generally have spread footings (Fig. 10). The exterior walls and the shaft walls are reinforced concrete, approximately 10 cm thick. These are considered nonstructural walls and are not included in the seismic design (EERI [14]).

Figure 10: Representative types of collapsed mid-rise buildings.

- Buildings up to 15 stories (50 m total height) suffered the most seismic damage, including collapses. However, compared to the total stock of such buildings, and considering the magnitude of the earthquake, the percentage of damage was small. The damage to these buildings could be attributed to the soft first story created by the «open space» policy, or to poor construction.
