## THE JANUARY-FEBRUARY 2014 CEPHALONIA (IONIAN SEA, WESTERN GREECE) EARTHQUAKE SEQUENCE: DAMAGE PATTERN ON BUILDINGS

P. Carydis<sup>(1)</sup>, S. Mavroulis<sup>(2)</sup>, V. Alexoudi<sup>(3)</sup>, A. Grambas<sup>(4)</sup>, E. Lekkas<sup>(5)</sup>

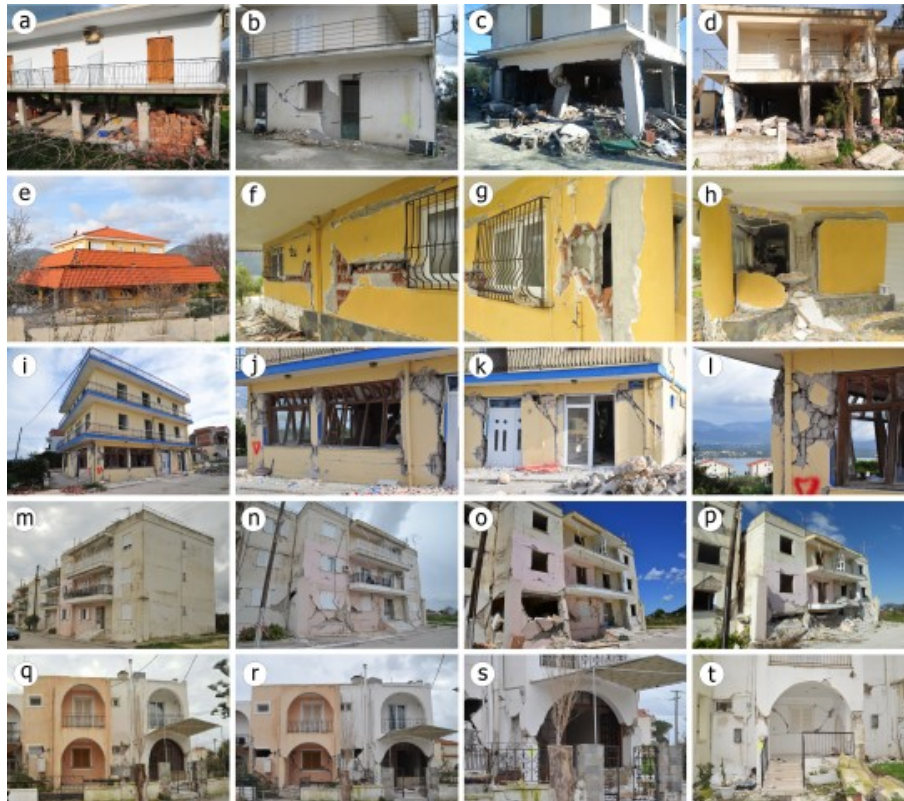
Damage in most of the RC buildings was concentrated in non-structural components. Most of the RC buildings suffer damage including roof detachment, fall of gables at the edge of double-pitched roofs, dislocation of the roof tiles due to the high accelerations involved and light cracks in the brick infill walls as well as detachment of the infill walls from the surrounding RC frame (Fig. 6). Diagonal cracking was only observed in buildings without reinforced infill walls. Damage was also observed at the connection area of adjacent buildings due to pounding.'

However, several exceptions were observed along the road extending from the Lixouri town to the villages of Agios Dimitrios and Livadi located north of Lixouri and along the southeastern coastal part of Paliki peninsula (Fig. 6). Several RC buildings designed under older anti-seismic codes and RC buildings with a soft storey at the ground level and stiffness considerably lower than the upper floors suffered severe structural damage to RC elements comprising concrete disorganization, flexural cracks and buckling of the longitudinal and transversal rods of the columns on the verge of collapse. Indicatively for this region, a two-story RC building in the Agios Dimitrios village without infill walls in the first floor suffered soft-story failure on the verge of collapse including buckling of steel bars and disorganization of concrete, while the second story remained intact (Fig. 6a). Another two-story RC building in the Agios Dimitrios village suffered diagonal cracks and detachment of infill walls of the first floor from the surrounding RC frame by the first earthquake (Fig. 6b) and failure of columns and joints by the second earthquake (Fig. 6c,6d). A three-story building sustained severe structural and non-structural damage due to poor and inadequate construction. The structural damage include total collapse of the second floor due to absence of columns (Fig. 6e) and the non-structural damage comprised detachment of the infill walls from the surrounding RC frame due to vertically perforated bricks in the infill walls of the first floor (Fig. 6f, 6g, 6h). A three-storey building in Lixouri probably built before 1984 without infill walls in the first floor sustained soft-story failure, while the two upper floors remained also intact (Fig. 6i-6l). Buildings in the Lixouri public housing complex sustained non-structural and structural damage including detachment of large pieces of plasters from the infill walls, extensive cracks of infill walls and failure of columns (Fig. 6m-6t). In conclusion, the abovementioned damage to RC buildings was induced due to open ground storey, asymmetric building construction, and heavy loads on the upper floors, short columns and inappropriate foundation on poor soils.

Fig. 6 – Damage to RC buildings. (a) A two-story RC building in the Agios Dimitrios village suffered soft-story failure on the verge of collapse, while the second story remained intact. (b – d) A two-story RC building in the Agios Dimitrios village suffered diagonal cracks and detachment of infill walls of the first floor from the surrounding RC frame by the first earthquake (b) and failure of columns and joints by the second earthquake (c, d). (e – h) A three-story building sustained total collapse of the second floor due to absence of columns (e) and detachment of the infill walls from the surrounding RC frame due to vertically perforated bricks in the infill walls of the first floor (f, g, h). (i – l) A three-storey building in Lixouri probably built before 1984 sustained soft-story failure, while the two upper floors remained also intact. (m – p) A three-story building in the Lixouri public housing complex. The first earthquake caused moderate damage (m), while the second earthquake aggravated damage (n). (o, p) The same building on the verge of collapse in July 2015 and in November 2015 immediately after the Mw 6.4 Lefkas (Ionian Sea, Western Greece) earthquake. (q – p) Another two-story building in the Lixouri public housing complex suffered moderate damage due to the first earthquake (q) and severed damage due to the second earthquake (r, s, t).

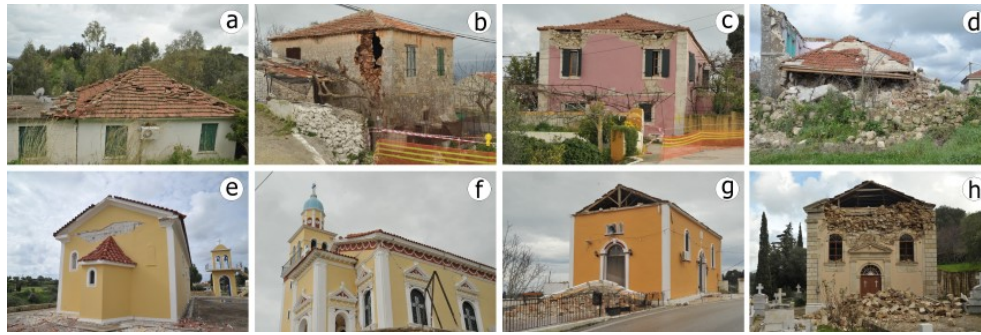
Masonry buildings suffered dislocation of several roof tiles (Fig. 7a), diagonal cracks in the masonry load-bearing walls, damage at the corners of longitudinal and transversal masonry walls (Fig. 7b) and detachment of large pieces of plaster from the masonry walls and of the roof from the rest of the building. Heavy damage included partial collapse of walls (Fig. 7c, 7d). After the second earthquake, many of these structures suffered destruction comprising total or near total collapse.

The RC churches suffered non-structural damage comprising light cracks in the brick infill walls, detachment of large pieces of plaster applied on the interior walls and damage occurred on bell towers (Fig. 7e-7h). The masonry churches suffered dislocation of several roof tiles and detachment of large pieces of plaster (Fig. 7e), light diagonal and vertical cracks in the masonry load-bearing walls (Fig. 7f) as well as fall of the church riser and gables at the edge of double-pitched roofs (Fig. 7g, 7h). Heavy damage included heavy diagonal and vertical cracks in the masonry load-carrying walls resulting in the disorganization of the masonry and the partial or total collapse of the structure. Damage in cemeteries includes partial or total collapse of retaining and perimeter walls and destruction of grave monuments. The ancient monuments of the affected area suffered no damage by the early 2014 Cephalonia earthquakes. On the contrary, the post-Byzantine monuments of the island including castles and churches suffered damage induced mainly by the first earthquake.

Fig. 7 – Damage to masonry buildings included (a) detachment of roof tiles, (b) partial collapse of the load bearing wall, (c) destruction of the upper corners of the buildings and (d) near total collapse of the building. Masonry churches suffered damage including (e) detachment of roof tiles and pieces of plaster, (f) cracks in masonry load bearing walls and in the upper corners of the structure and (g, h) fall of gables at the edge of double-pitched roofs.
