## **Learning from Earthquakes**

### **Preliminary Observations on the August 14, 2003 Lefkada Island, Western Greece, Earthquake**

*This reconnaissance report was compiled by P. Carydis of the Laboratory for Earthquake Engineering of the National Technical University of Athens (NTUA), A' Vice President of the EAEE and E. Lekkas, S. Lozios, E. Skourtsos and G. Danamos of the Laboratory for Tectonics and Geological Mapping of the University of Athens (UoA) and it is based on their own observations.*

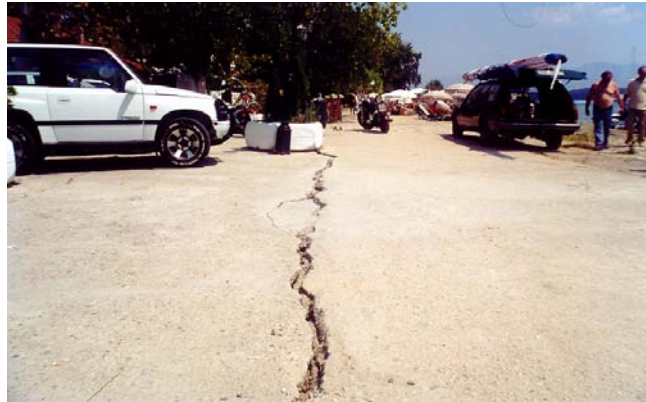
**Fig. 5:** *Ground fissures at Nydri Port.*

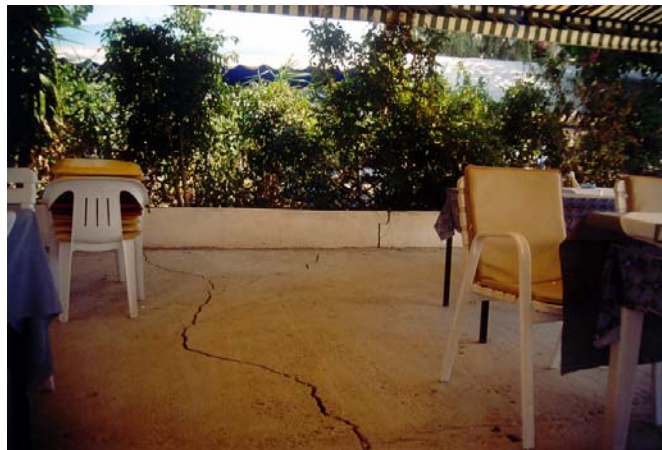
**Fig. 6:** *Ground fissures that cause small damage to tourist facilities.*

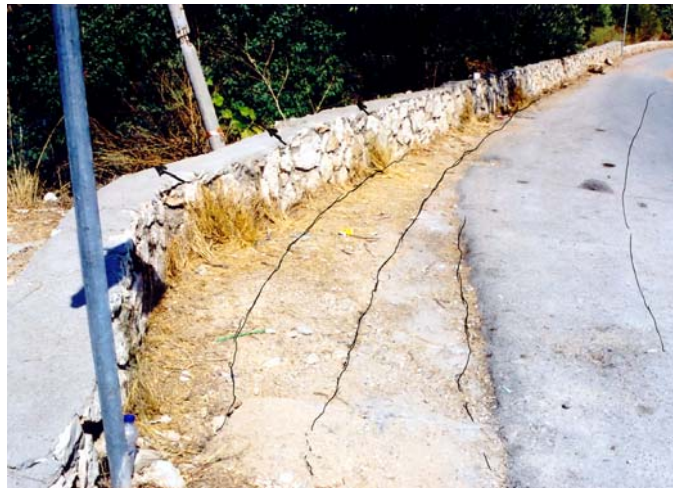
**Fig. 7:** *Many retaining walls leaned, towards the external part, the adjacent parts of the roads were subsided and cracks appeared on the pavement.*

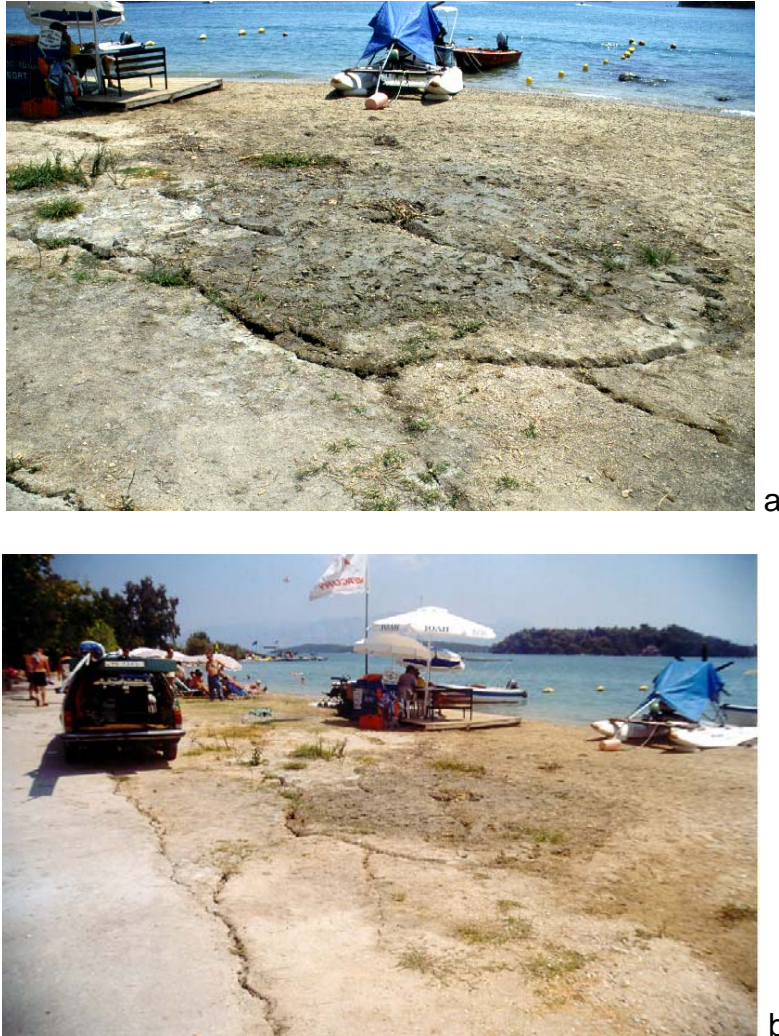
**Fig. 9:** Liquefaction and ground fissures at Nydri beach.

These phenomena mainly occurred in zones along the coastal areas, consisting of recent formations of coastal, alluvial and fluvial deposits, where the depth of the water table was very high, almost 0,7 m below the ground surface. The ejection of quicksand was done through craters and fissures. It was also reported that boreholes and drainage tubes served as funnels for the upward movement of the quicksand. The ejection resulted in mainly fine material to be deposited, as sand and silt but in other cases no surficial outflow was noticed, but the liquefied material caused loss of support of the overlying formations which in turn were deformed.

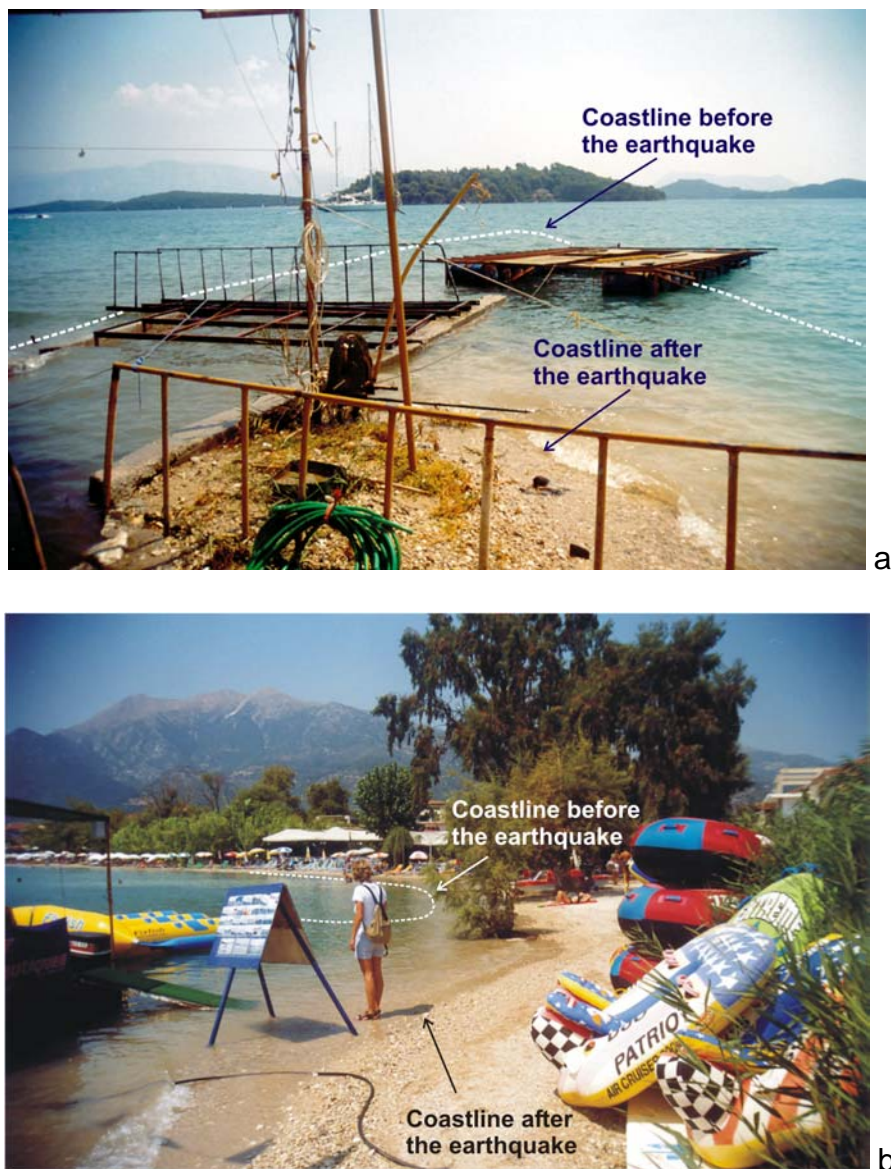
**Coastline changes:** The shock was accompanied by coastline change (Fig. 4, Fig. 10). The field study showed that the changes were located at the coastal area of the northern part of Nydri, at the river mouth of Aspropotamos torrent. The coastline retreat damaged a few minor human constructions and tourist and beach sport facilities. The coastline change was not uniform, but its magnitude varied from 1 m up to 20 m.

The most impressive change took place at the coast of Kambos where coastal deposits occur. At this place, the sea progresses inland for about 20 m, at the northern part of the affected zone and the total width of the land covered by the sea is more than 50 m. As a result, these parts of the shore do not exist any more. This change gradually becomes smaller to the south, until it disappears.

**Fig. 10:** Coastline changes at Nydri beach.

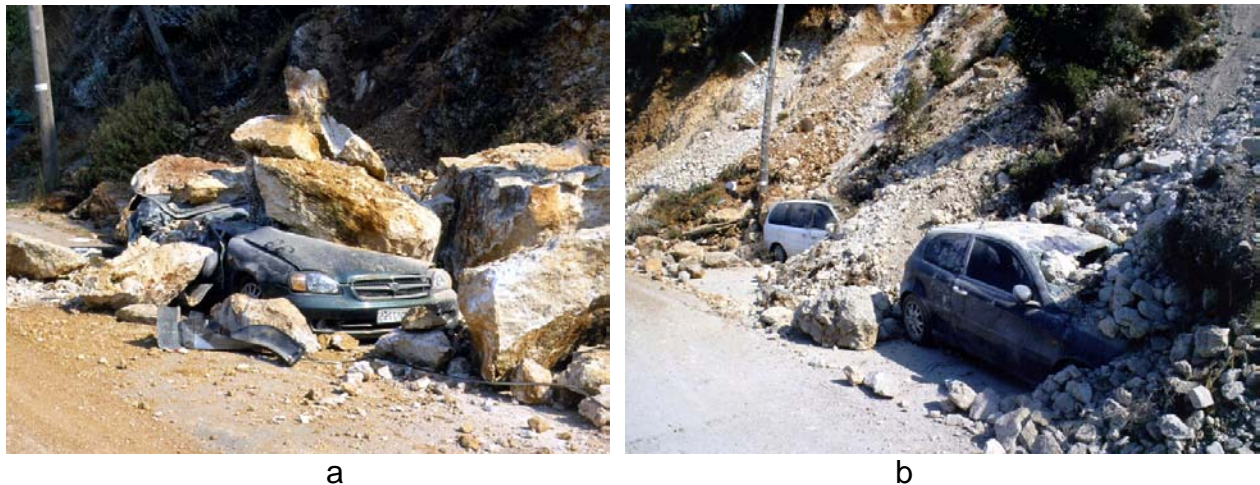
**Fig. 11:** Extensive rockfalls caused a lot of damage to cars.

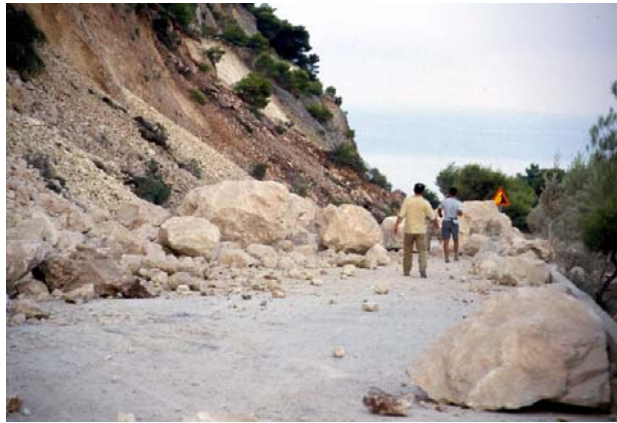
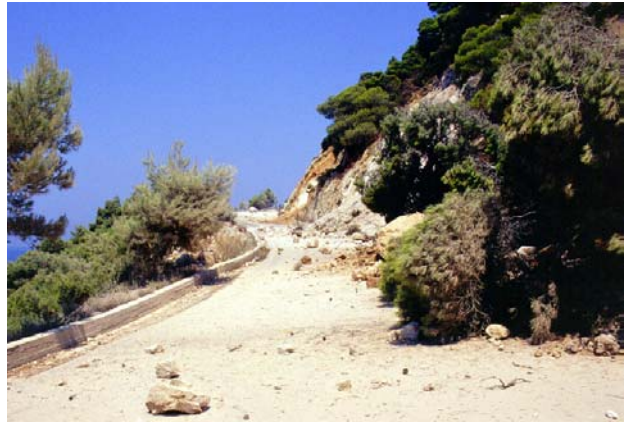
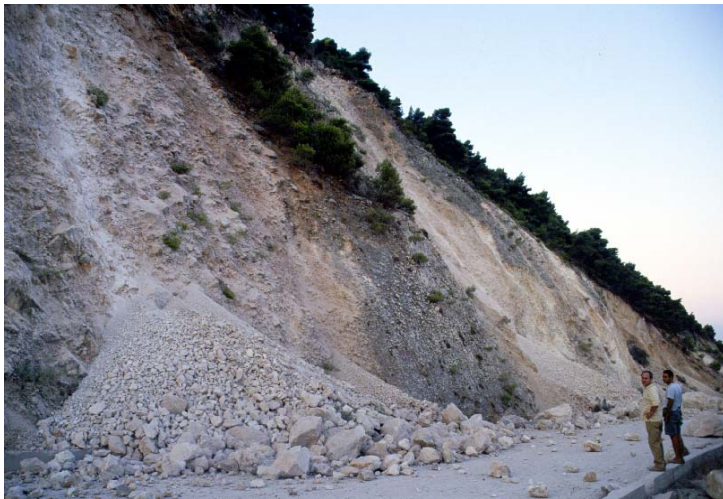
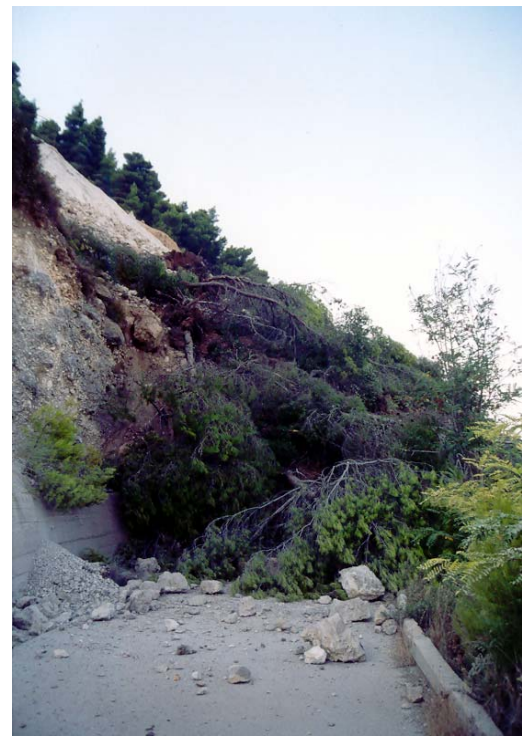
These phenomena were observed in many places within the stricken area, mainly in the road between Tsoukalades and Agios Nikitas, in the road between Sfakiotes and Agios Nikitas, in the road between Lefkada and Nydri, at the entrance of Karya village and in the beaches along the steep western coastal zone such as Porto Katsiki, Kathisma, Kalamitsi etc. The very steep morphology of the region, which is the result of the active tectonics, and the rock mass which is highly fractured and deformed representing in most cases a tectonic breccia or fault gouge material, are the principal factors provoking the rockfalls and landslides. These phenomena took place at the scarp of morphological discontinuities, which are mainly related with the faults of the area, at the slopes of the valleys which are crossing the area because of uplifting, but also at the road-cuts (Fig. 4, Fig. 12).

**Fig. 12:** Extensive slope failures occurred mainly at the central and northern part of the island.

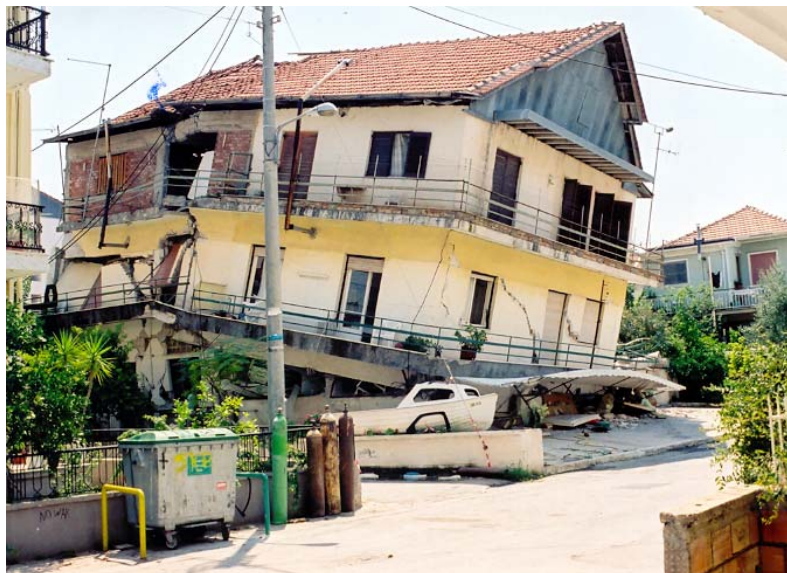
**Fig. 15:** A modern building toppled over. In the right hand side there are no brickwalls in the ground floor, where the building toppled. On the contrary the remaining part at the left hand side has partitions down to the foundation.

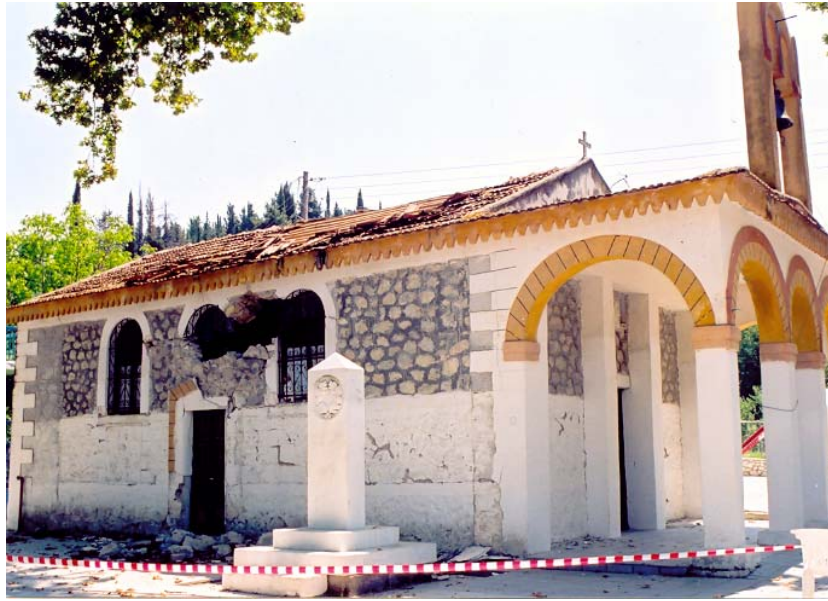
**Fig. 16:** Churches were build out of stone masonries. Suffered heavy damages. In various parts of Lefkada the roof tiles at the central part of the roofs were moved. This might be explained with the vertical flexibility of the roof at its centre.

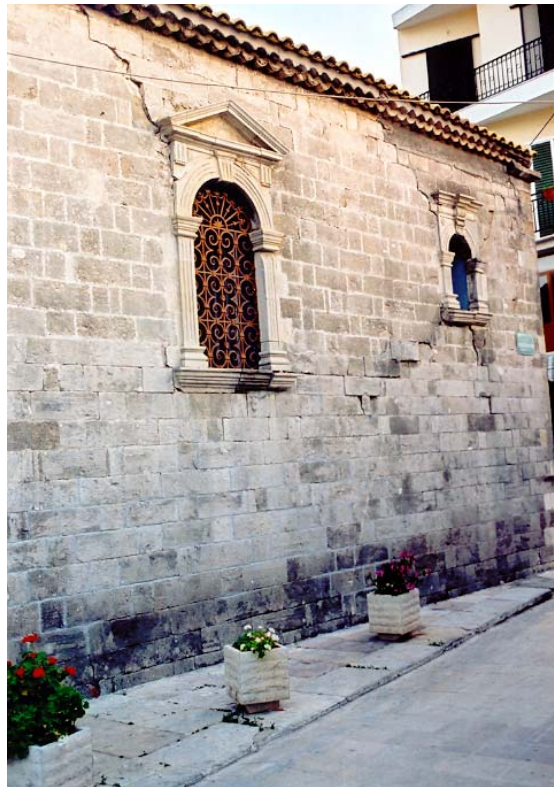
**Fig. 17:** The old churches suffered heavy damages but they did not collapse.

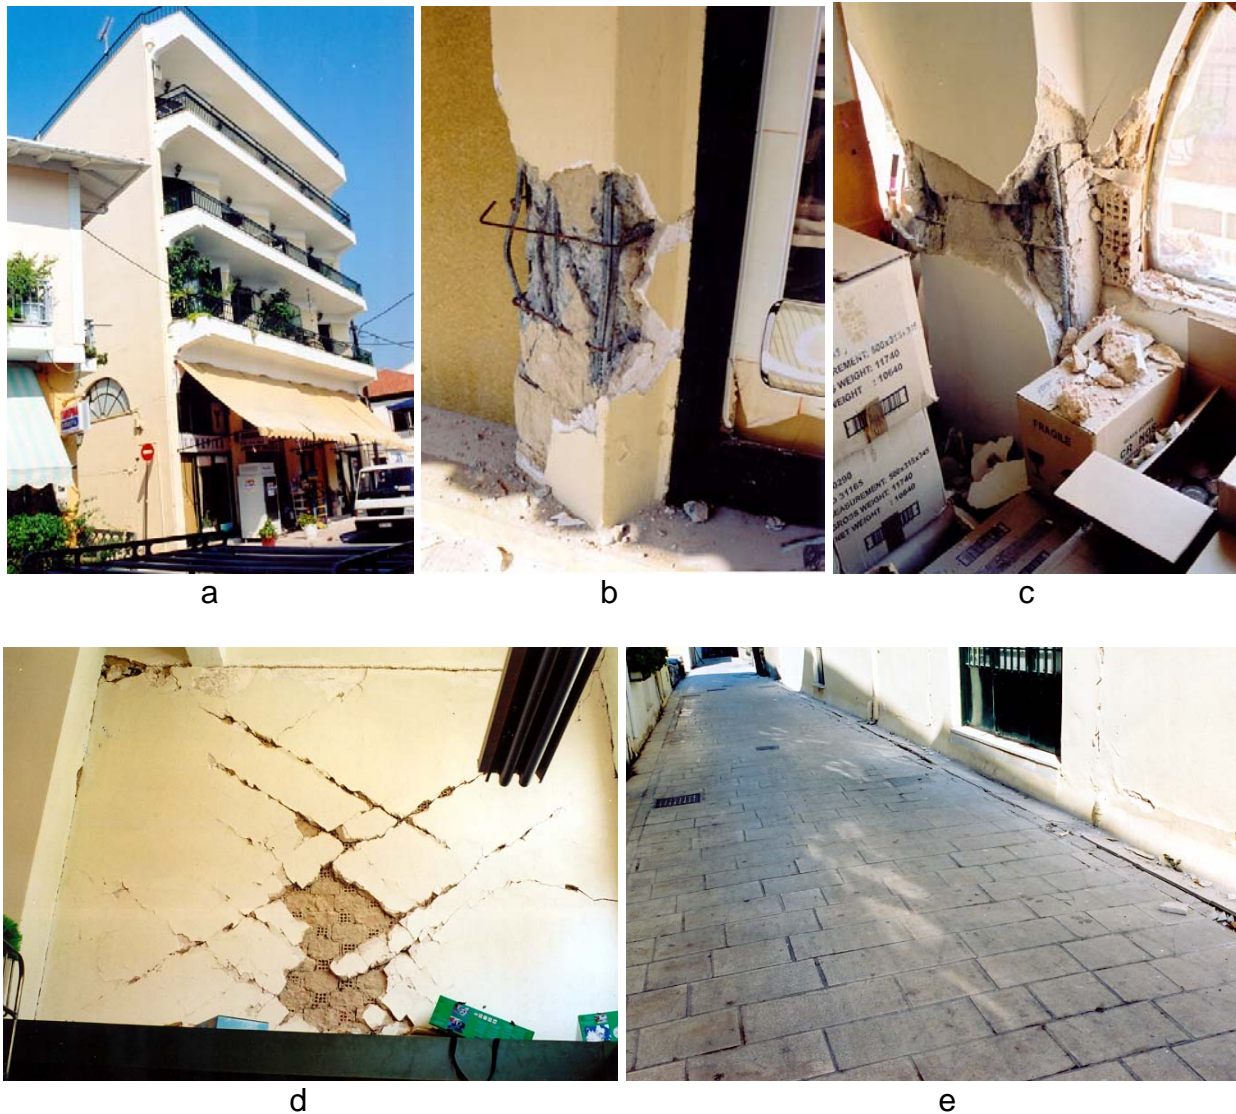
**Fig. 18:** A heavily damaged building in the city of Lefkada. The ground floor is a super market and has a mezzanine (a). The stirrups are insufficient and with wrong detailing (b). In the mezzanine the columns suffered also heavy damages on the surface between phases of concreting and in the lower part of the arches, formed with brickwalls (c). The inside brickwall partition in the ground floor absorbed a lot of energy and behaved as if it was reinforced (d). The building is on a pile foundation. A subsidence of few cm is shown in the figure (e).

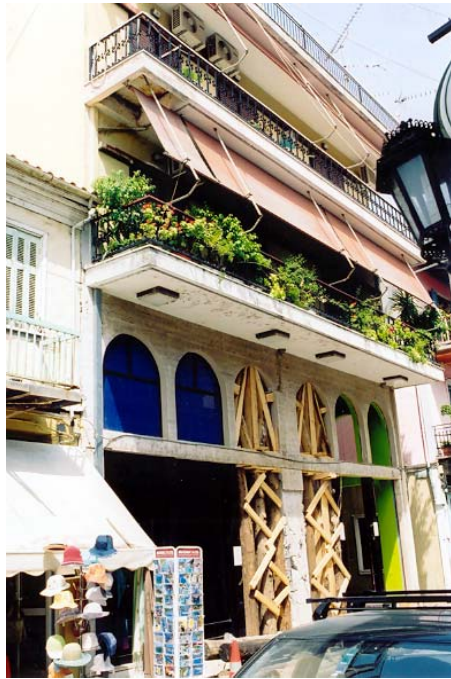
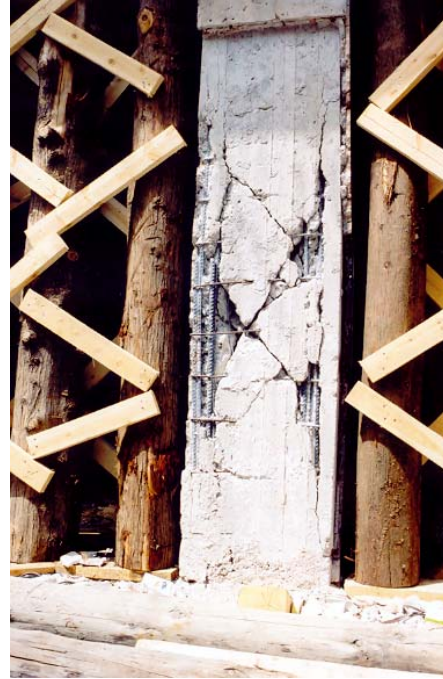
**Fig. 19:** A four storeyed building with a mezzanine was heavily damaged in the columns of the ground floor. The columns seem to have swollen in the centre due to insufficient transverse reinforcement.

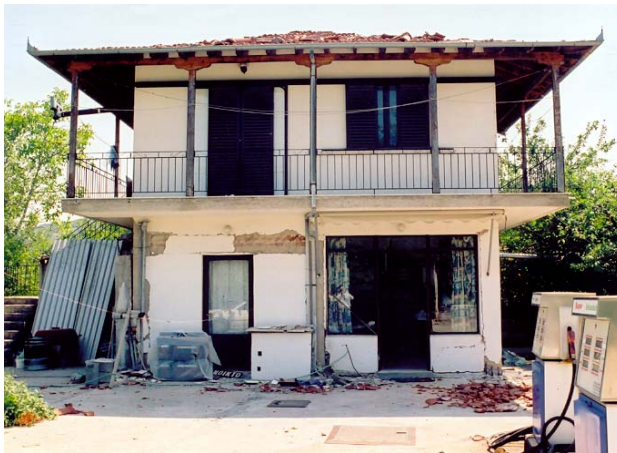
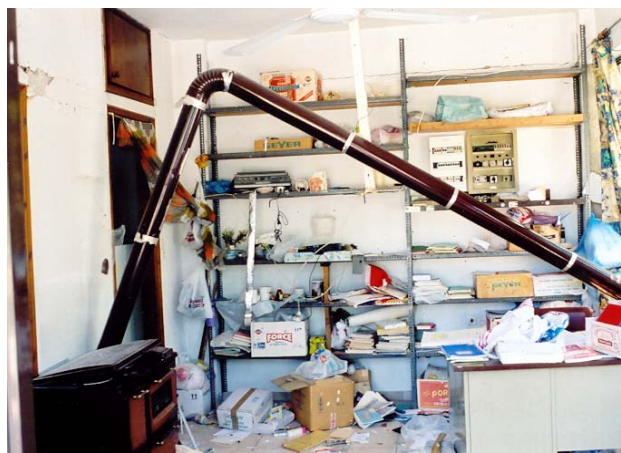
**Fig. 20:** A seriously damaged shop building in Lazarata.

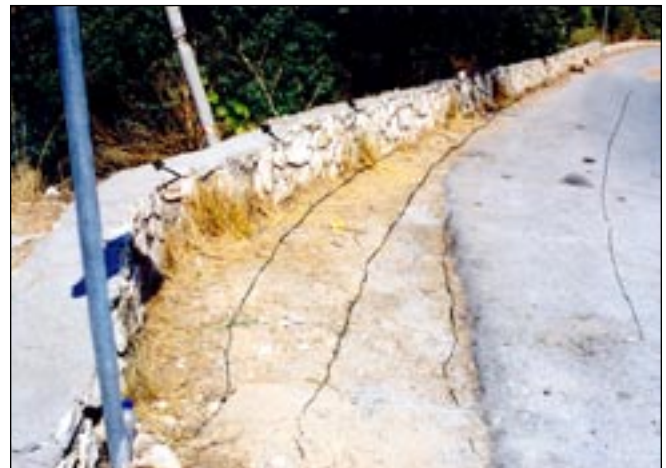
**Figure 9.** Many retaining walls leaned towards the external side; the adjacent parts of the roads subsided, and cracks appeared on the pavement (NTUA-UoA team).

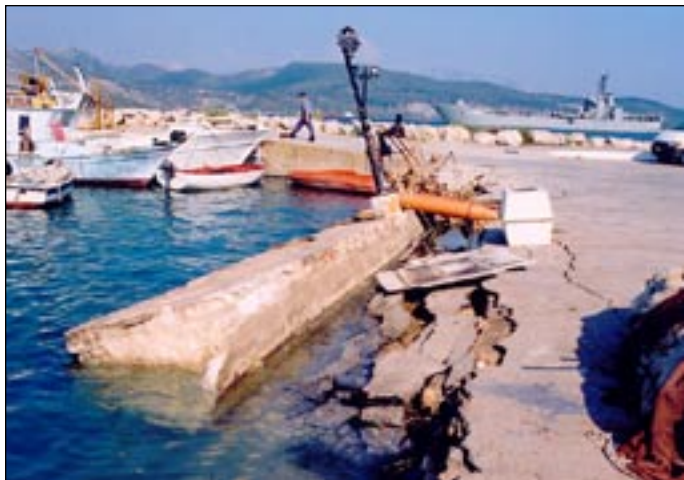
**Figure 10.** Ground subsidence of the fill material of about 30 cm (NTUA-UoA team).

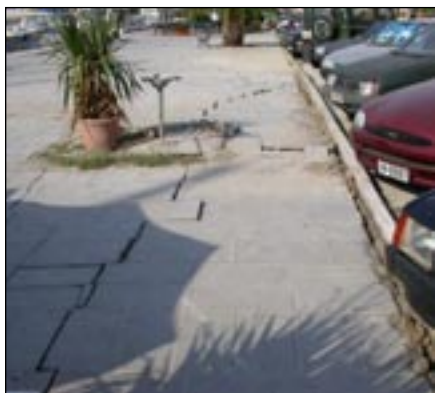
In the town of Lefkada, damage included uplifted, sunken or cracked concrete slabs, and distorted pavement and sidewalks (figure 11). Shallow subsurface materials at these sites probably consisted of uncompacted, miscellaneous fill. Local residents reported that muddy water was ejected from cracks in pavement surfaces. Observed ground cracking with lateral spreading, as well as silty-sandy boils along the waterfront in the town of Lefkada and in Nydri village, were the primary surface evidences of liquefaction, indicating high excess pore pressure generation during earthquake shaking.

**Figure 11.** In the town of Lefkada, distorted pavement and sidewalks due to ground settlement and lateral spread (ITS AK team).

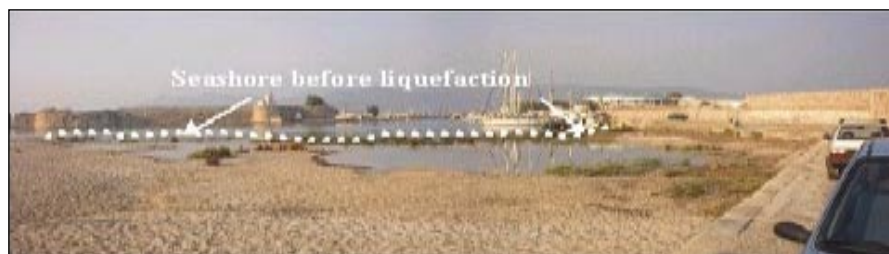
**Figure 12.** Area near the castle of Lefkada where soil liquefaction, lateral spreading, and ground settlement occurred (ITS AK team).

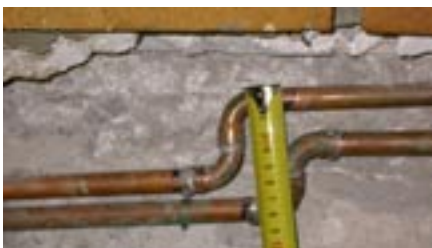
**Figure 14.** Plan view of two adjacent buildings with a common pipeline system that had a differential settlement of about 5 cm (ITSAK team). (Photo taken after repairing.)

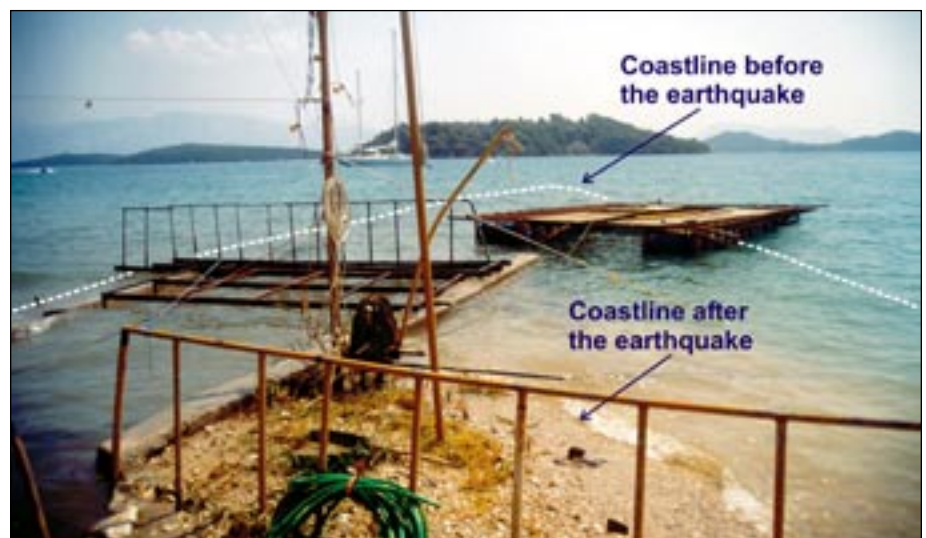
**Figure 15.** Coastline changes at Nydri beach (NTUA-UoA team).

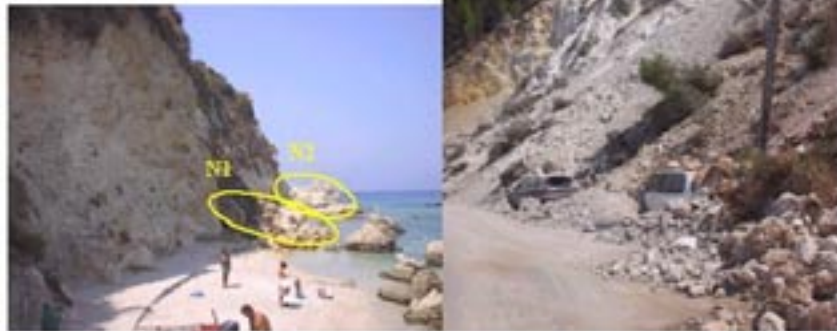
**Figure 16.** Rockfalls due to detachment and possible overturn at the Agios Nikitas (left); Cars were buried under landslides near the same beach (right) (ITSAK team).

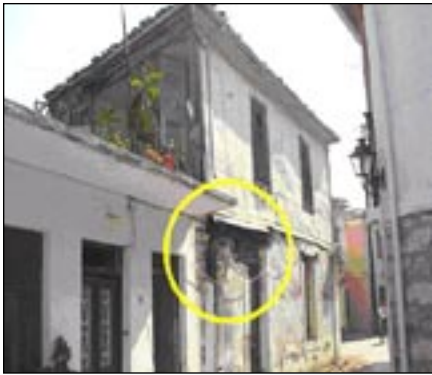
**Figure 18.** Partial collapse of masonry wall in a category B building (ITSAK team).

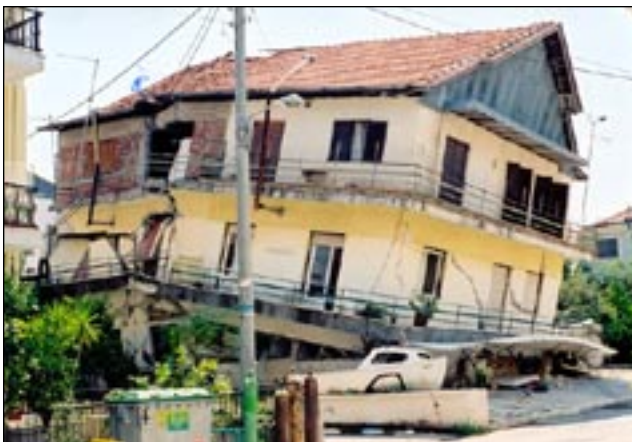
**Figure 19.** Collapse of R/C building in the town of Lefkada. On the right side, there are no brickwalls on the ground floor, where the building collapsed. The remaining part on the left side has partitions down to the foundation (NTUA-UoA team).

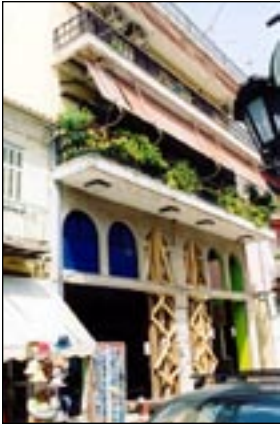
**Figures 21a and b.** A four-story building with a mezzanine was heavily damaged in the ground floor columns. The columns seem to have swollen in the center due to insufficient transverse reinforcement (NTUA-UoA team).
