Floods, geodynamic environment and human intervention. The case of Corinth (Greece)

E. Lekkas, S. Lozios, E. Skourtsos & H. Kranis

Abstract

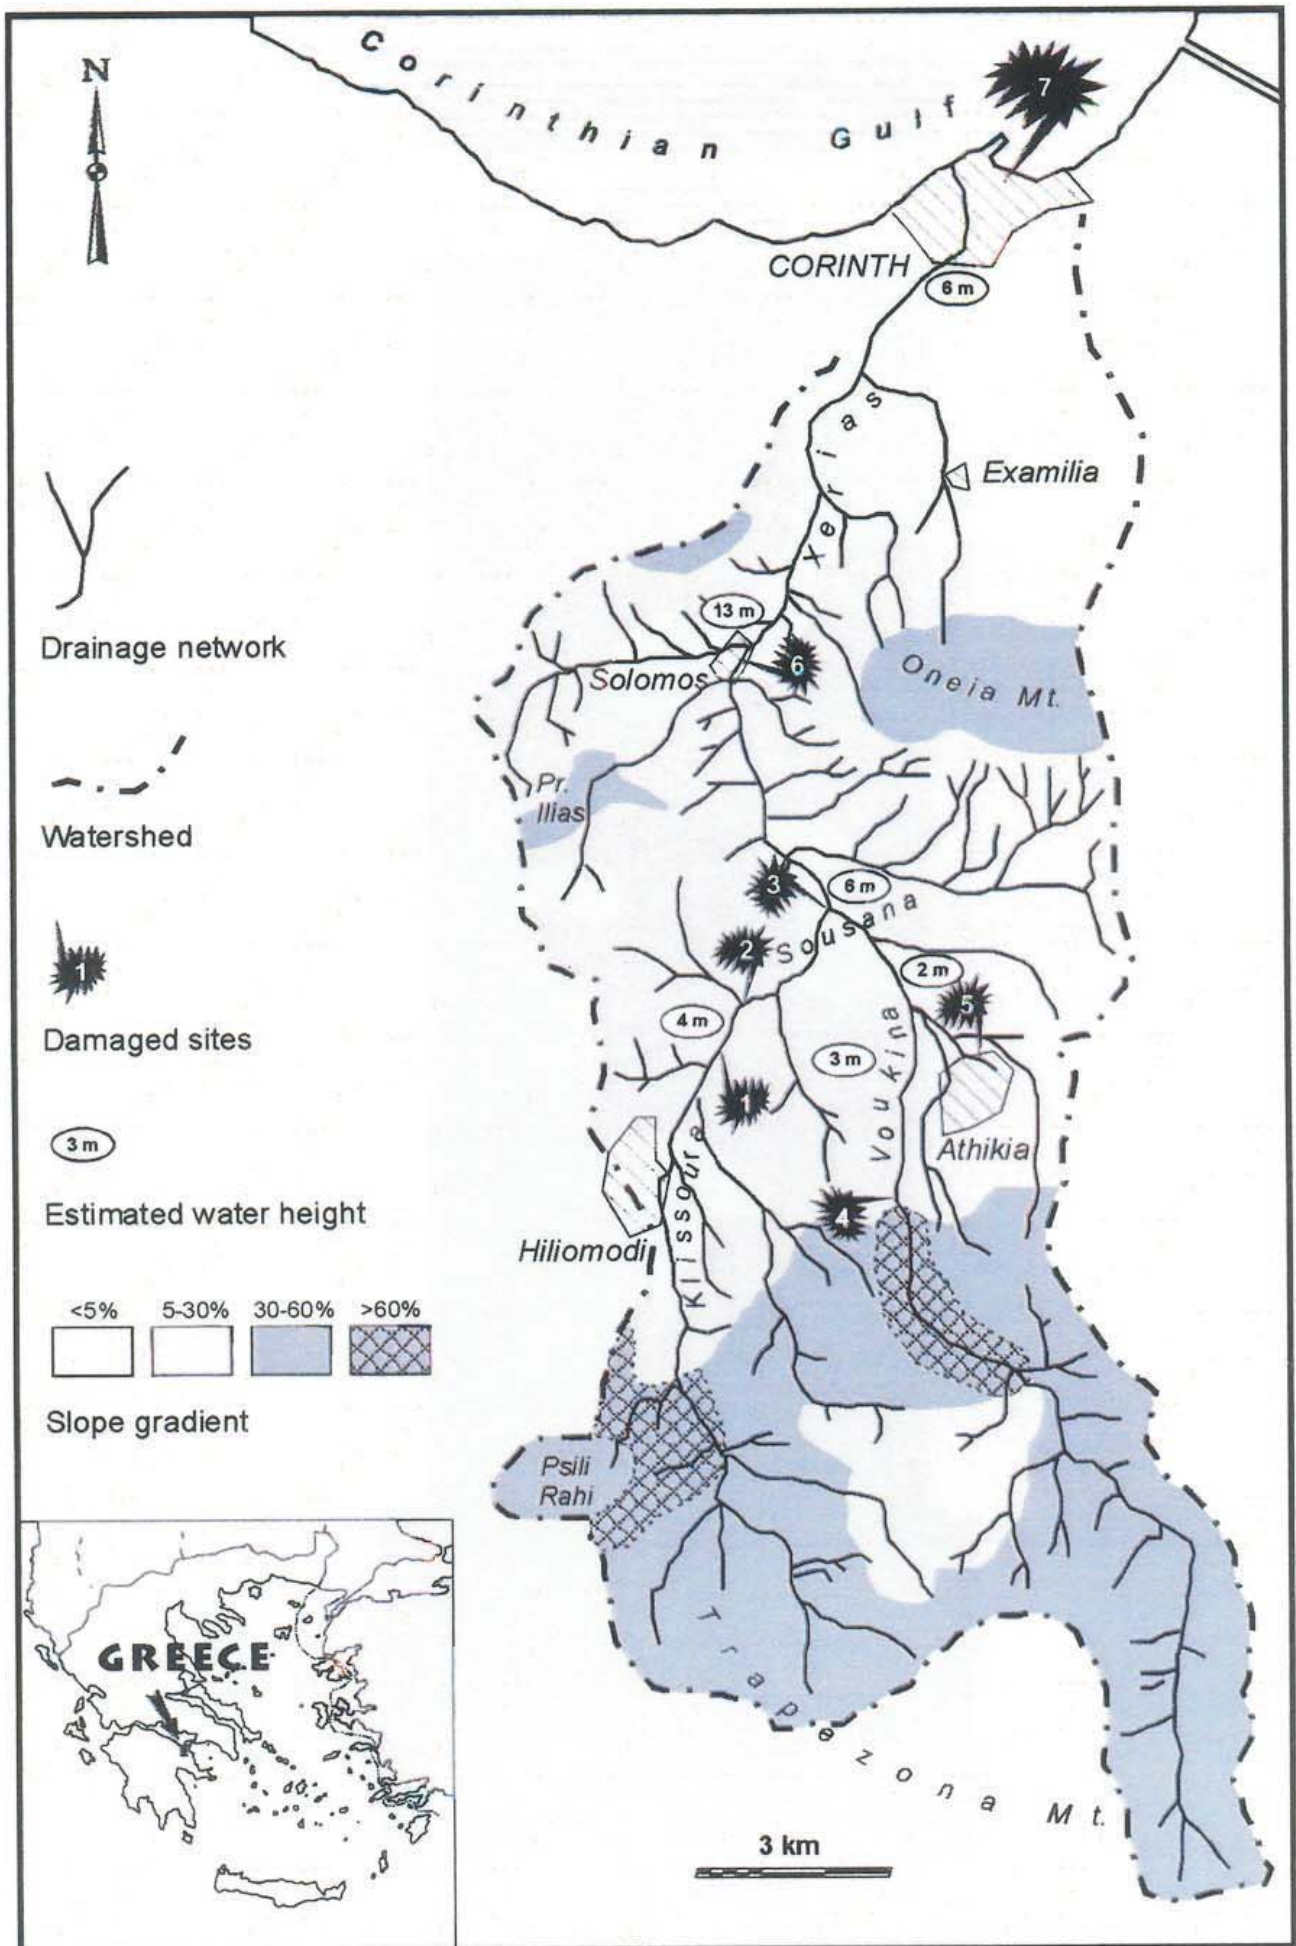
The Xerias catchment (Fig. 1) can be distinguished in three areas. A southern one, of highest altitude and high relief, with the mountains of Trapezona (1137 m) and Psili Rahi (1078 m). An intermediate area where other smaller mountain ranges with a general E-W orientation exist, separated by areas of smoother relief. These mountain ranges form the Oneia Mountains to the east (max elevation 562m) and the hills of Profitis Ilias and Tsouba (701 m and 621 m respectively). The third area lies north, after Examilia and up to the mouth of Xerias with lower heights and generally smoother relief.

The total area of Xerias catchment is 1600 km² and a total stream length (combined) of 143km (Kalliris,²) (Fig. 1). The main stream that issues from the mountain range of Trapezona has length of 30 km. A major tributary is Klissoura torrent (16km long), which converges with Sousana (next to the railway station into the main stream at Sousana).

Figure 1: The area that was affected by the intense rainfalls of January 1997.

In the area of Athikia and on the road that links the village with Hiliomodi, a small and low concrete bridge was built to facilitate the flow of rain waters, with a small, oblong-shaped opening (Fig. 1, damaged site 4). Apart from the inefficiencies that exhibited, it was also blocked by a boulder which caused the destruction of the road and a small downstream offset of the bridge itself. Athikia is built on a similar streams which discharge Mt. Trapezona. The result of the heavy rainfalls was the flooding of many houses (Fig. 1, damaged site 5).

From Hiliomodi to the area of Sousana occurs the second bigger branch of Xerias, the Klisoura stream. Along this appear small constructions, mainly bridges, with pipes of small cross-section that were finally blocked by washed off material, such as stones and logs (Fig. 1, damaged sites 1 & 2). Sand and silt of considerable thickness were deposited upstream of the constructions. Near Soussana, the bed of Klisoura is about 50-80m deep, while part of it has been cultivated; also a house was observed in it.

At the confluence of two main streams a new motorway bridge has been built, quite close to the older one. Both of them are made of concrete and have large, round openings that unfortunately proved inadequate to cope with such high precipitation (Fig. 1, damaged site 3). The old bridge was blocked by debris and the new one by a bus that was carried away by the torrential stream (Fig. 2). Vast expanse of vineyards was flooded and the new motorway was destroyed.

Even the high arch bridge at Solomos did not cope successfully with the torrential flow (Fig. 1, damaged site 6). Despite the fact that the river bed there is incised and deep enough and the arch is about 6m high, 20m wide, large uprooted trees blocked it (Fig. 3) and the water level rose and flooded the nearby houses 2 m above the road surface.

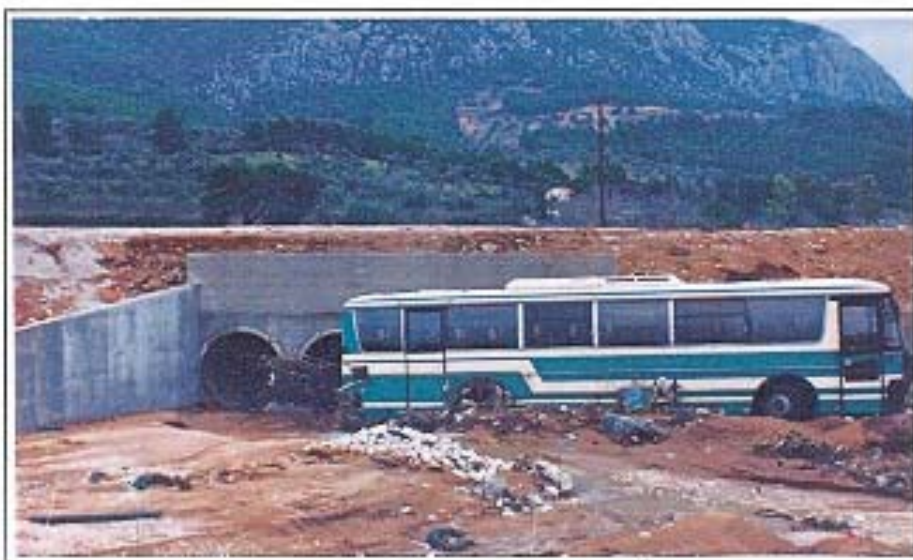
Figure 2: Motorway bridge pipes blocked by a bus that was carried away by the torrent.

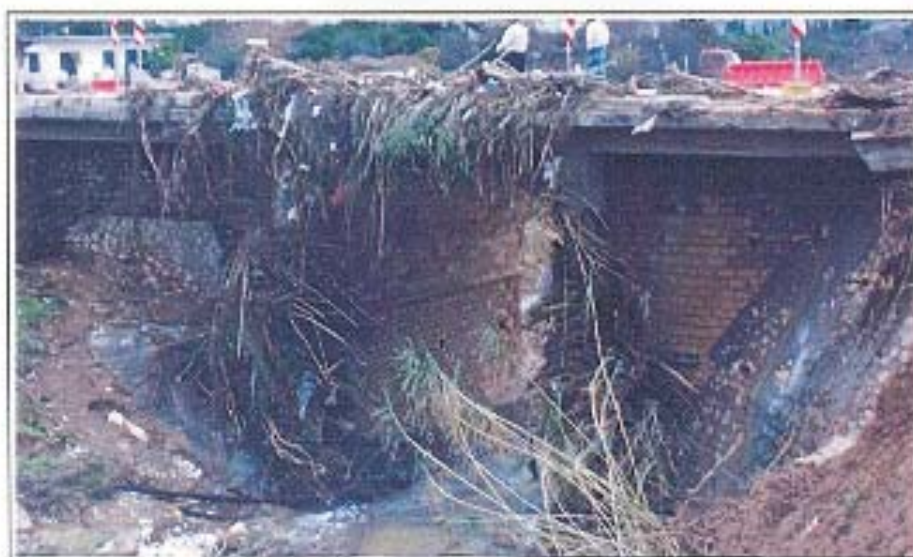
Figure 3: Large uprooted trees blocked the high arch bridge at Solomos village.

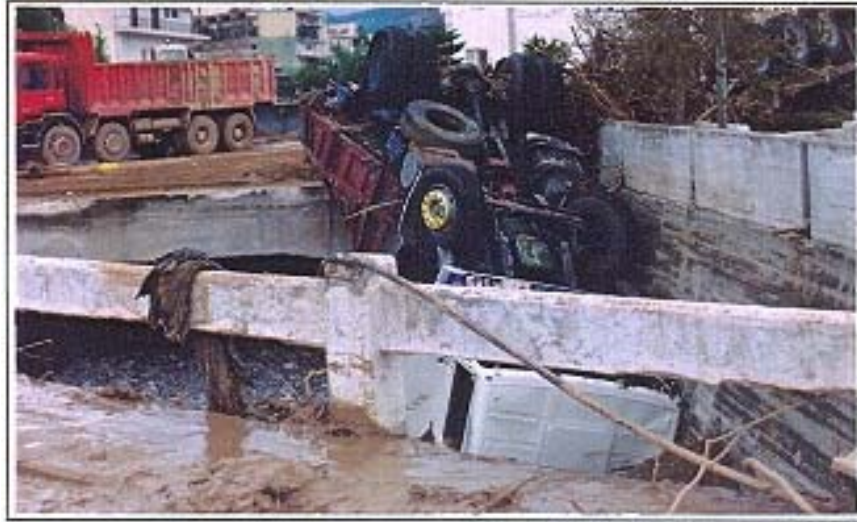
Corinth is built on the delta fan of Xerias. Within the town, the stream bed is artificially incised along the two thirds of its course, in a rectangular cross-section concrete canal, on the upstream end of which exist three concrete bridges, the parapets of which were destroyed and trucks, that were swept off by the torrent, were wedged in between (Fig. 4). The stream, on entering the town, turns 60° eastwards. On this bent an iron low railway bridge was built, and did not withstand the torrential flow. At the turn of the canal the low preventing wall could not hold away the water, which flooded hundreds of houses and swept away tens of cars.

Figure 4: The parapets of the bridge were destroyed and trucks, that were swept off by the torrent, were wedged in between.
