EARTHQUAKE ENGINEERING  
RESEARCH INSTITUTE

## NEWSLETTER

## The Egion, Greece, Earthquake of June 15, 1995

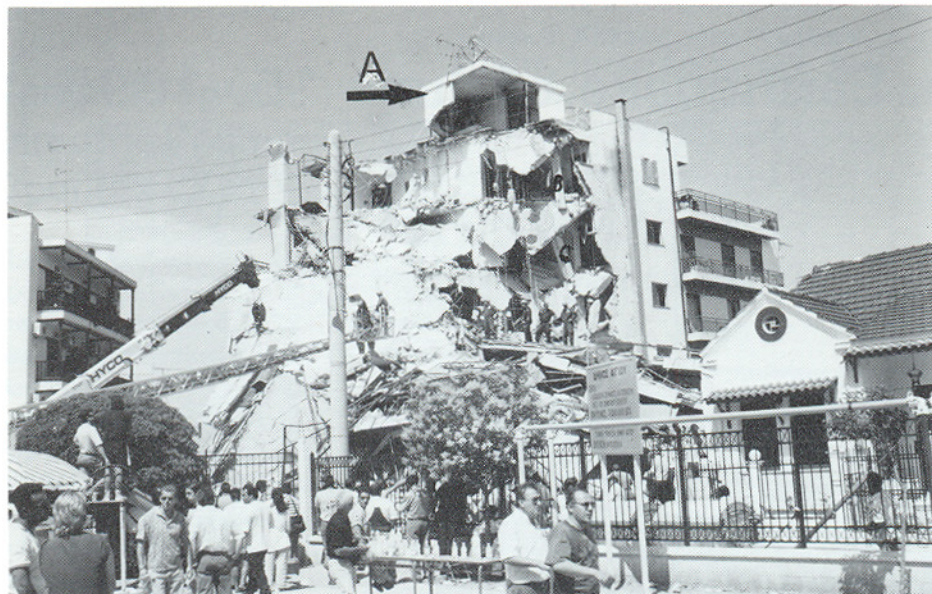
**Figure 2** - An L-shaped five-story apartment building in Egion partially collapsed. The collapse was in a counterclockwise torsional direction.

The partially-collapsed five story L-shaped apartment building in the center of Egon was built in 1978-1979. One leg of the L collapsed, blocking the exit stairwell. Most of the victims were later found around or in the stairwell. The collapsed section had 27 apartments (22 inhabited, 5 empty) and 3 shops. Fifty-four persons were trapped in the debris of this section, 38 of whom were rescued

- The shape of a building played a crucial role in the behavior of many structures during the strong earthquake shaking.

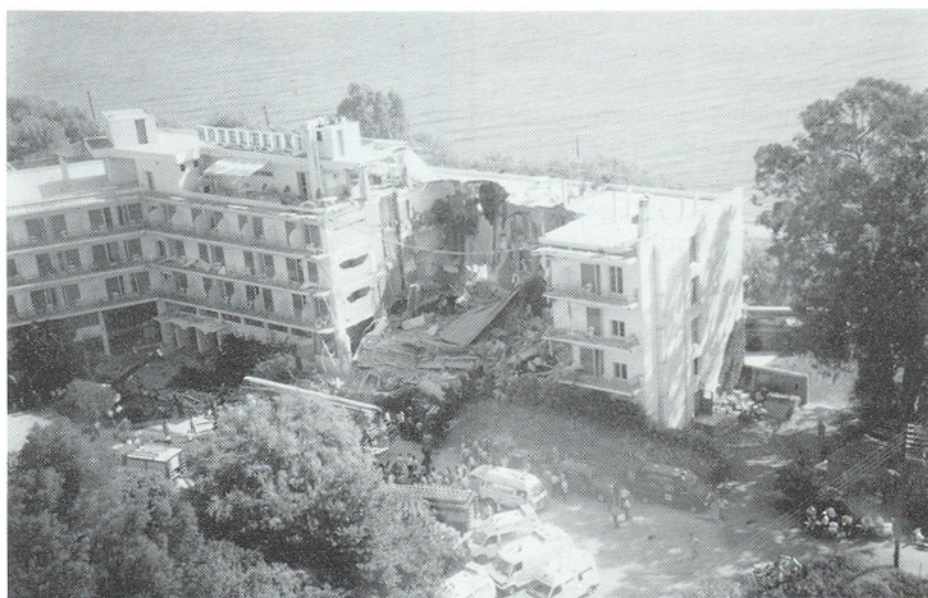
*Figure 3 - One wing of the Elikh Hotel in Valimitika partially collapsed, killing 10 tourists.*

The Elikh Hotel, a four-story, three-section building in Valimitika, suffered a partial collapse of the middle section. That night, 167 persons were lodged at the hotel. After the quake, 127 managed to escape the damaged building; 40 remained trapped under the debris. The operations of the Greek rescue teams, supported by a French rescue team, were rigorous. They managed to find and rescue 30 persons alive; the remaining 10 missing, all French tourists, were found dead. The entire operation lasted 40 hours.
