PROCEEDINGS

4th International Symposium
on the Conservation of
Monuments in the Mediterranean

OBSERVATIONS ON THE ACTION OF GEOLOGICALLY -INDUCED HAZARDS IN THE ANCIENT TOWN OF RHODES (GREECE)

Efthimios Lekkas, Dimitris Sakellariou & Stelios Lozios

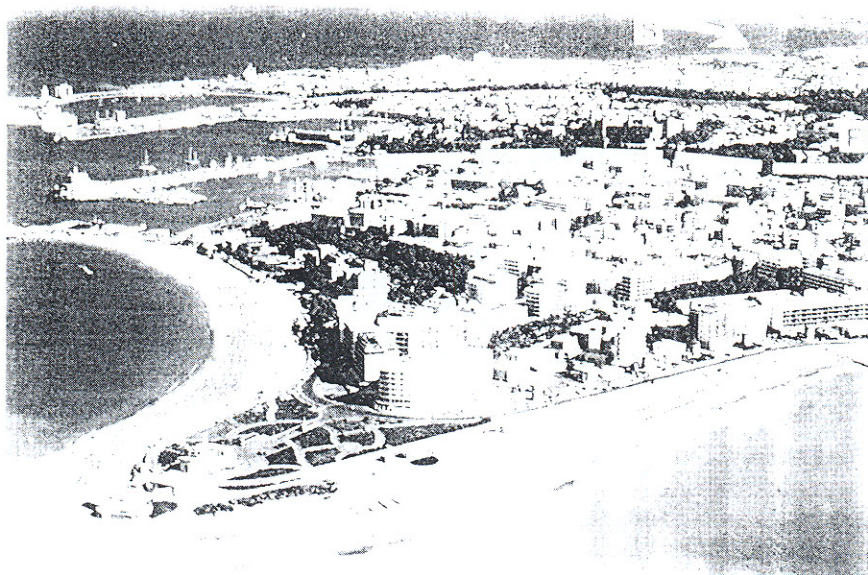
Figure 1. View of the present city of Rhodes at the northern border of the island. The area crossed by the active fault which was probably reactivated within historical times (F), as well as the Korakoneri area which was subject to subsidence movements just after the Roman period (S), are noted.

The city of Rhodes is located in the north end of the island and occupies the geographic triangle (Fig. 1) which is formed by the two coastlines on the one hand and by the hills of Monte Smith and Rodini on the other hand. In its northern extremity the area is plane but moving towards the south-southwest the morphological slopes become steeper, locally reaching values over 20%, while in some locations morphological discontinuities can be observed especially in the area north of the Monte Smith hill.

most significant fault has an east-west direction and it is the one which starts from the northern border of the morphological rise of Monte Smith and ends at the northern section of the Medieval wall, right where it displaces the Rhodes formation on which the Medieval wall is founded (Fig. 1). According to the existing data (LEKKAS et al.² LEKKAS³) this particular fault is considered to be an active fault which has been activated within the Pleistocene period but also within the Holocene period with a throw of at least 100m.

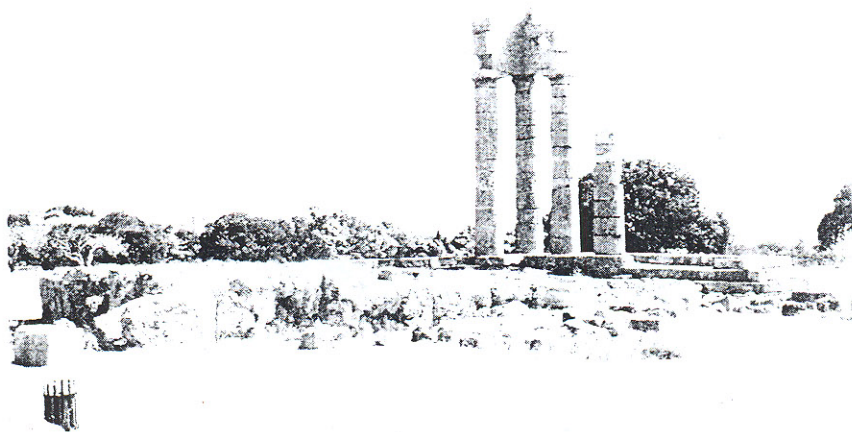
Figure 3. The temple at Monte Smith which is founded on the Rhodes formation.

- Seismic movements. The island of Rhodes and Dodekanese in general are characterised by a high seismicity due to the neighbouring of this area with the convergence boundary between the two lithospheric plates. According to historical sources it is concluded that destructive seismic events took place in 227BC, 197BC, 183BC, 344AC, 477AC, 516AC, 1481AC (PAPAZACHOS & PAPAZACHOU⁵). In order to reduce the seismic hazard in the city of Rhodes, the locations where rock formations where outcropping were selected for construction activities (e.g. Rhodes formation) while other areas where the formations with a negative response to the seismic events were prevailing, were avoided. This is deduced by the fact that in all historical times, from Classical times up to Middle Age the important buildings and the fortification walls were founded solely on the Rhodes formation. Typical examples are the Stadium, the Temple in Monte Smith (Fig. 3) and the Medieval town (Fig. 4), which are entirely founded

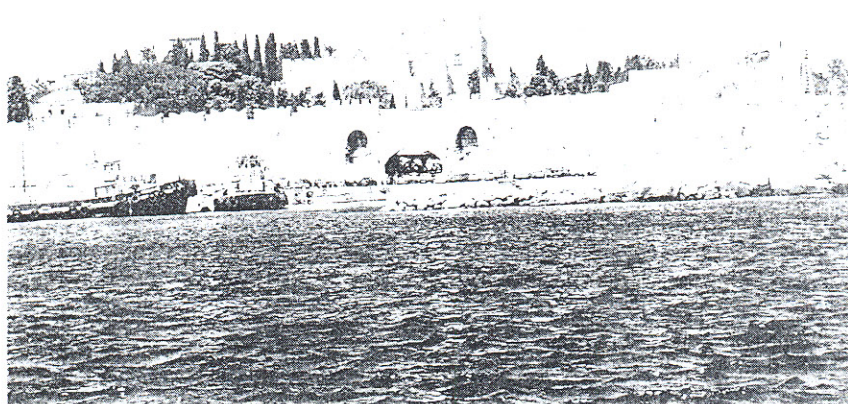
Figure 4. Foundation of the preserved part of the Medieval wall and of the old city on the Rhodes formation so as to reduce the seismic hazard.

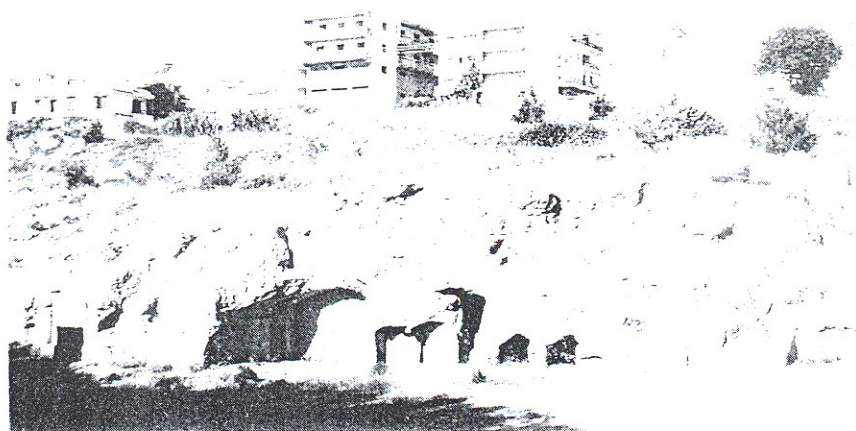
Figure 5. Carved monuments on the Rhodes formation as opposed to the recent constructions which are founded on recent loose deposits and are in great danger by the seismic movements.

on outcrops of the Rhodes formation. On the other hand, nowadays this measure was not always followed and thus the present city of Rhodes was quickly expanded on some not so favourable areas resulting in increasing the seismic hazard. The case of the foundation of large structures on loose soil formations which had covered ancient ruins that were founded on the Rhodes formation is quite characteristic (Fig. 5).
