The Umbria (Central Italy) earthquake series of September 26, 1997

E. Lekkas & I. Fountoulis

Abstract

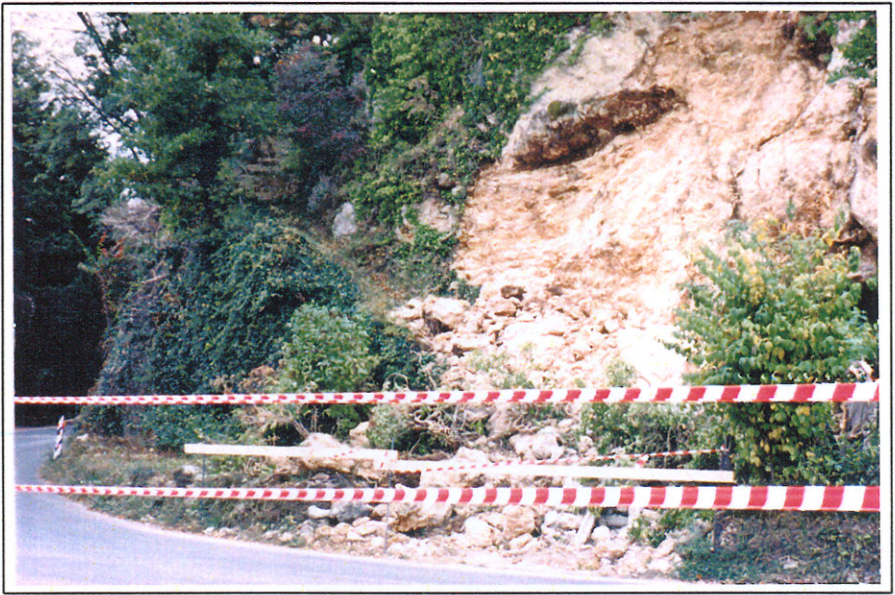
Figure 2: Small-scale landslide along the road Umbria Nocera – Annifo

magnitude landslides of materials which are not characterized by satisfying values of the geomechanical properties, which occur for instance in the roads Nocera Umbria - Corfiorito, Casenova - Volpino, Cesi-Rasenna, etc., however without causing any problem (Fig. 2).

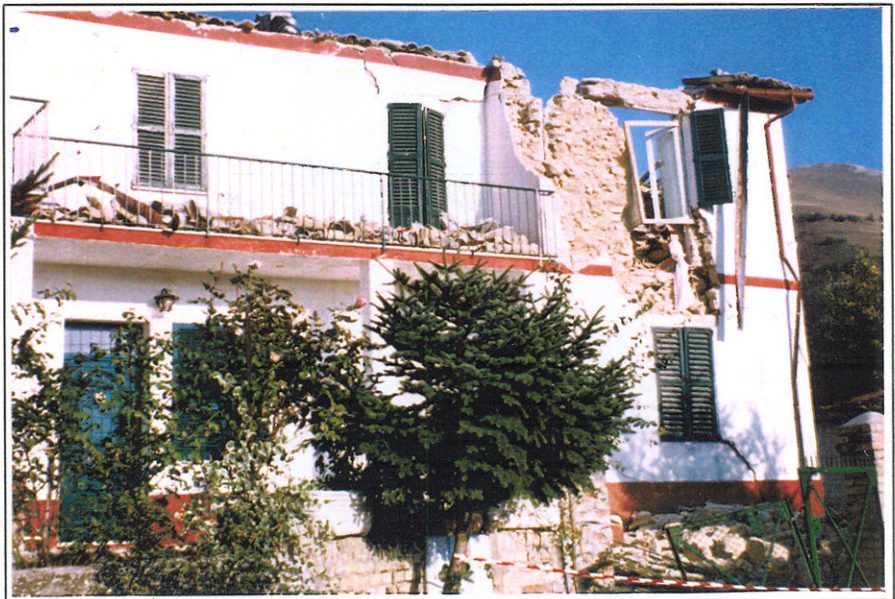
Figure 3: Collapse of the two-story building rubble masonry, in the settlement of Cesi

Extensive damage was observed in buildings of Vernacular architecture. Such constructions are relatively consistent having stone masonry bearing walls with a wood roof structure. In some cases only individual structures were damaged. In other cases the extent of the damage in the community was so great that the entire town was vacated. Nonstructural damage usually included the loss of roof tiles of the low roof at the exterior wall. Moreover plaster spalling from the exterior walls was also observed. Such conditions created a situation where the sidewalk, street, or highway adjacent to the buildings was blocked off. The observed structural damage included many items that would result in a threat of life. The typical failure was in the outward movement of the wall, due to the deflection of the diaphragm pushing the wall outward. This, coupled with inadequate anchorage between the walls and roof, resulted in the wall collapse. In some cases portions of the walls were blown outward. Such type of collapse cause roof collapse too. Many structures had earthquake tie rods visible on the exterior walls (Fig. 3, 4).

Moreover there is limited evidence of significant damage in engineered structures and this is attributed to the high modern design standards. Stone vernacular buildings behaved much similar to any other vernacular structures around the world, where failing occurred due to inadequate anchorage of walls to roofs, with heavy roofs and chimneys pushing outward. However most damaged buildings can be repaired but not upgraded significantly. By contrast, monumental structures and particularly churches have already been through a number of earthquakes

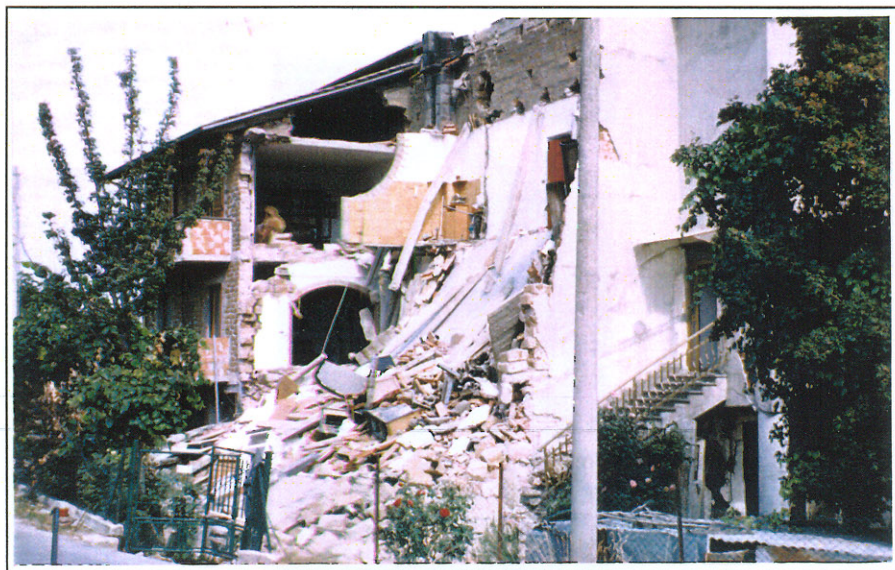
Figure 4: Partial collapse of two-story building in the settlement of Annifo.
