The 12 May 2008 M_w 7.9 Wenchuan, China, Earthquake: Macroseismic Intensity Assessment Using the EMS-98 and ESI 2007 Scales and Their Correlation with the Geological Structure

by Efthymis L. Lekkas

Abstract The Wenchuan earthquake of 12 May 2008 in Sichuan Province, China, can be classified as a large-scale event based on the tectonic structures that triggered the earthquake and the effects caused on the human, structural, and natural environment.

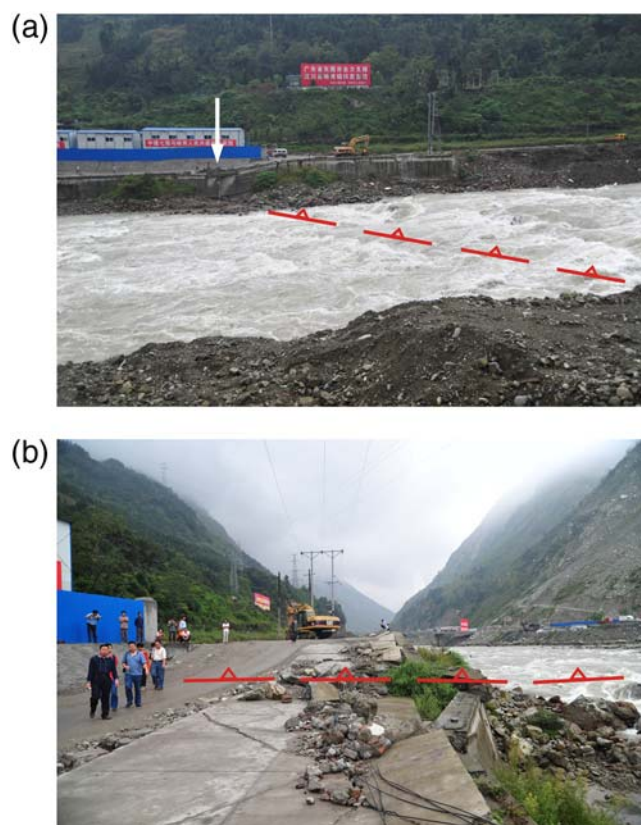
Figure 4. The Yingxiu-Beichuan seismic fault at the outskirts of Yingxiu town. The color version of this figure is available only in the electronic edition.

The earthquake generated 220 km of surface rupture along the Yingxiu–Beichuan fault (Fig. 4), characterized by right-lateral oblique slip, and 72 km of surface rupture along the Guanxian–Anxian fault, characterized by reverse slip. Maximum vertical and horizontal displacements of 6.2 m and 4.9 m, respectively, were recorded along the Yingxiu–Beichuan fault, whereas maximum vertical and horizontal displacements of 3.5 m and 1.0 m, respectively were recorded along the Guanxian–Anxian fault ([Chen *et al.*, 2008](#); [Hao *et al.*, 2008](#); [Xu *et al.*, 2008](#)).

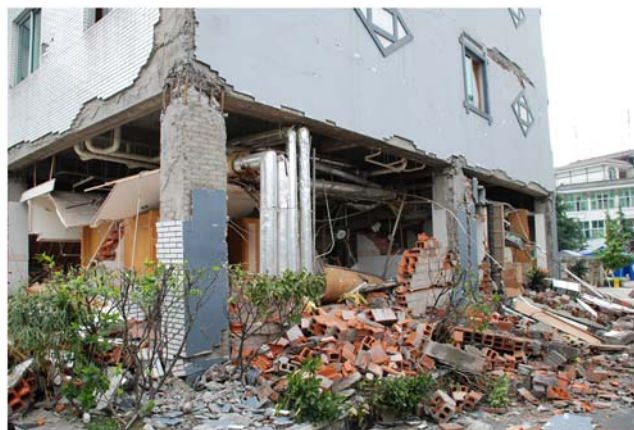
Figure 6. A building in Dujiangyan founded on river deposits with serious structural damage on the ground floor props (type of construction D, damage degree 4). The color version of this figure is available only in the electronic edition.

Within the town, approximately 300 constructions (approximately 5%) totally or partially collapsed, while 20% of the buildings suffered serious structural damage. Modern and older multistory reinforced concrete buildings were mainly the ones that collapsed. Most collapses were located on the foothills of the mountainous region toward the west and the morphologically higher areas; there were fewer in the lowlands. It is interesting to note that new buildings that were under construction and built to meet the modern seismic design regulations and were located toward the higher elevations of the town also collapsed or underwent serious structural damage. A crucial factor in these areas must have been the nature of the foundation formations, which comprise remnants of unconsolidated river deposits and debris of limited thickness on the rocky basement. It is estimated that 30%

of the building collapses observed in this town were located on similar deposits (Fig. 5 and Fig. 6).

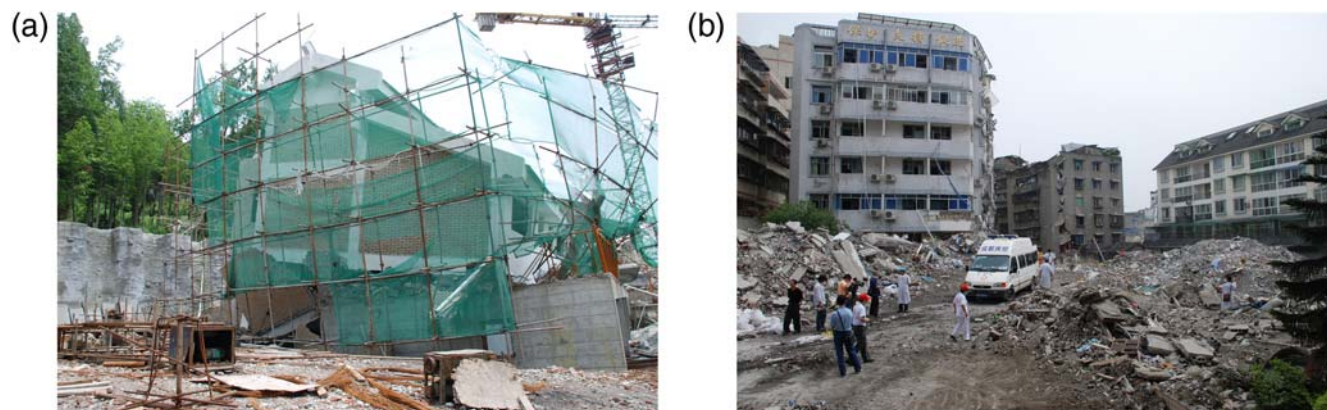
Figure 5. (a) A recently constructed building at the suburbs of Dujiangyan that collapsed (type of construction D, damage degree 5) and (b) a hospital unit in the same town that totally collapsed (type of construction D, damage degree 5). The color version of this figure is available only in the electronic edition.

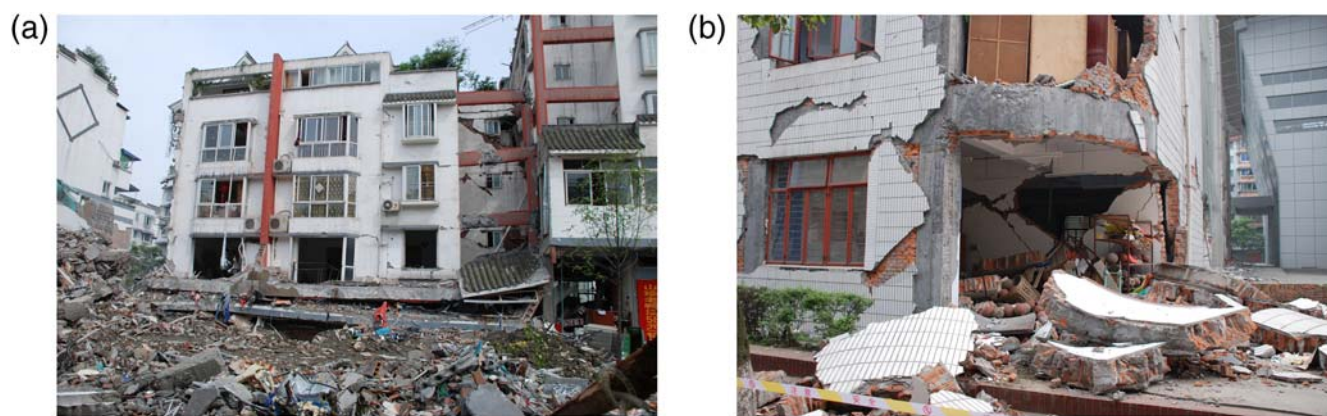
Figure 7. (a) Buildings in Mianzhu town that suffered severe damage. Buildings with partial or total collapse could be seen (type of construction D, damage degree 5) and (b) buildings that suffered minor or no structural damage (type of construction D, damage degree 3). The color version of this figure is available only in the electronic edition.

B2. Mianzhu Town. The town of Mianzhu is located 80 km northeast of the town of Dujiangyan and only 10 km south-east of the surface fault rupture. It is estimated that 20% of the buildings totally or partially collapsed, while 60% of the buildings suffered considerable damage. Mostly multistory buildings, both modern and older, were damaged, while single or double-story constructions suffered less. Dominant causes for the damage in many constructions were the architectural peculiarities and features, especially in cases of constructions with frames lacking proper seismic design. Moreover, many schools, hospitals, and industrial units collapsed, causing thousands of casualties while the infrastructure was either destroyed or seriously damaged (Fig. 7). The town expands practically on the foothills of the mountainous region to the west, while the foundation formations are alluvial deposits and debris that mainly develop toward the east.

The estimated intensity in the area exceeded $\text{VIII}_{\text{EMS-98}}$ and locally approached $\text{IX}_{\text{EMS-98}}$.

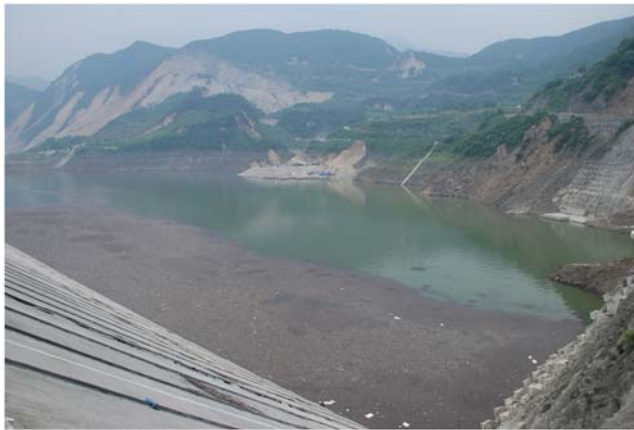
Figure 9. The artificial lake that was formed along the course of the Min River by the Zipingpu Dam. During the earthquake, large-scale landslides (background) triggered water waves 15 m high. The color version of this figure is available only in the electronic edition.

An unusual behavior was exhibited by the existing dams in the mountainous region. More specifically, according to official data, 300 out of 450 dams in the region suffered considerable damage, while some caused serious problems downstream due to the excessive water flow. In a great number of dams, the crown was destroyed and the connection between the two sides of the dam was not possible, blocking the road network for a considerable number of areas. It is estimated that 30% of the dams in the mountainous region

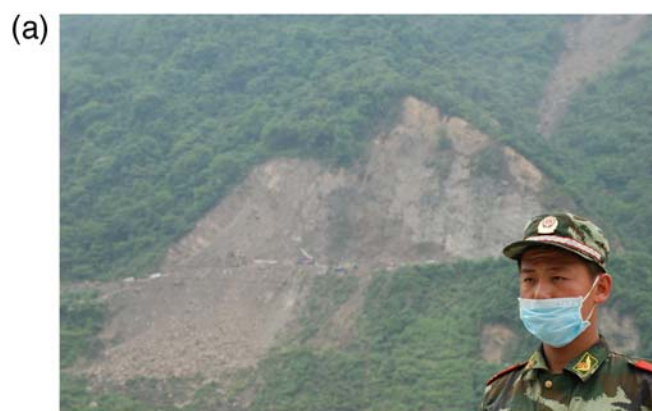
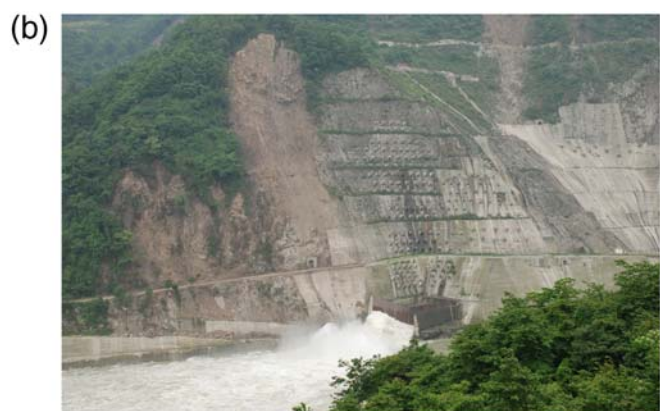
Figure 10. (a) Large-scale landslides that were triggered in the mountainous region along river Min. (b) The Zipingpu Dam. The color version of this figure is available only in the electronic edition.

C5. Large landslides and rock-falls ($> 10^5$ – 10^6 m³) were frequently recorded, practically regardless of equilibrium state of slopes (Fig. 10, Fig. 11, and Fig. 12), producing many temporary or permanent barrier lakes. River banks, artificial embankments, and sides of excavations collapsed. Levees and earth dams incurred serious damage (Lekkas, 2008b; Zhao *et al.*, 2008; Xu *et al.*, 2009).

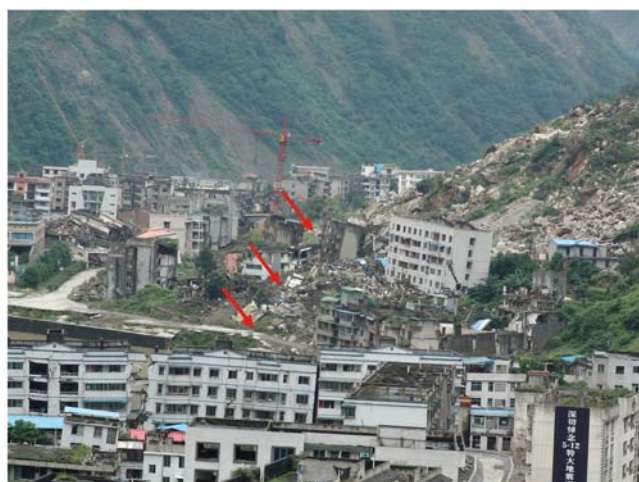
Figure 11. Partial view of Beichuan town, which was almost totally destroyed ($ESI\ 2007 = XII$) due to the combined action of the seismic fault Yingxiu-Beichuan (arrows) and the massive landslides. The color version of this figure is available only in the electronic edition.

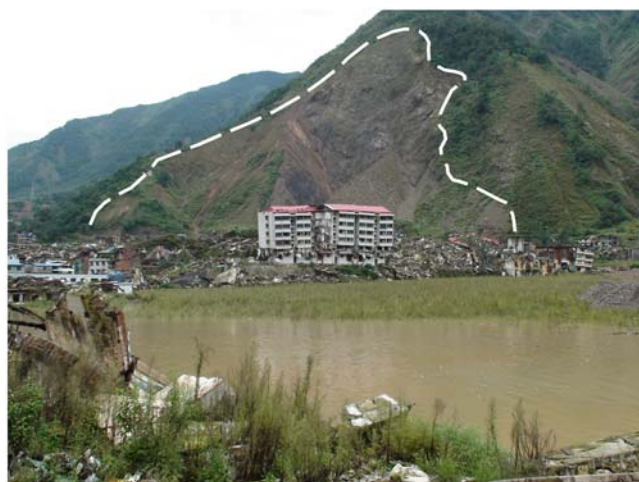
Figure 12. Partial view of Beichuan town, which was totally destroyed by the earthquake and a huge landslide. The color version of this figure is available only in the electronic edition.
