4ου Διεθνούς Συνεδρίου
για τη Συντήρηση των
Μνημείων της Μεσογείου

4th International Symposium
on the Conservation of
Monuments in the Mediterranean

**NATURAL - GEOLOGICAL PROCESSES AS A DESTRUCTION FACTOR
OF THE FORTIFICATIONS AND DECAY OF THE ANCIENT “KATO
POLI” OF EDESSA (MACEDONIA, GREECE)**

Efthimios Lekkas & Ilias Mariolakos

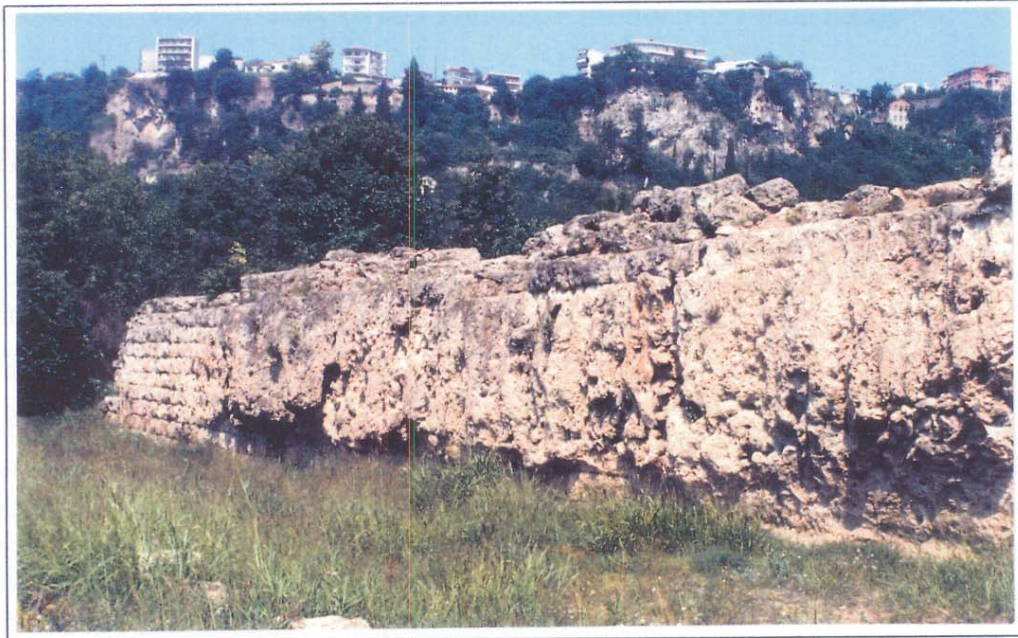
Figure 1. Part of the fortification wall of the “Kato Polis” and a view of the present city of Edessa at the upper level.

In the city of Edessa, from a morphological point of view, two level surfaces can be distinguished. The upper level has an elevation of 300-320 meters and is located towards the west. The ancient Ano Polis ('Uptown') as well as the current city of Edessa were built on this surface. The lower level is located eastwards at an altitude of 150-180 meters where the ancient city with the ancient fortification wall was built (Fig. 1, 2).

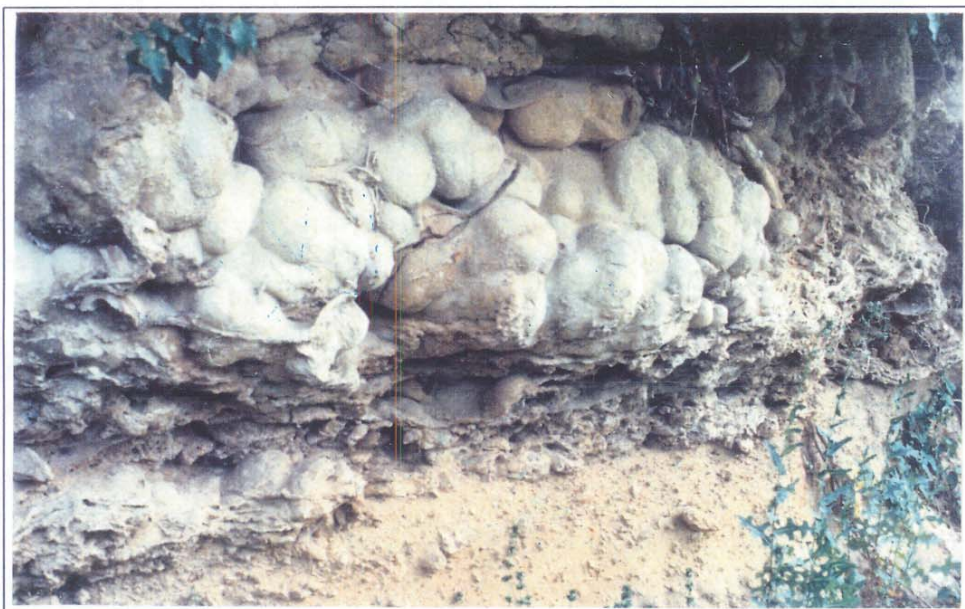
Figure 3. Travertine limestone of botryoidal shape within the wall of the “Kato Polis”, which overlies ruins of the Roman period.

- Botryoidal deposits of travertine limestone over the ruins of the Roman period (Fig. 3) in the internal part of the walls as well as atop the wall, with a thickness that reaches about 2 meters, revealing again that the water which was the main agent of deposition reached a level much higher than that of the city and the wall.

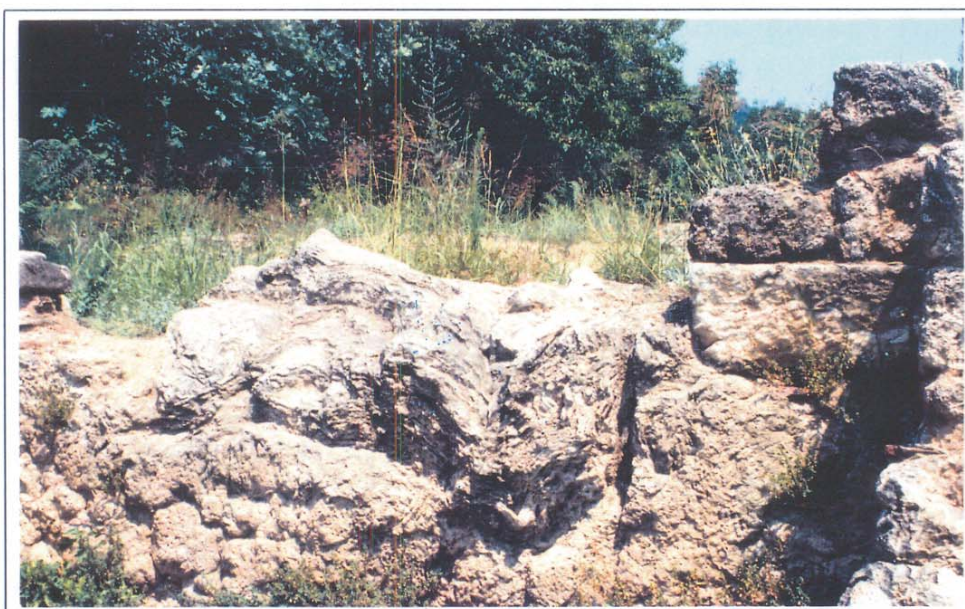
Figure 4. Travertine limestone with extraordinary erosional features of ‘V’ type on the flagstones of the fortification wall of the “Kato Polis”.

- Various peculiar erosional features both of the wall itself and of the deposits that are covering it. In particular, the 'V'-shaped type was characteristic, which indicates prolonged flow and weathering effect over the wall and its coatings (Fig. 4).
