The Role of Earthquake-Related Effects in Urban Complexes

E. L. LEKKAS

Abstract. A number of cases where earthquake-induced damage was massive or presented interesting distribution patterns in recent earthquakes are presented. The highly serious damage along reactivated seismic faults and fractures is discussed for the earthquakes of Pyrgos (Greece), Egio (Greece) and Kobe (Japan). Additionally, we describe characteristic types of building failure in the earthquake of Egio, caused by the coexistence of surficial faulting and liquefaction. Of particular interest is the damage pattern in the Kobe and Dinar earthquakes, attributed to seismic wave directivity, caused by migration of the earthquake source. Finally, a special case of building damage is described for the case of the Adana, Turkey earthquake, which is connected to the shape and the azimuthal location of buildings in respect to the epicentre. All the above cases are valuable sources of information and can be utilized in the reduction of seismic risk in constructions and urban complexes.

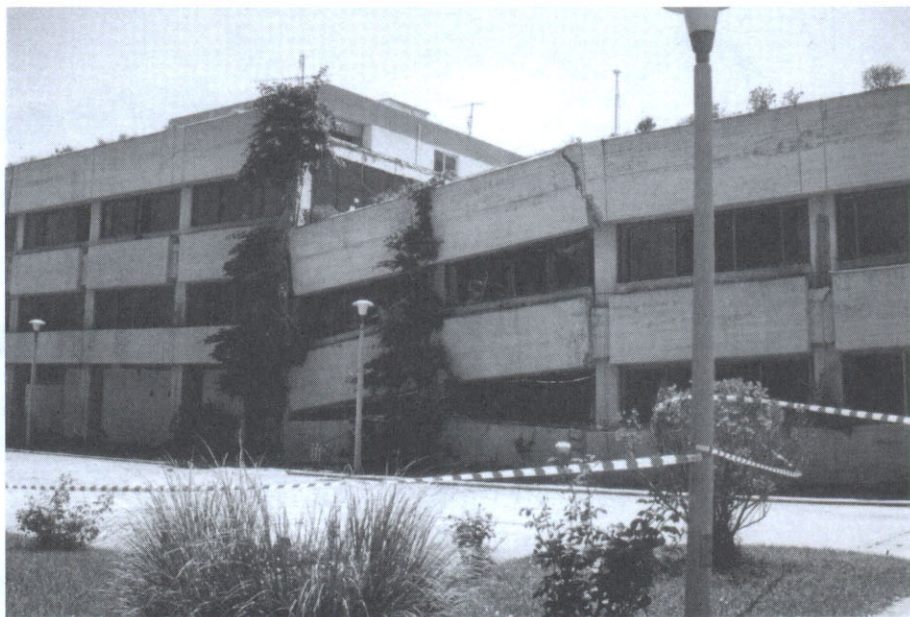
Figure 4. Collapse of industrial buildings, built to meet high earthquake design standards, and founded close to the surficial expression of seismic fractures and liquefaction.

In the Egio earthquake, a series of liquefied sites were observed along the surficial fracture, especially close to the western extremity of it (Carydis *et al.*, 1995a; Lekkas *et al.*, 1996b, 1998). One such example was the partial collapse of the building of the Hellenic Weapon Industry, a two-storey earthquake-proof R/C frame construction located only a few meters away from the fracture, along which liquefaction was observed (Figure 2). Parts of the building collapsed totally, while others suffered heavy structural damage (Figure 4). Besides, a number of other buildings located on the fracture also collapsed or had heavy structural damage, too.

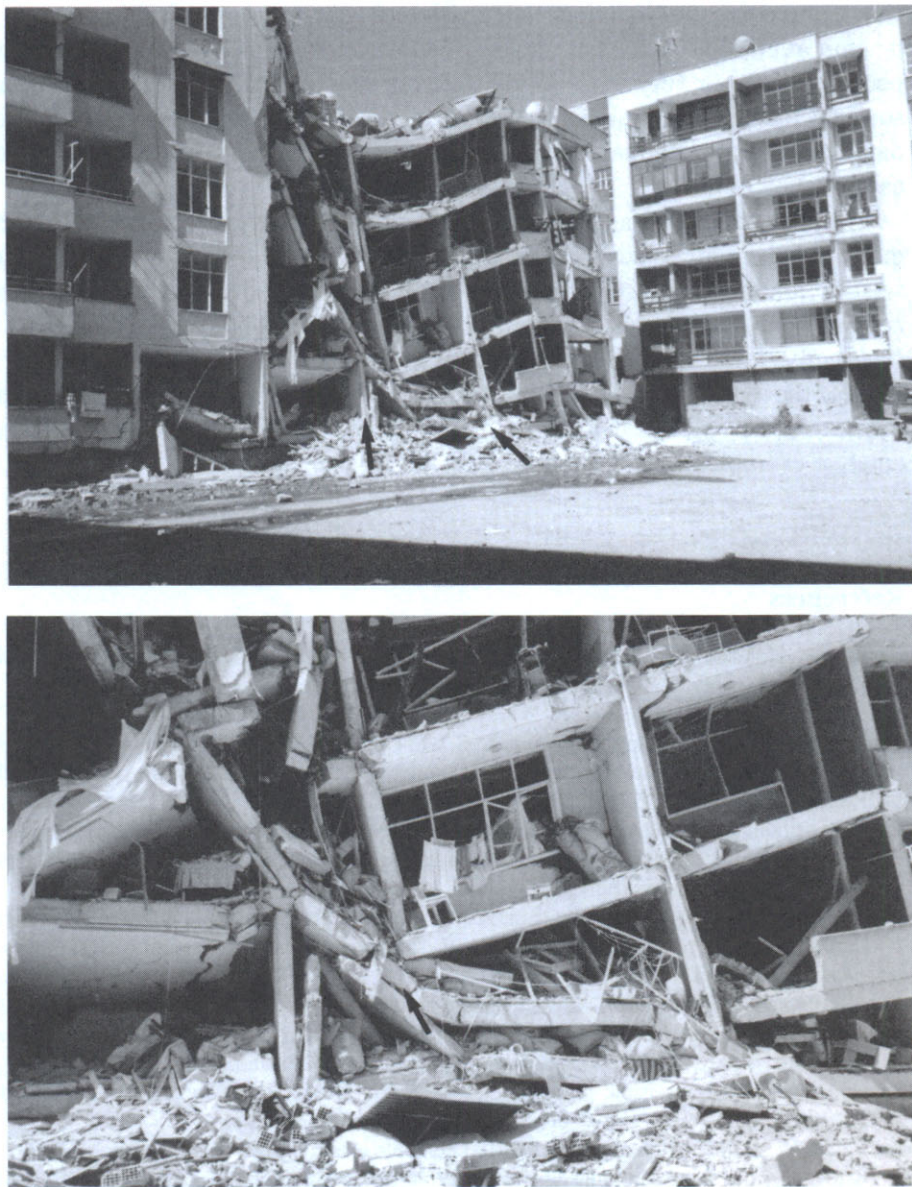
Figure 10. View of the NE-SW oriented apartment blocks that collapsed, with the NW-SE ones having remained relatively intact. Also shown the longitudinal arrangement of the supporting columns. At different azimuth, in respect to the epicentre, damage was quite less, a fact confirming the decisive role of the trend of the reactivated fault zone (NE-SE) in the distribution of damage (Figure 8).

Of all the apartment blocks, the ones that collapsed were those oriented NE-SW (with NW-SE supporting columns). On the contrary, no collapse was observed at the NW-SE oriented buildings (with NE-SW supporting columns) (Figure 10). This was due to (i) the orientation of the long side of the buildings in relation to the epicentre and (ii) the increased strength of the elongated supporting columns along the direction parallel to their long side. The ones that were oriented parallel to the direction of the seismic wave propagation withstood the shock while the others did not. Finally, it should be noted that within the broader area and in different azimuthal directions (Figure 8) in respect to the epicentre (Tarsus, Yumurtalik, Karatas, etc.), earthquake-induced damage was not significantly increased. This fact underlines the decisive impact of the reactivated NE-SW trending zone on the distribution of damage.
