Ishinomaki Tsunami Intensity Mapping (ITIS₂₀₁₂) for the 9Mw Tohoku Event, March 11 2011, Japan

Katerina-Navsika Katsetsiadou,¹
Emmanuel Andreadakis,¹
Efthimis Lekkas¹

¹Department of Geology and
Geoenvironment, National and
Kapodistrian University of Athens

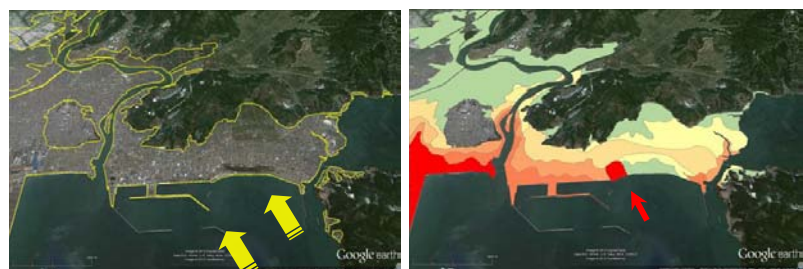
Figure 11: Protection lack in the area between the coastal forest and the port facilities in eastern Ishinomaki

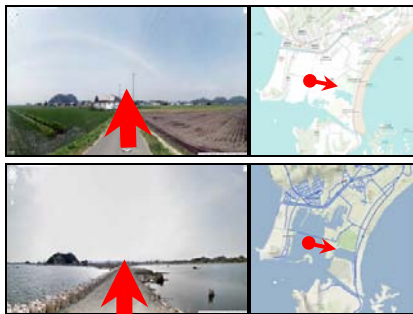
Figure 15: 27 km² area in western Higashimatsushima before (up) and after (down) the event.¹⁵

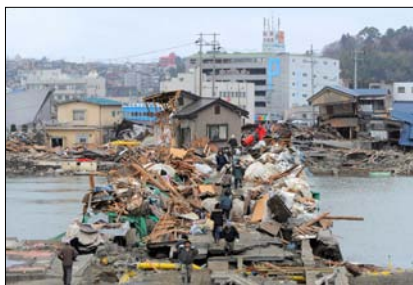
Figure 17: Debris on Kitakami River Bridge at 15-03-2011 (Kim Jae-Hwan, Toru Yamanaka/AFP/Getty Images)
