## INITIAL GEOLOGICAL AND ENGINEERING ASSESSMENT OF THE 2015 NEPAL, GORKHA M7.8 EARTHQUAKE AND ITS SOCIETAL AFTERMATH

**Keywords:** Himalaya; Nepal; Kathmandu Basin; Building Damage; Earthquake Environmental Effects

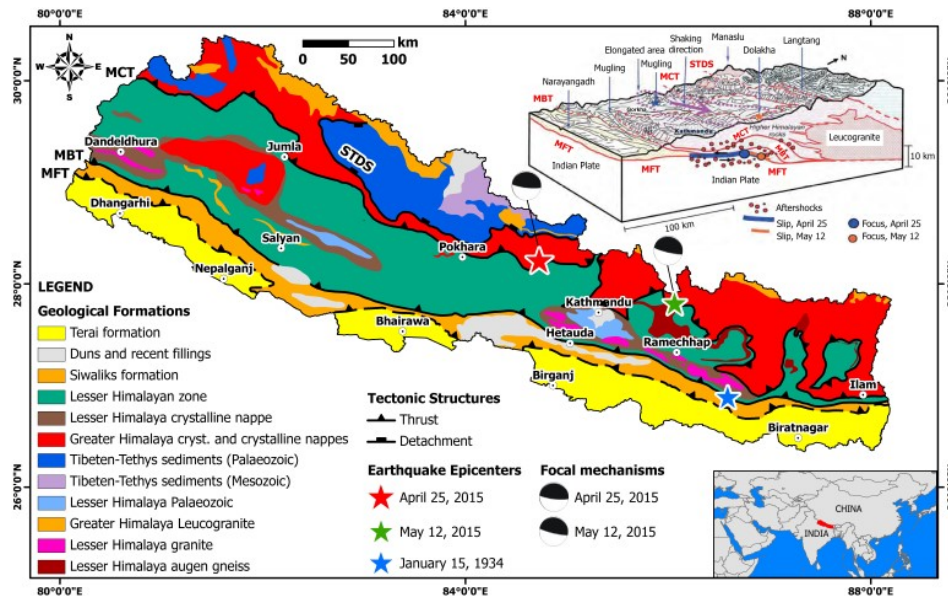
Fig. 1 – Geological map of Nepal after [8] with the epicenters of the April 25, 2015 Nepal, Gorkha earthquake and its largest aftershock and a block diagram after [9] illustrating the approximate locations of slip during the April 25 and May 12, 2015 ruptures and the aftershocks. The elongated area suffered severe damage.

Nepal (Fig. 1) is located in the central part of the Himalayan arc and extends between 80°04' and 88°12' east longitude, and 26°22' and 30°27' north latitude. The country approximates an oblong and occupies an area of 147181 km<sup>2</sup>. Its maximum length is about 825 km, and its width varies between 250 and 170 km from west to

In Nepal, the structural setting is defined by three northerly dipping major thrusts, which are the Main Frontal Thrust (MFT), the Main Boundary Thrust (MBT) and the Main Central Thrust (MCT) from south to north respectively (Fig. 1). These three major thrust faults in the Nepal Himalaya sole at depth into the Main Himalayan Thrust (MHT), which marks the underthrusting of the Indian Plate [5, 6]. Moreover, they clearly separate the major tectonostratigraphic units of Nepal Himalaya, which are the MFT hanging wall (Sub-Himalayan or Siwalik Zone), MBT hanging wall (Lesser Himalayan Zone), MCT hanging wall (Higher Himalayan Zone) and STD hanging wall (Tibetan – Tethyan Himalayan Zone) (Fig. 1). More specifically, the MFT separates the Quaternary alluvium of the Indo-Gangetic depression from the Siwalik Group comprising Neogene fine- to coarse-grained continental strata (~20 - 2 Ma). The MBT separates the Siwalik Group from the weakly metamorphosed rocks of the Lesser Himalayan Sequence comprising low-grade Proterozoic metasedimentary and metavolcanic strata, augen gneiss (1870-800 Ma). The MCT places high-grade metamorphic rocks (800-480 Ma) of the Greater Himalayan Zone comprising kyanite-sillimanite, gneiss, schist and quartzite over the low-grade metamorphic rocks of the Lesser Himalayan Sequence [6] (Fig. 1). It has been recognized that metamorphic grade increases up-structural section towards the north from the Lesser Himalaya to the Greater Himalaya [7]. The MCT is the oldest of these gently north-dipping thrusts followed by the MBT and the MFT respectively.

The Kathmandu basin is an intermontane basin lying on the Kathmandu Nappe located in the Lesser Himalayan zone [6] (Fig. 1). It is filled with young semi-consolidated fluvio-lacustrine sediments of Pliocene to

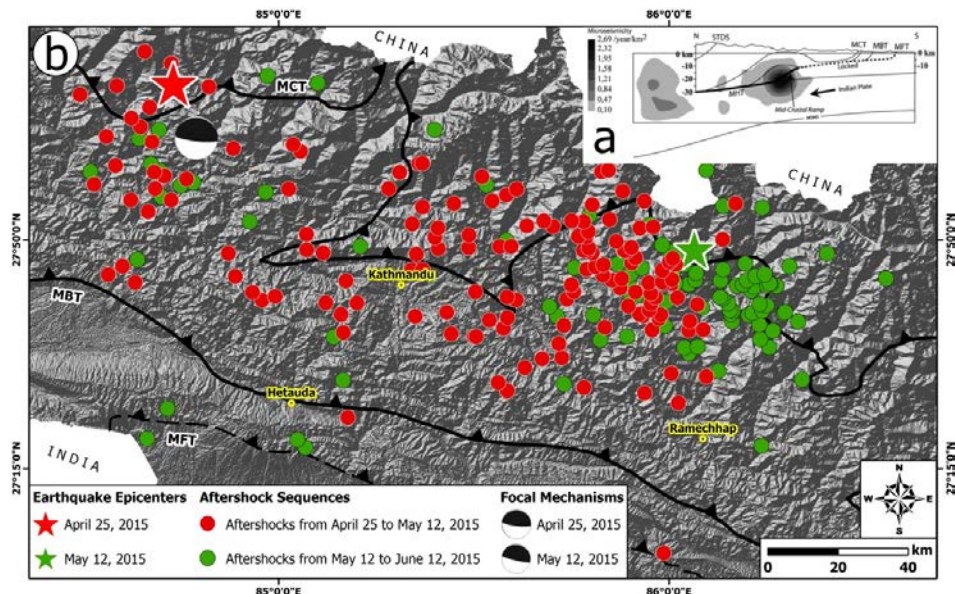
Fig. 2 – (a) Generalized N-S cross section through the Central Himalaya. The southern flat along the MHT is locked during the inter-seismic period resulting in elastic stress accumulation, which is released through microseismicity in Nepal Himalaya. The great earthquakes are generally originated along the northern flat just front of the Higher Himalaya [6]. (b) The epicenters, the aftershock sequences and the focal mechanisms of the main shock on April 25, 2015 and of its largest aftershock on May 12, 2015 respectively based on [21].

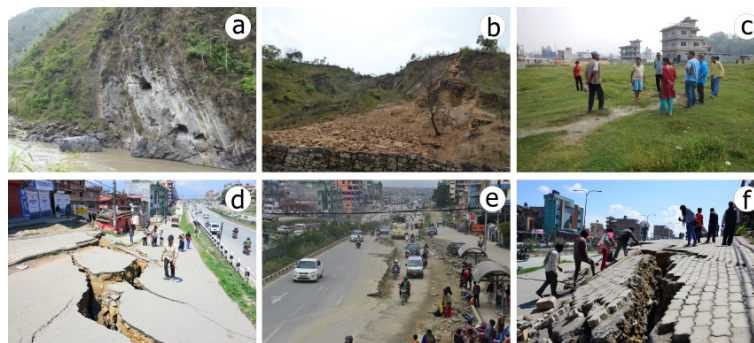
Fig. 3 – Typical EEE induced by the 2015 Nepal, Gorkha earthquake: (a, b) landslides along the road network of the affected area, (c) liquefaction phenomena in Guheshwori from [26] (d, e, f) ground cracks strongly related to liquefaction-induced lateral spreading along a segment of the Kathmandu-Bhaktapur road section of the Araniko Highway in the Lokanthali area.

Based on [23, 24, 26], primary effects directly linked to the surface expression of the seismogenic source were not detected in the field after the 2015 Nepal, Gorkha earthquake. Palaeoseismological studies suggest that the 1255 and 1934 earthquakes ( $M_w \geq 8.1$ ) ruptured the surface along the MFT south of Kathmandu [27], while field observations and related studies after the 2015 main shock suggest that the rupture extended only to the base of the MFT [23, 24, 26]. However, as mentioned above, a wide ground deformation zone in Araniko Highway could be attributed to thrust faulting directly located under the Kathmandu basin (Fig. 3a, b, c)

The 2015 Nepal, Gorkha earthquake and its aftershocks induced slope movements with adverse effects on the local population, buildings and infrastructure including burial and destruction of several villages, hundreds of fatalities, partial or total destruction of roads and natural damming of rivers posing significant hazard due to landslide dam burst and consequent catastrophic downstream flooding. Almost 6000 of landslides were triggered by the earthquake sequence and were distributed over an area of approximately 35000 km<sup>2</sup> in Nepal [28]. Few extremely large-volume ( $>250000$  m<sup>3</sup>) landslides were triggered despite the magnitudes of the April 25 and May 12 events and the rugged morphology of the affected area. The observed slope movements were classified as rock falls, rock slides, soil falls and soil slides (Fig. 3a, b). The majority of them occurred in areas comprising fractured, weathered and thus unstable geological material susceptible to failure along steep slopes. They were observed not only close to the epicenter of the main shock, but also in the eastern part of the seismic sequence due to the eastward-directed fault rupture of the main shock and the generation of the largest aftershock  $M_w$  7.3 on May 12 in the same area. Almost 70 valley-blocking landslides were reported in the affected region with volume ranging from 500 to 2000000 m<sup>3</sup>, while half of the dams were empty due to either dry rivers or dam breaching [28]. The observed lake surface areas ranged from 50 to 35000 m<sup>2</sup> and averaged 1700 m<sup>2</sup> [28]. Nearly all of them were breached within one month following the earthquake.

Liquefaction induced by the 2015 Nepal, Gorkha earthquake appears to be limited and localized in susceptible to liquefaction areas along the fringes and within Kathmandu valley and was sparser than usually expected from an earthquake of such magnitude. The generation of this earthquake sequence in the middle of the dry season, when the moisture level in the soil was quite low, might have contributed to lower instances of soil liquefaction. These phenomena were induced particularly in Ramkot, Manamaiju, Guheshwori, Lokanthali, Bungamati, Changu Narayan, Mulpani, Gwarko/Imadol, Hattiban, Kamalvinayak, Bhaktapur, Syuchatar, Jharuwarashi and Nepal Engineering College areas [26, 29, this study]. Moreover, liquefaction in the form of silt boils and lateral spreading occurred due to the earthquake inside Trishuli dam reservoir located northwest of Kathmandu valley. The main liquefaction manifestation in the affected area included (i) sand boils ejecting sandy material resulting in flooding of the surrounding area (Fig. 3c) during and after the main shock in April 25 and the large aftershocks followed in the first hours and (ii) ground fissures associated with lateral spreading in gentle slopes and in short distance from rivers within the Kathmandu valley. The soil profile of the liquefaction-affected areas comprises silty clay or silt on the top followed by low-plasticity silty clay locally known as black cotton clay 0.5-1.5 thick and loose fine sand up to 3 m depth. These deposits coincide with shallow water table up to 1.3 to 3 m below ground surface. Liquefaction phenomena caused severe damage mainly to masonry buildings in Kamalvinayak, Bhaktapur and Syuchatar areas, while few of the reinforced concrete buildings experienced damage where liquefaction occurred under the building foundation.

lateral spreading and in geotechnical unstable areas due to the generation of earthquake-induced slope movements. A characteristic example of cracks was observed along a segment of the Kathmandu-Bhaktapur Road section of the Araniko Highway in the Lokanthali area (Fig. 3d, e, f). Cracks with 2 m deep fissures and vertical offset up to 1.5 m were observed over a large area with gentle slope to a river channel and caused ground fissuring and subsidence, slope failures and sinking of the main and access roads, damage to reinforced and gravity retaining walls, settlement and tilting of buildings and damage to footbridges. Based on various field reports [23, 24, 26], these structures were associated with lateral spreading. However, taking into account the observed structures such as monoclinal escarpment, tension cracks and small-amplitude folds and the fact that these cracks are in agreement with preliminary models of co-seismic slip suggesting that the largest amount of slip on the fault was located just below the Kathmandu city, this highly deformed zone could be attributed to thrust faulting.

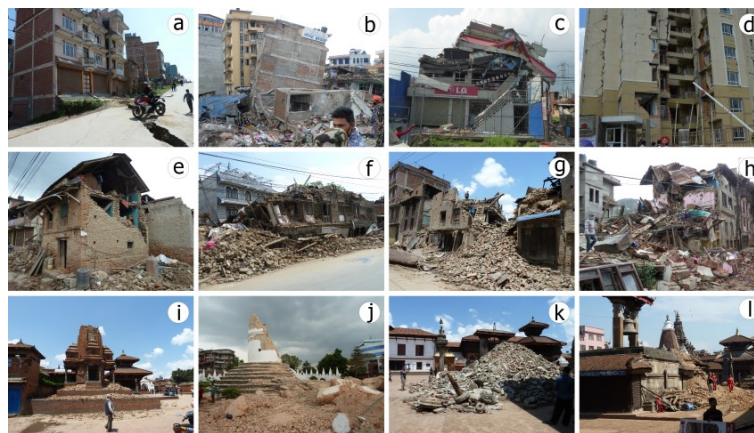
Fig. 4 – The first row illustrates damage on RC buildings: (a) Tilting close to ground cracks strongly related to liquefaction-induced lateral spreading, (b, c) partial and total collapse, (d) moderate damage to non-structural elements of high-rise apartment building. The second row illustrates damage to masonry buildings: (e) partial collapses of the side walls, (f, g) partial collapse and (h) total collapse of masonry buildings close to undamaged RC buildings (f, g, h). The third row illustrates damage to old cultural heritage buildings of various construction types and especially partial (i) and total collapse of temples (j, k, l).

Well-constructed RC buildings sustained no to moderate damage. Poorly built and non-engineered RC buildings suffered minor, moderate and severe damage not only to non-structural but also to structural elements. Non-structural damage included cracks with multiple patterns in infill walls (e.g. diagonal cracks, horizontal cracks at the beam interface and vertical cracks at the column interface), detachment of large pieces of plaster from infill walls, detachment of infill walls from the surrounding RC frame and partial or total collapse of infill walls. Damage to structural elements of low- and mid-rise buildings comprised cracks and fracturing in beam and columns, shear failure or compression crushing of the supporting columns along with the elastic behaviour of beams, tilting (Fig. 4a, b), foundation failure resulting in overturning and partial or total collapse, soft story failure due to absence of infill walls and stirrups at the beam-column joint location, pounding of adjacent buildings resulting in partial collapse or tilting (Fig. 4b,c) as well as pan-cake type collapse due to heavy loads from the upper stories and insufficient column sizes. Damage to high-rise buildings was observed to non-structural elements and comprised cracks in infill walls and detachment of large pieces of plaster in the lower stories (first and second) followed by the medium stories. Damage to RC buildings was due to poor geometric configuration (too long in one direction, extension of masonry wall beyond column line), poor quality of construction materials and concrete with comprehensive strength lower than the expected, non-seismic detailing and absence of earthquake resistant features, lack of implementation of proper ductile detailing of reinforcement even in recent constructions, lack of geotechnical provision and inappropriate foundation on slopes.

Damage to unreinforced masonry buildings include diagonal cracks often originating from the openings in the masonry load-bearing walls (doors and windows), vertical corner cracks along the mortar joints of the brick walls, partial collapse of multi-layered walls, collapse of the upper stories of the buildings and roofs, while the lower stories remained intact, out-of-plane failure of roof gable due to its location at the top of the building and to its vibration as a free standing unit, tilting due to foundation failure, damage due to pounding with heavier adjacent buildings and partial or total collapse of the building (Fig. 4e, f, g, h). Damage to unreinforced masonry buildings were due to the placement of construction materials in a random manner, the large thickness of the load-bearing walls along with heavy floors and roofs resulting in heavy structures attracting large inertial forces during large shocks, lack of interlocking connection between main and cross walls, poor connection between the wall and the diaphragm and absence of continuous horizontal bands for developing confining box action of walls.

Major destruction was observed at various square complexes, world heritage sites and many other historical structures of cultural and archaeological significance in Kathmandu valley. The observed damage varied significantly based on the construction age and the structural systems. It mainly comprised residual deformation of the ground floor level of the temple, cracks in masonry walls, partial or total collapse of masonry walls (Fig. 4i, k, l), sway of the timber frame and partial or total collapse of the structure. Damage to old cultural heritage structures were due to old construction age, unusual structural systems, fatigue of monuments from past earthquakes, lack of maintenance and poor quality restoration after the 1934 Nepal-Bihar earthquake.

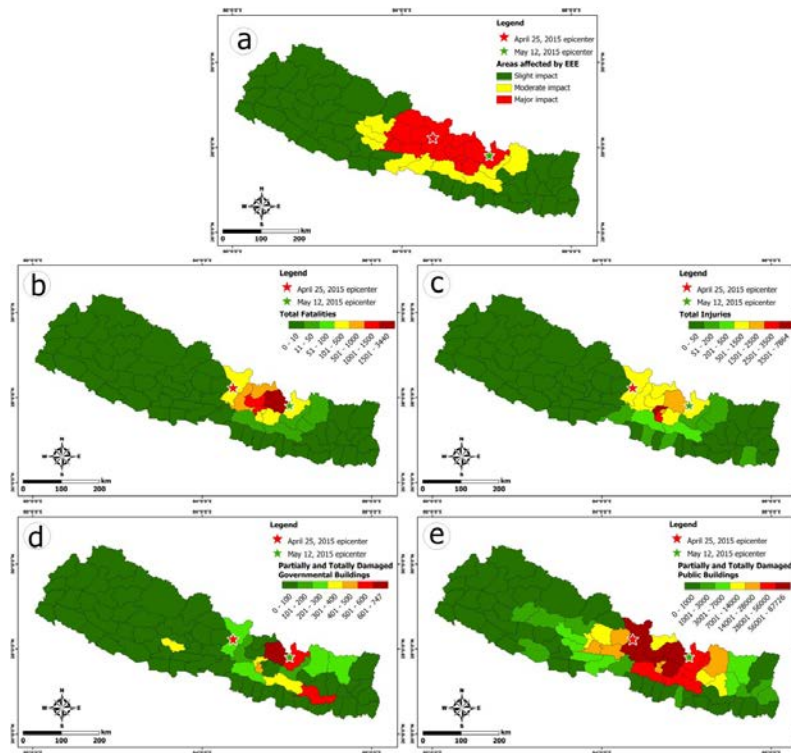
Fig. 5 – Distribution of (a) EEE, (b) fatalities, (c) injuries, (d) damaged governmental buildings and (e) damaged public buildings induced by the 2015 Nepal, Gorkha earthquake and its largest aftershocks to the Nepal districts based on governmental reports [30] last updated on June 05, 2015.
