The recent seismic activity in Gujarat region (Western India)

S. G. Lozios¹, E. L. Lekkas¹ & G. D. Danamos¹

Abstract

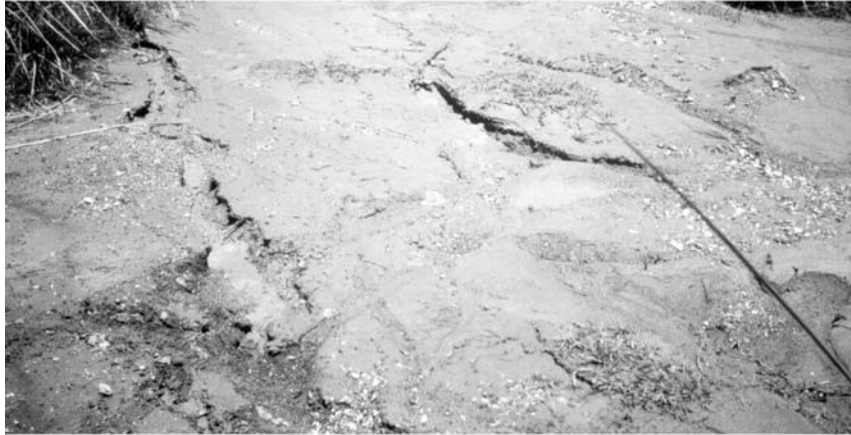
Figure 2: Sand boils, extensional failures and open cracks.
5 Km to the north of Bhachau.

In the surface these phenomena recognized as sand boils, lateral spreads, extensional failures and collapse features. A great number of surface raptures that observed in the greater area is the result of liquefaction phenomena. Those raptures however have different characteristics, relative to the others mentioned

above, as they don't show relevant kinematic and dynamic features and their space distribution is neither systematic nor along distinct tectonic zones. Usually they are parallel to some morphological structures, such as shore lines, river beds, valley slopes etc. So on, their direction trend varies, as well as their size, which could be from a few centimeters to several ten of meters.

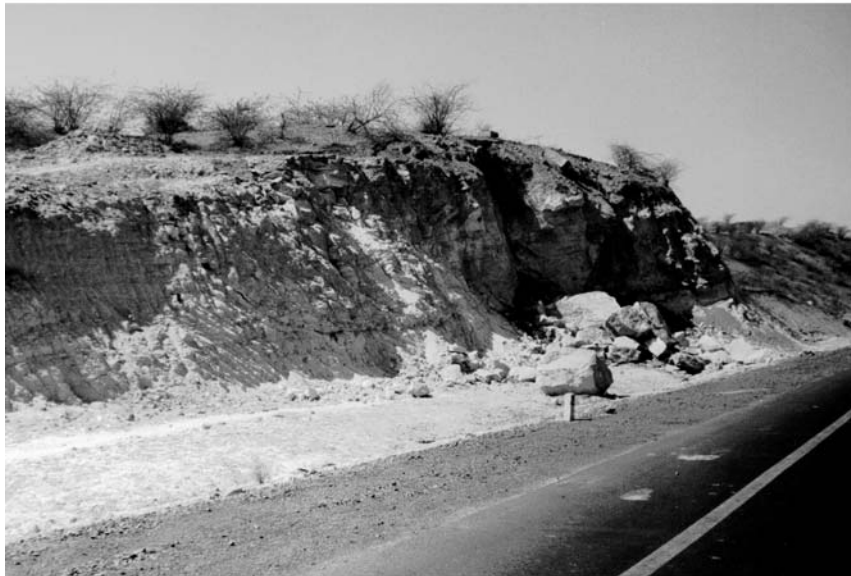
Figure 3: Small scale rock-falls in the road cut, 25 Km to
the east of Bhachau.

The slope failures represented mainly by rock-falls phenomena and were observed in many places within the stricken area, mainly in the south of Kachchh Mainland Fault and in lesser extent in the region of Rapar and Rann of Kachchh. These phenomena have been detected in the areas where the morphological slopes, the lithology and the geometry of joints and other discontinuities of the rocks, generated the proper conditions.

The morphology of the region, which is the result of the active tectonics, is the principal factor provoking the rockfalls. These phenomena took place at the scarp of morphological discontinuities, which are mainly related with the faults of the area, at the slopes of the valleys which are crossing the area because of uplifting, but also at the road-cuts or on the anticlinal slopes.
