## **CORRELATING THE DAMAGE PATTERN AND THE GEOLOGICAL STRUCTURE. LOCAL SITE EFFECTS FROM THE 2006 MW=6.7 KYTHIRA ISLAND INTERMEDIATE DEPTH EVENT, SW GREECE.**

**E.L. Lekkas<sup>1</sup>, I. D. Papanikolaou<sup>1,2</sup>, D.I. Papanikolaou<sup>1</sup> and Danamos<sup>1</sup> G.**

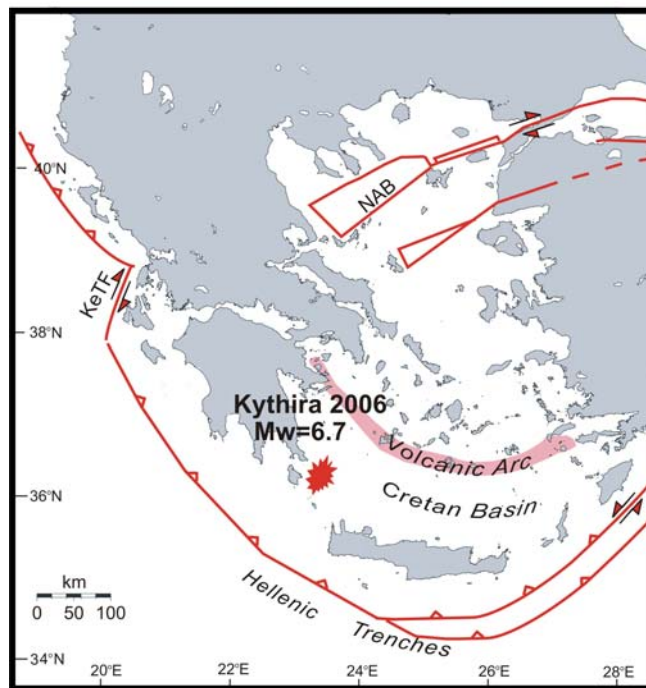
Figure 1. On January 8, 2006 a  $M_w=6.7$  thrust faulting event occurred on the Hellenic subduction zone. The epicentre was located about 30 km east of the island of Kythira and the focal depth was estimated at 70 km.

On January 8, 2006 an  $M_w=6.7$  thrust faulting event with considerable amount of strike slip motion occurred in the Southwestern Greece (EMSC European Mediterranean Seismological Centre; KONSTANTINOOU ET AL. 2006). This event is related to the Hellenic subduction zone (Figure 1) and the epicentre was located a few tens of km east of the island of Kythira with focal depth estimated at 70 km. The African Plate and the remnants of the Tethyan Ocean are subducting below the Eurasia Plate at about 40 mm/yr (MCCLUSKY ET AL. 2000). The Hellenic subduction zone can generate large earthquakes ( $M>7.0$ ) with shallow or deep focal depths, (reaching up to 200 km). These events can cause significant widespread damages far beyond the epicentral area and are regarded as potential threats particularly for multi-storey buildings even if they are located hundreds of km away from the epicentre. The area of Kythira is characterized by an extensional stress field (DANAMOS 1992), involving the presence of NNW-SSE trending active normal faults, which formed the ridge between the Peloponnese and Crete (LYBERIS ET AL. 1982).

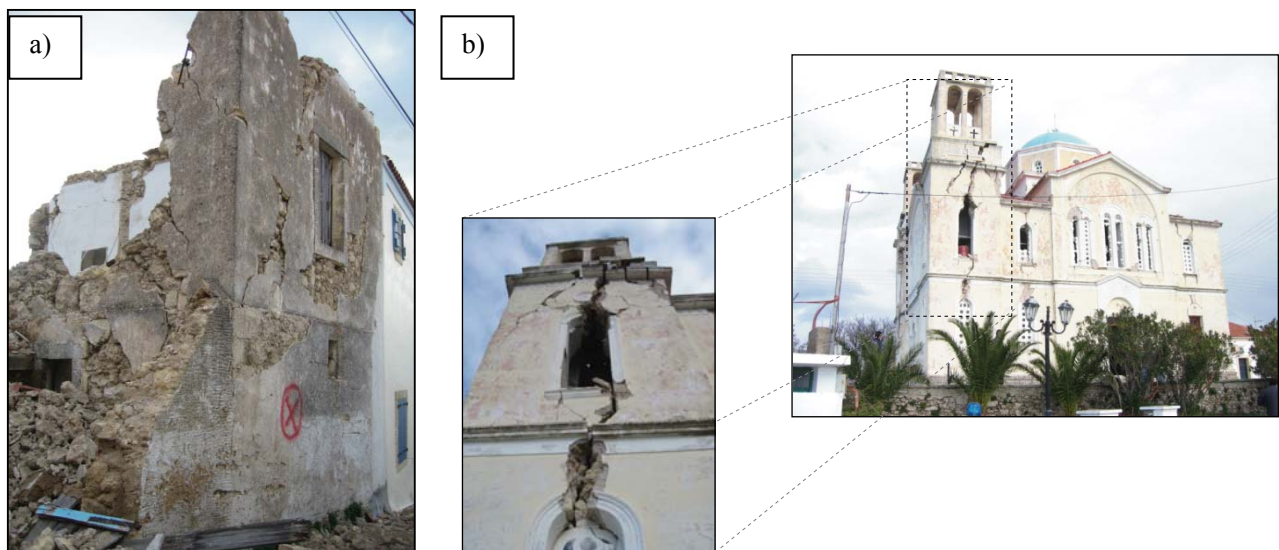
Figure 2. View of the damages in the Mitata village. a) Collapses of old plain stone masonry buildings, b) Damages inflicted on the metropolitan church of the Mitata village. The church located in the village square, is constructed with porous limestone blocks cemented with lime wash without concrete columns. Both bell towers experienced significant damages.

The earthquake was felt throughout Greece and the Eastern Mediterranean in general (from S. Italy and Dalmatic coasts, to Bulgaria, Turkey, Jordan, Israel and Egypt). No casualties were reported and damages were restricted only in the village of Mitata in the island of Kythira (Figure 1, Figure 2). Several old stone masonry

buildings experienced significant damage (including a few collapses, Figure 2a), however modern reinforced concrete buildings did not undergo any damage. The metropolitan church located in the square of the village, sustained severe damage (Figure 2b) and several stone fences collapsed. A number of rockfalls, landslides and fractures disturbed the local road network (Figure 3), affecting an area of about 15 km<sup>2</sup> (Figure 4). A few meters-long fractures were observed on paved roads within the village (Figure 3b). The biggest landslide affected the Mitata village square that was partly detached (Figure 3a), involving a collapsing volume of about 5.000 m<sup>3</sup>. Several masses of rock were detached and accumulated at the base of the slope on the Mitata-Viaradika road (Figure 3c). A few more rockfalls were observed along the remaining road network of the island, but no liquefaction phenomena were recorded. It is interesting to note that even though several villages of the island are equidistant from the epicentre, only the Mitata village was damaged and experienced some noteworthy earthquake environmental effects. Based on the earthquake environmental effects **PAPANIKOLAOU ET AL. (IN PRESS)** assigned an ESI 2007 (Earthquake Seismic Intensity) maximum epicentral intensity VII-VIII, which is similar the MM reported intensity value (**KONSTANTINOU ET AL. 2006**). The ESI 2007 has been recently introduced by INQUA (**MICHETTI ET AL. 2007**) and aims at evaluating earthquake size and epicentre solely from the Earthquake Environmental Effects (EEE). The EEE are not influenced by human parameters such as effects on people and the manmade environment as the traditional intensity scales (MCS, MM, EMS 1992, etc) predominantly imply. Traditional intensities tend to reflect mainly the economic development and the cultural setting of the area that experienced the earthquake, instead of its “strength” (**SERVA 1994**)

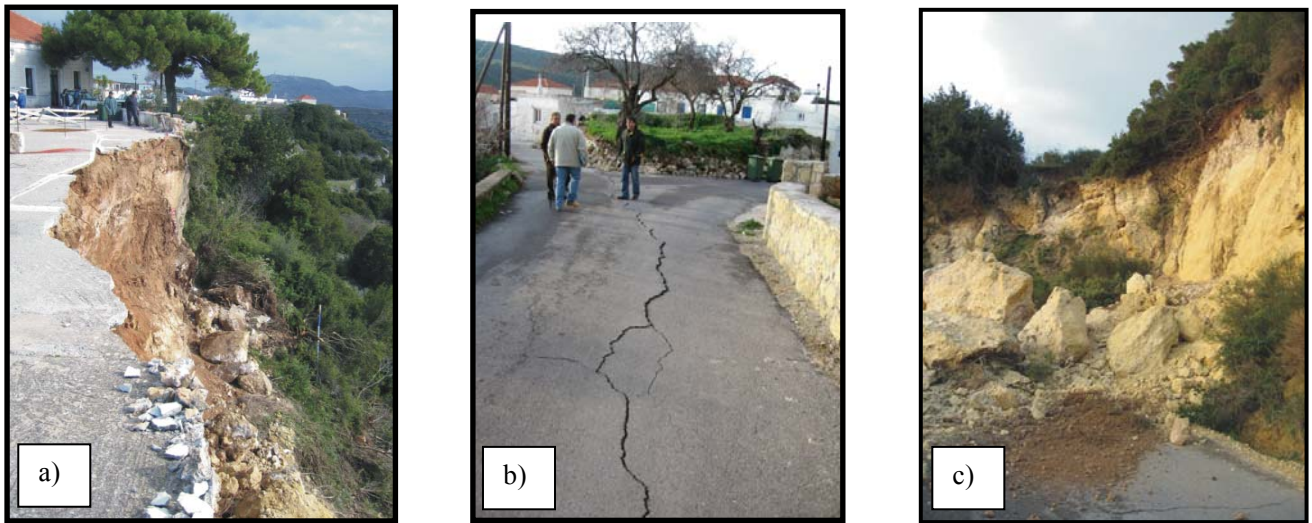
Figure 3. View of the environmental effects recorded in the Mitata village. a) View of the landslide that affected the Mitata village square, which was partly detached, involving a collapsing volume of about 5.000 m<sup>3</sup>, b) Ground ruptures on paved road. c) View of rockfalls disturbing the road network.

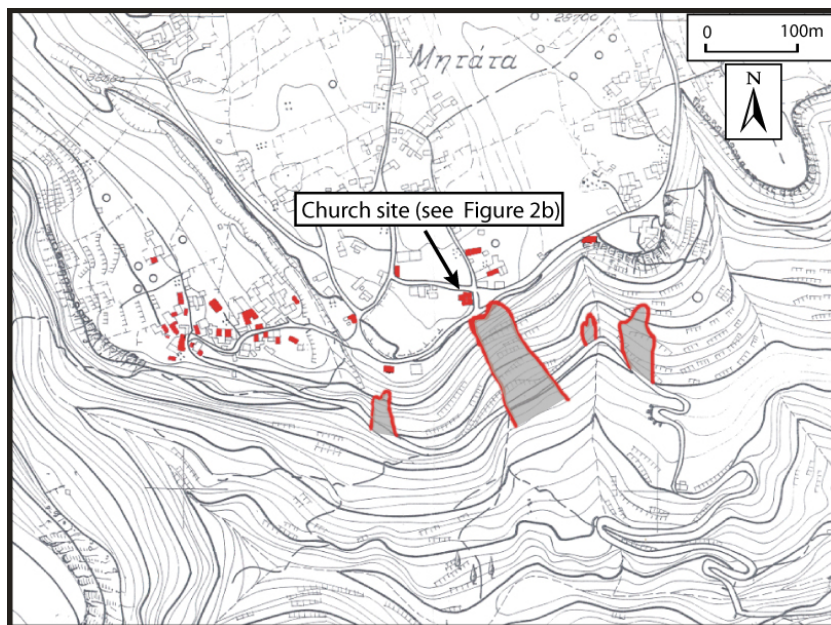
Figure 4. Landslide (grey areas) and damage (bold blocks) distribution around the Mitata village mapped at a 1:5.000 scale. Thick contours represent intervals of 20 m and thin contours intervals of 4 m.

The village of Mitata is founded on Pliocene marine sediments that rest on a large NNW-SSE trending detachment fault. This detachment fault is situated a few hundred meters below the village. It separates the non-metamorphic rocks from the underlying metamorphic rocks of the Arna Unit, belonging to the East Peloponnesus detachment system (**PAPANIKOLAOU AND ROYDEN, 2007**). Moreover, the village of Mitata is also located in the immediate hangingwall of an active NW-SE trending normal fault that bounds and downthrows a Late Miocene-Pliocene basin, representing the larger sedimentary basin of the island. Even though both geological structures (e.g. the detachment and the neotectonic fault) have not been activated, they have exerted a significant influence on the damage pattern. In addition, the village is located at the top of a hill, forming a 150 m steep slope. The topographic relief is another factor that affects the intensity distribution, producing higher intensities in areas of morphologic discontinuities.

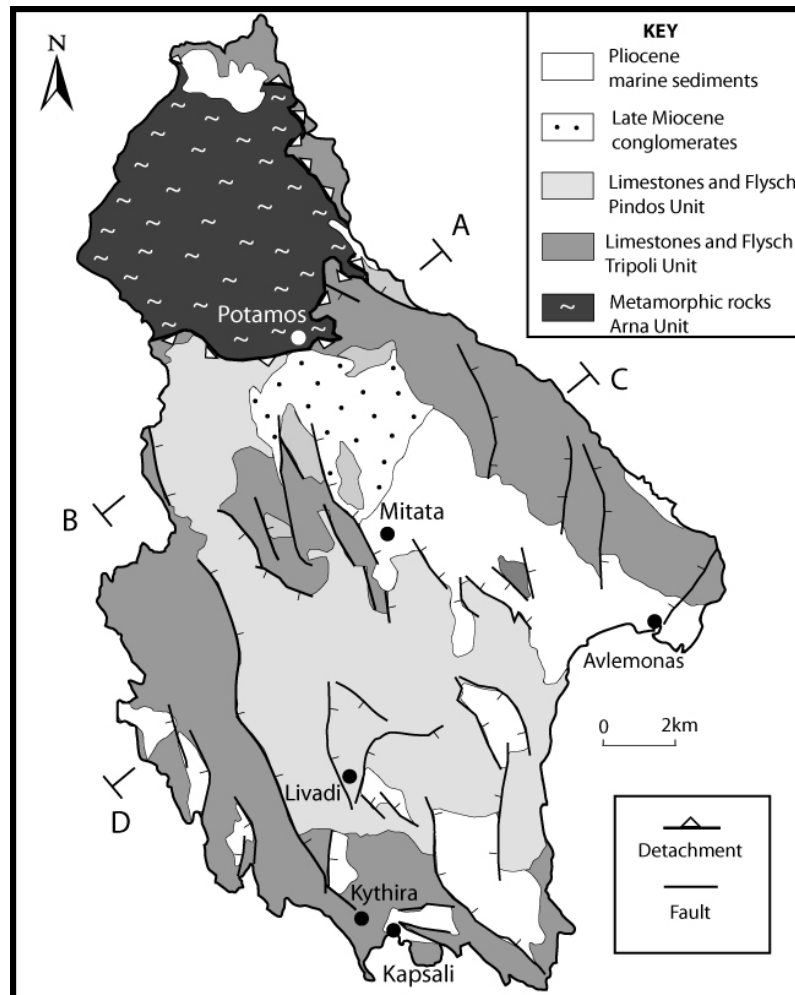
Figure 5. Geological map of the Kythira island (modified from PAPANIKOLAOU AND DANAMOS 1991). Letters A, B and C, D show the traces of the cross sections presented in Figure 6.

It is interesting to note that villages that are equidistant from the epicenter recorded intensity values that differ up to two degrees. In particular, in the Potamos village situated only 35 km from the epicentre (Figure 5) the reported MM intensity value was V+, whereas in the Mitata village situated ~40 km the intensity was VII+ (**KONSTANTINOU ET AL. 2006**). In order to examine the role and the effect of the geological structure into the damage pattern we studied the geology using the available geological maps (**PAPANIKOLAOU AND DANAMOS 1991, DANAMOS, 1992**). Moreover, two geological NE-SW trending cross-sections have been constructed, so as to demonstrate the variations in the geological structure between the Mitata and Potamos villages (Figure 6).

On the other hand, the Potamos village is founded on older and stiff metamorphic rocks, consisting of schists and some gneiss lenses, which experienced a High pressure/low temperature (HP-LT) metamorphism about 19 Million Years ago (SEIDEL ET AL. 2006, XYPOLIAS ET AL. 2006). These schists are part of the metamorphic rocks of the Arna Unit (PAPANIKOLAOU AND DANAMOS 1991) and consequently the Potamos village is located below the detachment (Figure 6). Finally, the village is distant from any major neotectonic fault and in a subhorizontal smooth relief.

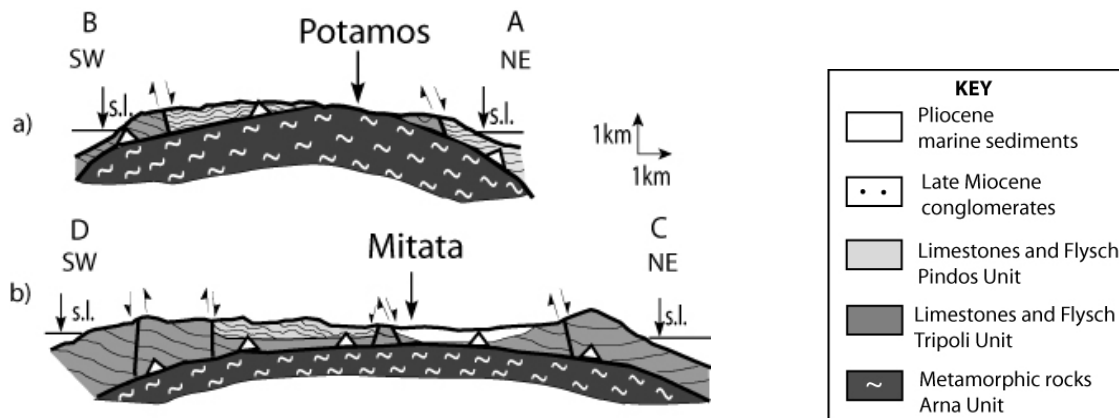
Figure 6. Cross-sections across: a) the Potamos village and b) the Mitata village, showing the variations in the geological structure (see Figure 5 for the cross section traces). The Mitata village is: a) founded on Pliocene marine sediments, b) located a few hundred meters above a major detachment fault and c) situated on the immediate hanging-wall of an active fault. On the other hand, the Potamos village is: a) founded on older and stiff metamorphic rocks b) situated below the major detachment fault and c) distant from any neotectonic fault.

Following the previous chapter, it is clear that the high intensity value recorded in the village of Mitata was likely due to: a) the relatively poor foundation conditions of the village, b) its proximity to an active neotectonic fault, c) the presence of a large detachment fault, a few hundred meters below the village and d) the location of the village at a topographic high. Most of these factors are not accurately known and usually their effect is overshadowed by the effect produced by the bedrock geology. Moreover, they are "highly interdependent" making it difficult to separate near surface from deeper effects (FIELD ET AL. 2000). However, in the Mitata village the bedrock geology does not play the fundamental role. It is true that the Potamos village is founded on a higher quality formation, in terms of its geotechnical characteristics, but the foundation material of the Mitata village comprises firm sediments of Pliocene age (2-5 Million Years ago), which are not regarded as high risk. Moreover, other villages such as the Avlemonas, which are founded on the same formation, recorded also lower
