Landslide hazard and risk in geologically active areas. The case of the caldera of the Santorini (Thera) volcano island complex (Greece)

Prof. Efthymis Lekkas

Faculty of Geology & Geoenvironment, National University of Athens, Greece

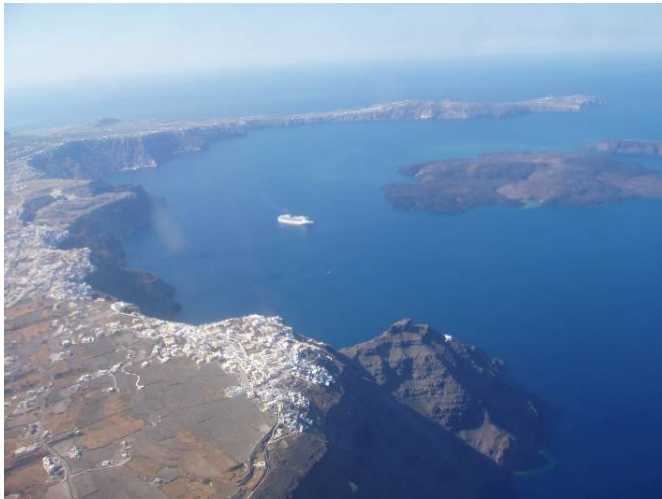
Figure 3. View of the volcanic complex of Santorini (Thera) including the Fira town on the caldera brow.

The morphology of the island complex is composed by: (i) the internal rocky and steep slopes of Thera, Therasia and Aspronisi islands (Figs 3-5) forming the aforementioned caldera ring, characterized by high morphological dip values that in locations approach vertical values, with impressive morphological discontinuities and (ii) the external sections of the islands, characterized by smooth surfaces of relatively low dipping angles and radial distribution to the volcanic centre, representing the remnant outer slopes of the volcanic cone.

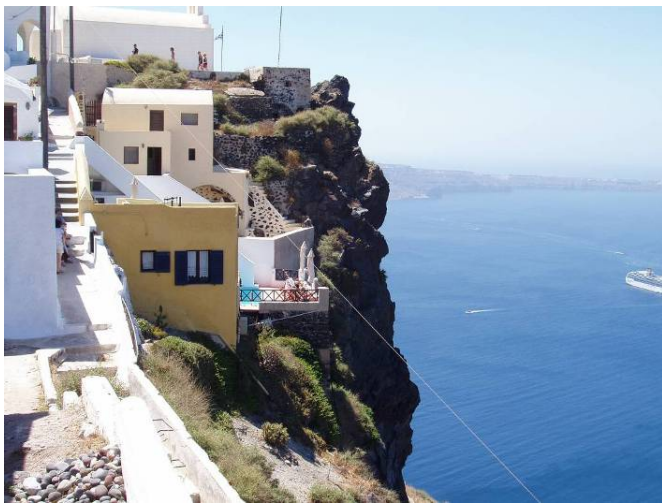
Figure 4. View of constructions founded on lava in the area of Skaros at the caldera brow in critical stability conditions.

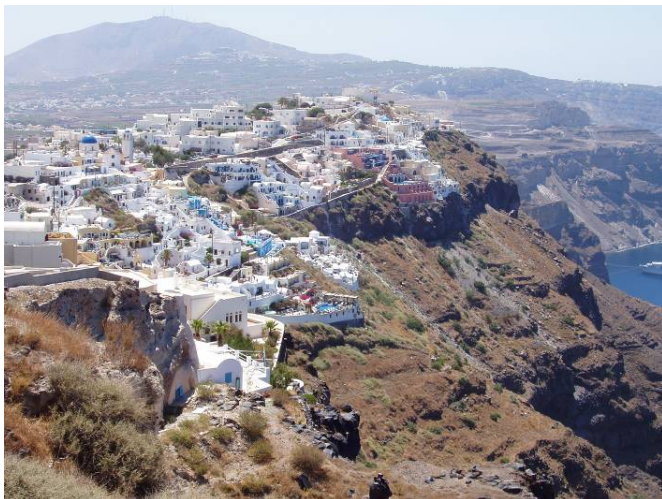
Figure 5. View of Fira town from the north. High morphological dip values and morphological discontinuities can be observed.

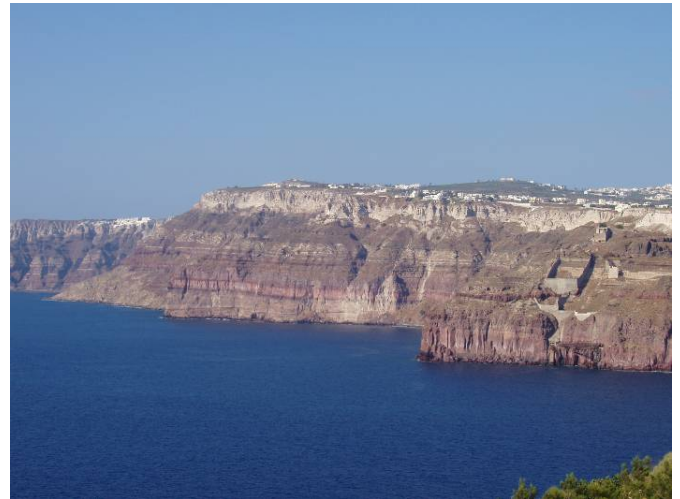
Figure 6. View of the caldera exhibiting sequential volcanic formations including the Upper Pumice formation as the top-most formation that was deposited during the Minoan eruption (~ 1644 BC.).

The volcanic formations are the products of sequential volcanic activity during the Pliocene – Holocene (Figs 2-6). This activity was distributed in various volcanic centers that erupted in various volcanic periods and covered the Alpine substratum composed of metamorphic rocks mainly marbles and phyllites (Papastamatiou 1958), that outcrop in several locations around the caldera, the largest outcrop being that of Athinios port.

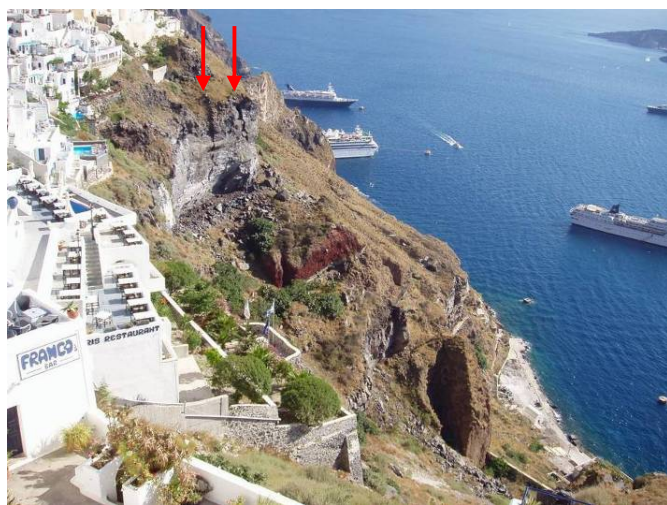
Figure 7. Views of the Pyroclastic Formations that compose the lower section of the slopes under Fira town. The discontinuities that develop in the overlying lava formations (arrows) that increase landslide hazard can be observed.

A primary factor controlling instability is the succession of the volcanic formation such as for example the presence of friable formations e.g. pyroclastics and pumice under the rocky lava formations. The weathering and erosion of these underlying formations leads to instability of the overlying lava formations resulting to increase of landslide hazard (Figs 7-8).

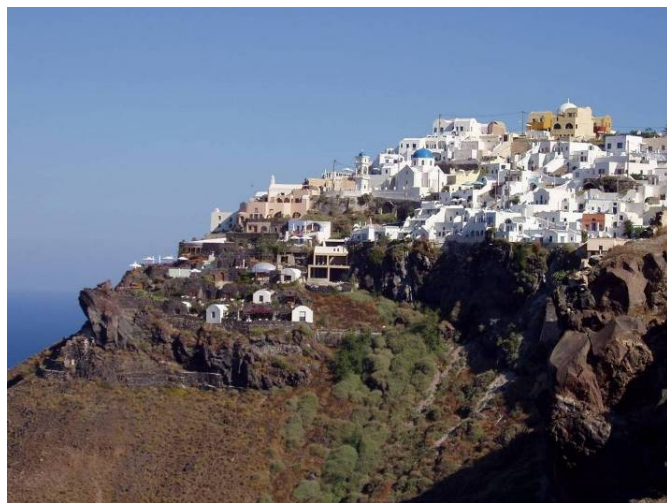
Figure 8. View of residential constructions founded on the brow of the caldera on lava formations.

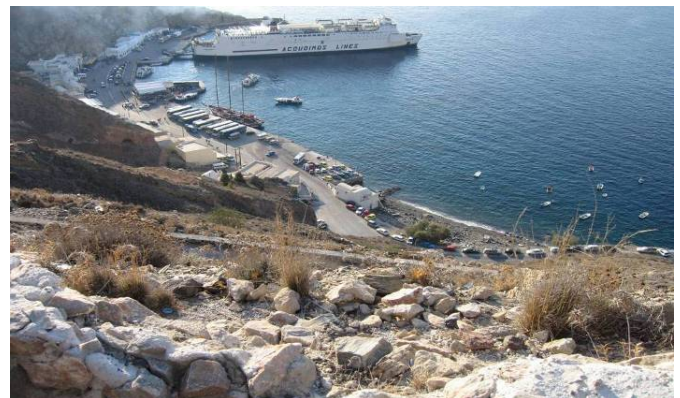
Figure 9. Unconsolidated colluvial deposits on the slopes of Athinios port.

processes or due to human activity and as a result large blocks become detached and slide. Finally, in many locations unconsolidated colluvial deposits have been recorded that form debris fans sliding down-slope (Figs 9-10).

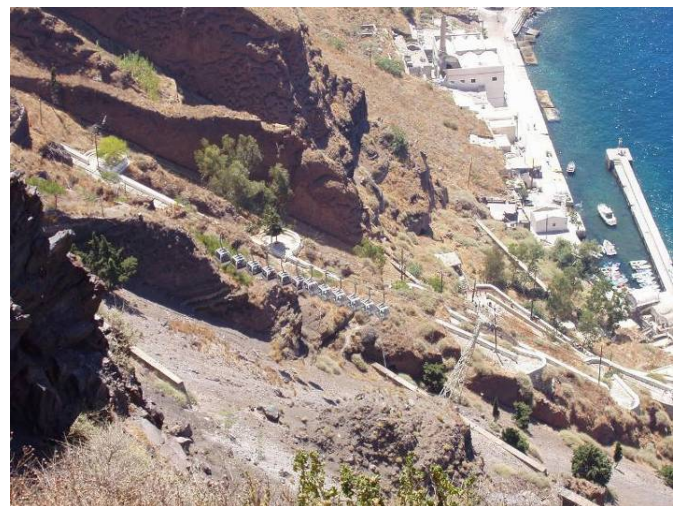
Figure 10. View of colluvial deposits that develop on the caldera slopes near the cableway and Fira Port.

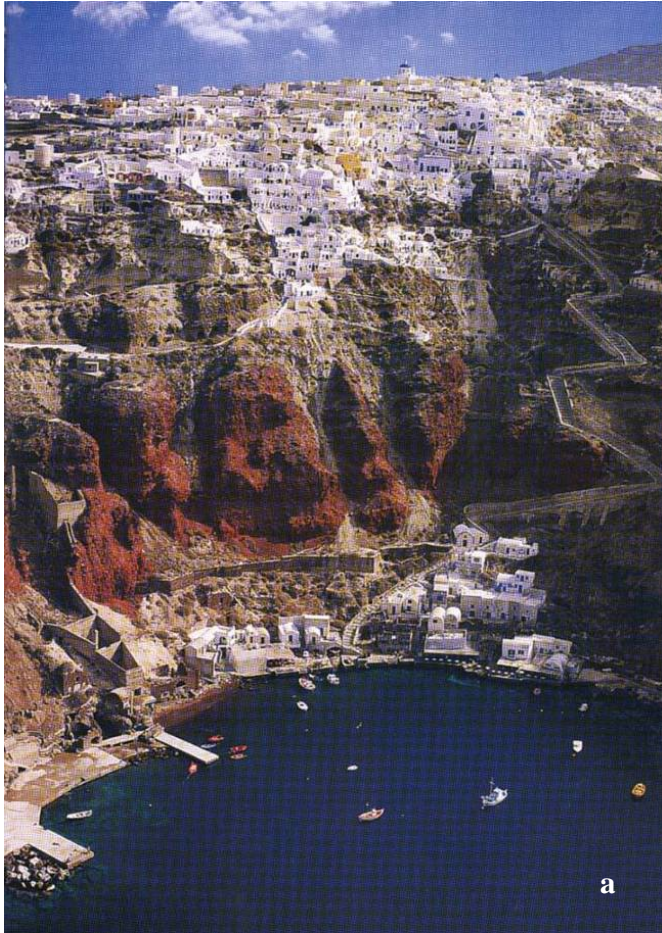
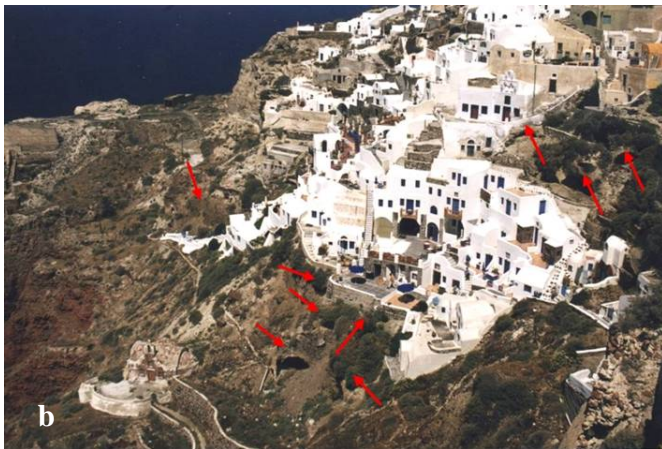
Figure 11. a. Views of Oia, town located over Ammoudi cove. b. Constructions on Upper Pumice slopes with high morphological dip values. The existing stability conditions are aggravated by the numerous caverns located under the constructions (arrows).

Due to the comparative advantages of certain areas of the caldera, significant pressure for “exploitation” of land is exceeded, that most of the time leads to considerable alterations of the caldera features such as excavations, landscaping, constructions and additional load due to aggregate disposals etc. (Fig. 11).

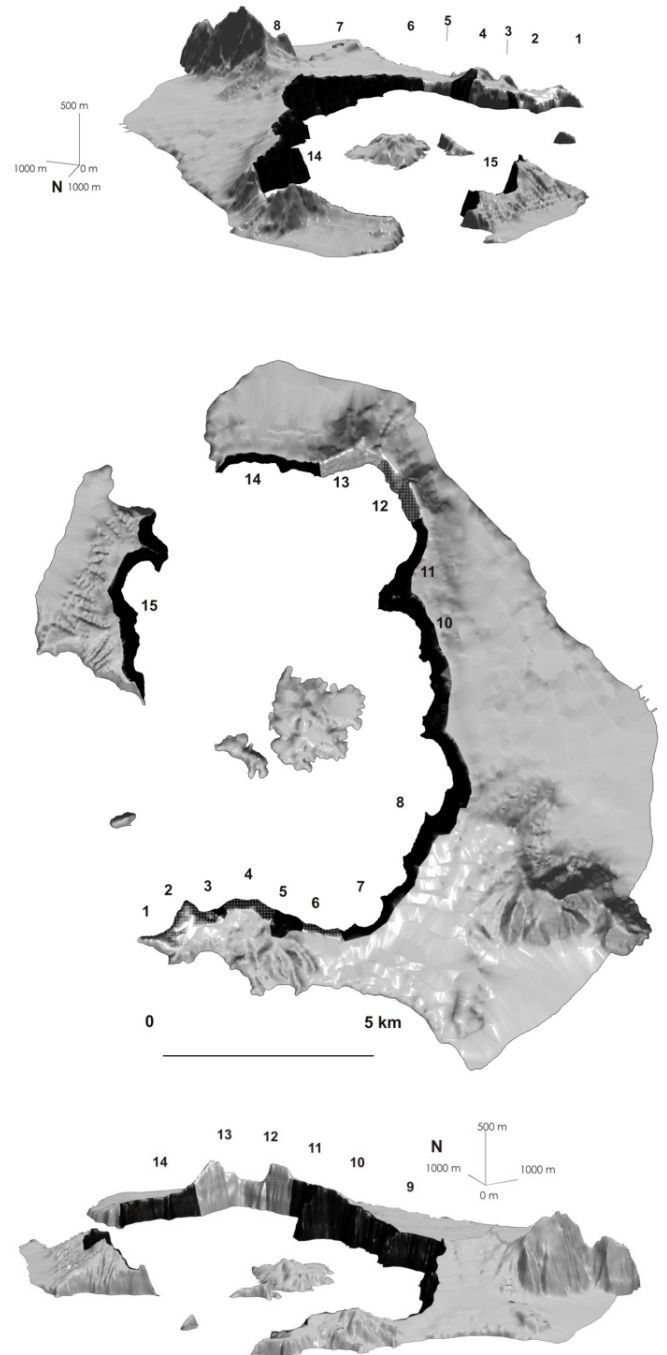
Figure 12. Sectors of Landslide Hazard on the caldera slopes of Santorini volcano.

The Landslide Hazard sectors determination is an essential step towards the confrontation of the problem since it represents a useful tool that encloses and evaluates certain key factors necessary for the hazard assessment that in its turn is calibrated in three levels, Low, Medium and High (Fig. 12).

In total, along the caldera slopes of Santorini volcano 15 sectors of Landslide Hazard were identified (Table 1).

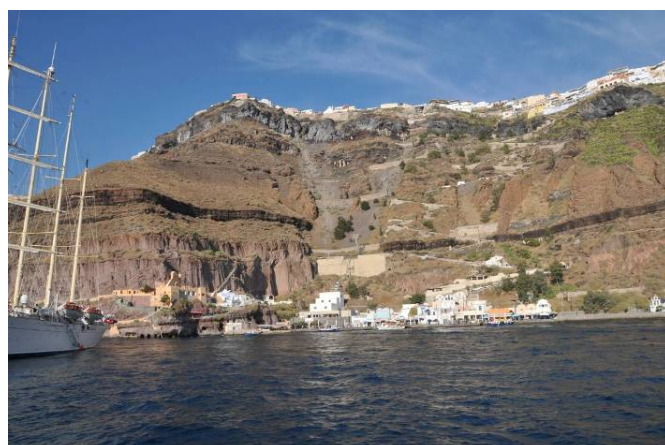
Figure 13. View of Fira town where landslide risk is considered as high due to the existing port constructions, the cable-way and the large number of visitors during the summer period.

At this point it should be mentioned that the Landslide risk is the measure of Landslide Hazard that is applied on works, constructions, humans that occupy each sector along the caldera (Table 2). In other words it is a measure of the possible or expected consequences – losses caused in the event of a landslide in each sector (Figs 13-14).

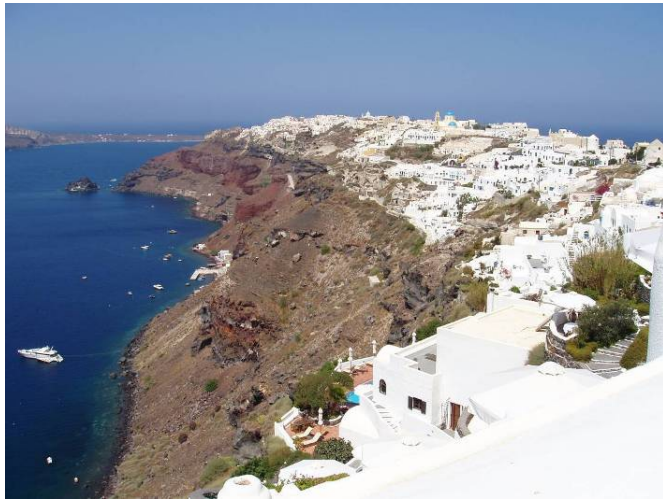
Figure 14. View of Oia town for which landslide risk is considered as high.
