# UAV and GIS based rapid earthquake-induced building damage assessment and methodology for EMS-98 isoseismal map drawing: The June 12, 2017 Mw 6.3 Lesvos (Northeastern Aegean, Greece) earthquake

On June 12, 2017, an Mw 6.3 earthquake struck Lesvos Island (Northeastern Aegean, Greece). Building damage was observed in its southeastern part with very heavy structural damage limited in the settlement of Vrissa. Taking into account that Vrissa is located further inland from the epicenter than other settlements with less damage, Vrissa looks like an earthquake impact paradox. For interpreting this paradox, a complete approach for damage assessment in an earthquake-affected area was applied during the first hours of the emergency response phase in order to provide crucial information to civil protection agencies. It comprises integration of building-by-building inspection, use of desktop and web GIS applications, UAV survey and digital post processing, extraction of data and information related to the buildings of the affected area, application of the European Macroseismic Scale 1998 and assignment of macroseismic intensities. Correlation of the all aforementioned data with the geologic

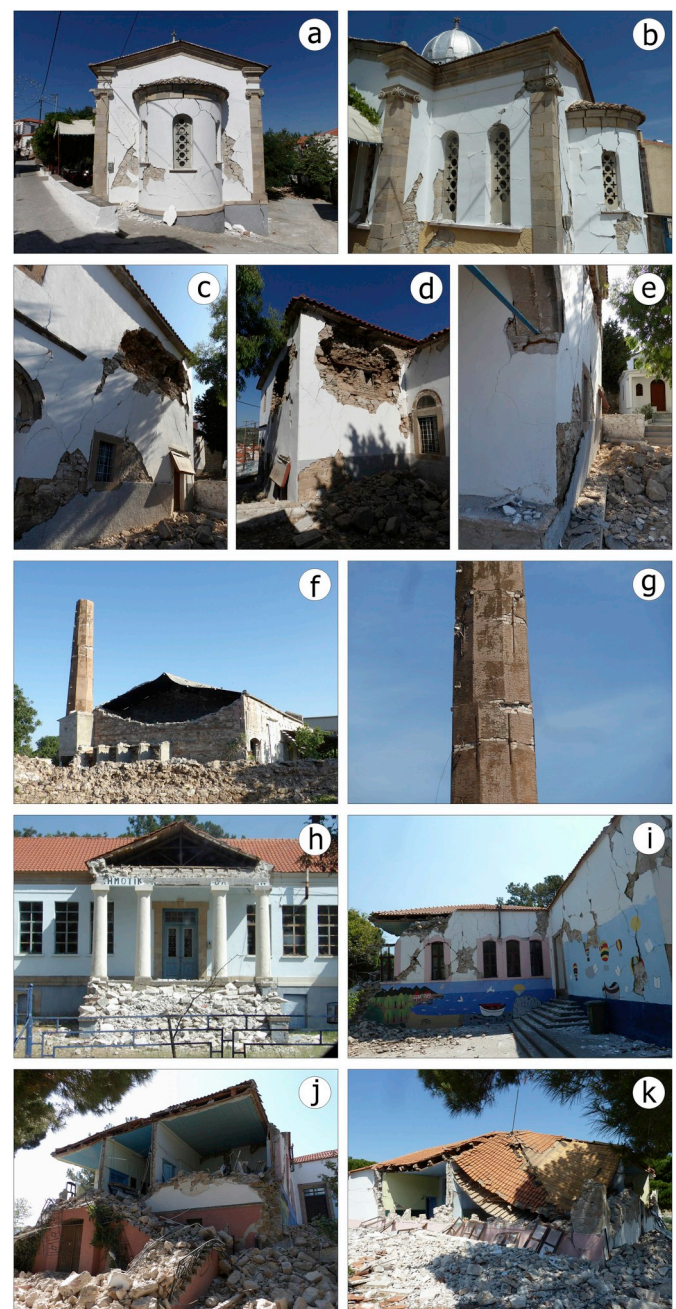
**Fig. 10.** Special structures including churches, industrial buildings and their masonry chimneys as well as schools suffered heavy damage from the 2017 Lesvos earthquake. Churches suffered damage including large cracks in various parts such as walls (a–e) and the dome, detachment of large pieces of plaster from load-bearing masonry walls (a, b, c, e), dislocation and fall of several roof tiles (e) and partial collapse of load-bearing masonry walls (c, d, e). Masonry industrial buildings in Vrissa suffered large cracks and partial collapse of their masonry walls (f) and large cracks of their masonry chimneys on the verge of collapse (g). School buildings suffered damage varying from fall of the gable over the main entrance (h) and cracks in their masonry walls (i, j) to partial collapse (k).

The special structures including temples, post-byzantine structures, museums, schools and industrial buildings with masonry load-bearing walls suffered similar damage with the masonry residential buildings. More specifically, temples suffered damage comprising cracks in most of the masonry walls (Fig. 10a and b) and in other parts such the dome, the columns, the aisles, the apse and the gable. Post-byzantine structures suffered the aforementioned damage as well as partial collapse of the walls (Fig. 10c–e).

Industrial buildings suffered partial collapse of the perimeter masonry walls and damage of the masonry chimneys on the verge of collapse (Fig. 10f and g). A typical example is the industrial building located at the northern entrance of Vrissa settlement comprising an oil-mill along with its masonry chimney (Fig. 10f and g). The main building is composed of masonry load-bearing walls built with roughly treated stones and handmade solid clay bricks, while the masonry chimney has been built with solid clay bricks (Fig. 10f and g). Unfortunately, both structures were abandoned since the late 90s, but they were typical examples and reminders of the industrial prosperity of Vrissa during the late 19th century.

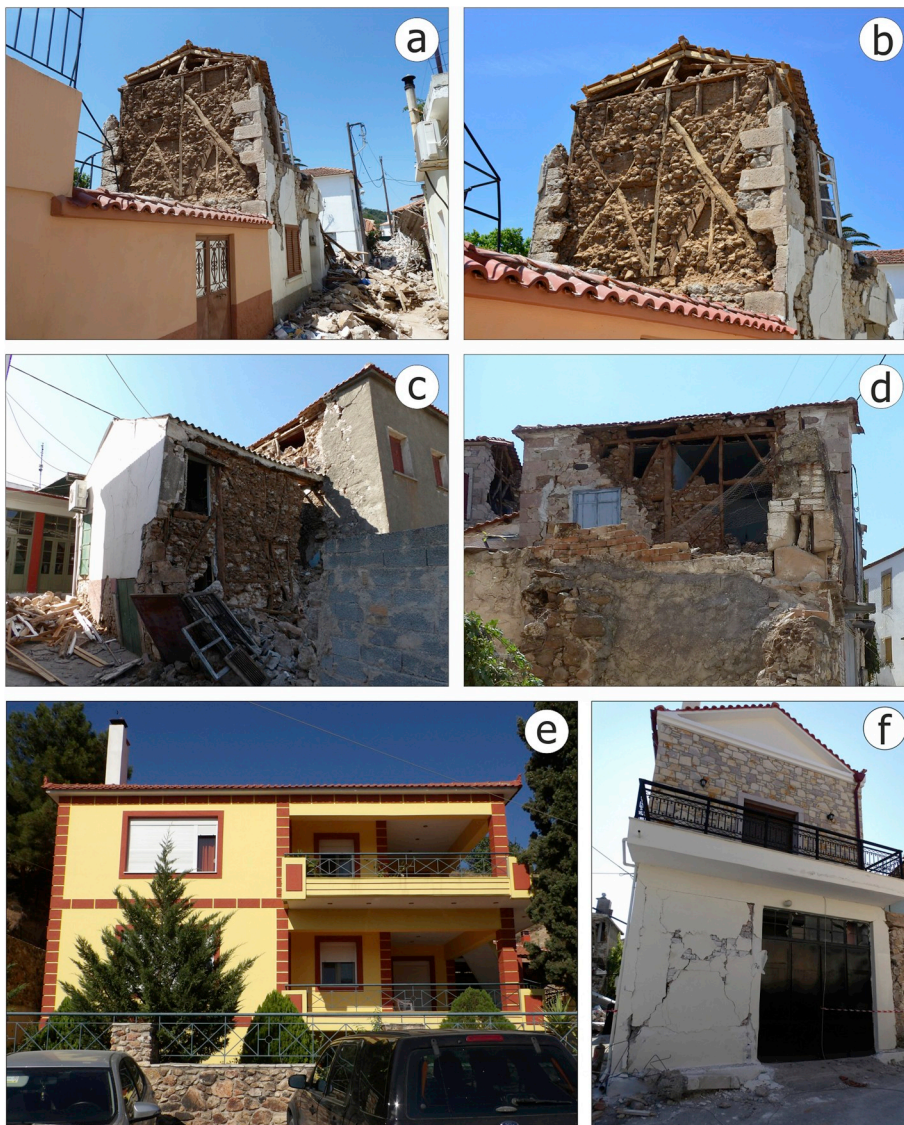
**Fig. 11.** (a–d) Traditional residential buildings with dual structural system including masonry walls and timber frames with extensive “X” bracing in Vrissa settlement (a–d). During an earthquake, these frames could guarantee the stability of the roof in case of a partial collapse of the masonry structure. This dual structural system represents one of the earliest surviving architectural responses to earthquake motion in Greece and Turkey and was also observed in Eressos and Bergama by Refs. [64,65]. (e–f) The R/C buildings showed good performance and remained almost intact (e) by the 2017 Lesvos earthquake. But there were exceptions (f) including cracks in the infill walls, detachment of large pieces of plaster from the infill walls of the ground floor as well as detachment of the infill wall from the surrounding RC frame.

As regards traditional buildings with the dual structural system, they performed better than the masonry structures with load-bearing walls. The primary structural system comprising the masonry walls of the ground floor sustained no structural damage and light non-structural damage including cracks of the masonry (Fig. 11a–d). The secondary structural system showed good performance during the earthquake sustaining successfully the vertical loads of the upper floor and resulting in still standing residential buildings after the earthquake, despite the fact that the masonry suffered damage varying from large cracks to partial collapse (Fig. 11a–d).
