**4<sup>th</sup> Joint International Symposium on  
Deformation Monitoring**

**PROCEEDINGS**

## Multitemporal Surface Deformation Analysis of Amyntaio Slide (Greece) using Remotely Piloted Airborne System and Structure-from-Motion photogrammetry

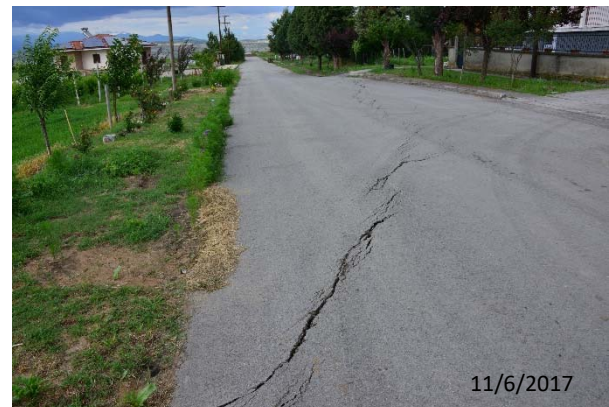
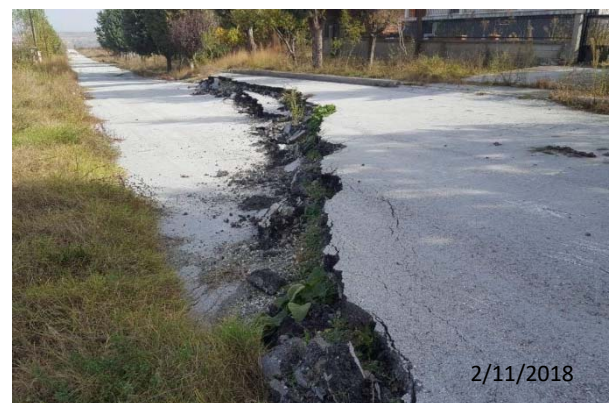
Figure 3. The main E-W trending surface fracture immediately after the landslide (top) and fifteen months later (bottom ). It is clear that the fracture is still active and the displacement exceeds 0.7 meters.

Several surface fractures have appeared around the wider area of the village either on the road network or in the cultivated parcels (Figure 3).
