MACROSEISMICITY AND GEOLOGICAL EFFECTS OF THE WENCHUAN EARTHQUAKE (Ms 8.0R - 12 MAY 2008), SICHUAN, CHINA: MACRO-DISTRIBUTION AND COMPARISON OF EMS₁₉₉₈ AND ESI₂₀₀₇ INTENSITIES

Lekkas, E.

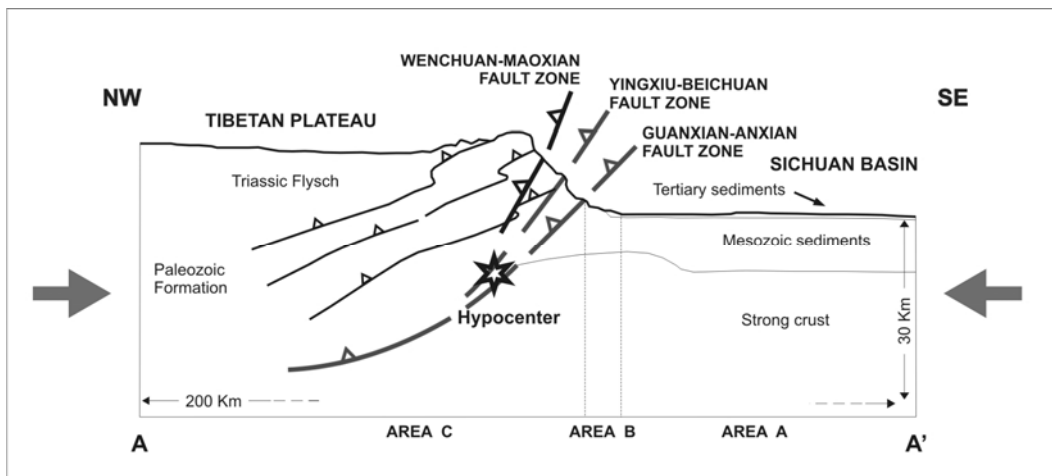
Fig. 2: Geological section trending NW-SE across the tectonic structure of the affected region with the activated faults and the epicenter location. The areas A, B and C are noted to exhibit variations of the intensities values (Burchfiel et al. 1995, Densmore et al. 2007).

It mainly corresponds to the extended lowland region of Sichuan Basin (Figs 1, 2) with altitudes that do not exceed 1000 m.

Essentially, this area, 10-20 km wide and 250 km long (Figs 1, 2), corresponds to the elongated region of NE-SW direction that includes the foothills of the Tibetan Plateau and more specifically it is bounded by the flat lowland region towards the southeast of Sichuan Basin and by the trace of the coseismic fault rupture to the northwest.

This region characterized by widespread damage represents the mountainous section of the Tibetan Plateau that includes towards the southeast the outcrop of the seismic fault extending northwest for at least 100 km (Figs 1, 2).

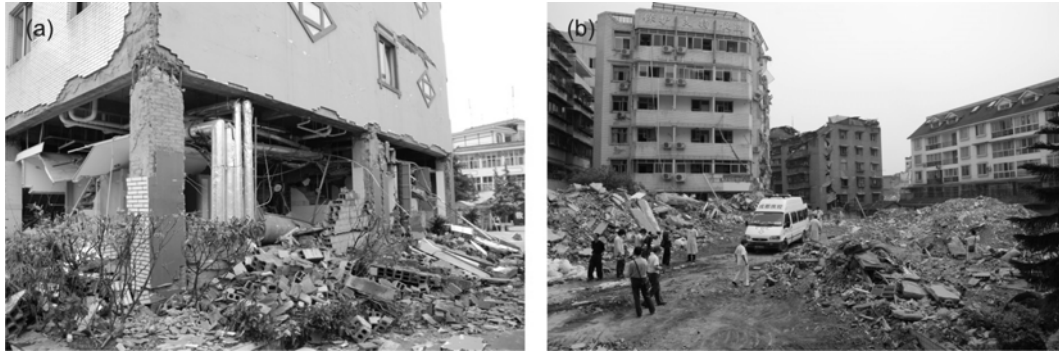
Fig. 3: View of a recently constructed building at the suburbs of Dujiangyan (Guanxian) with serious structural damages on the ground floor props. (type of construction D, damage degree 4) (a) and view of a hospital unit in the same town that totally collapsed (type of construction D, damage degree 5) (b).

lowlands. Especially interesting are the new buildings under construction that follow modern anti-seismic design regulation at the higher elevations of the town that collapsed or underwent serious structural damages. In these areas, it seems that the nature of the founding ground which is composed of remnants of river deposits and debris of limited thickness on the rocky background played a determinant role. It is estimated that 30% of the building collapses observed in this town were located on similar deposits (Fig. 3). Finally it should be mentioned that schools, hospitals and tenths of factories and industrial constructions collapsed in the greater urban area while all sort of infrastructure suffered serious damage. The estimated general intensity value in the area is on the order of VIII_{EMS-1998}, while locally it approached IX_{EMS-1998}.

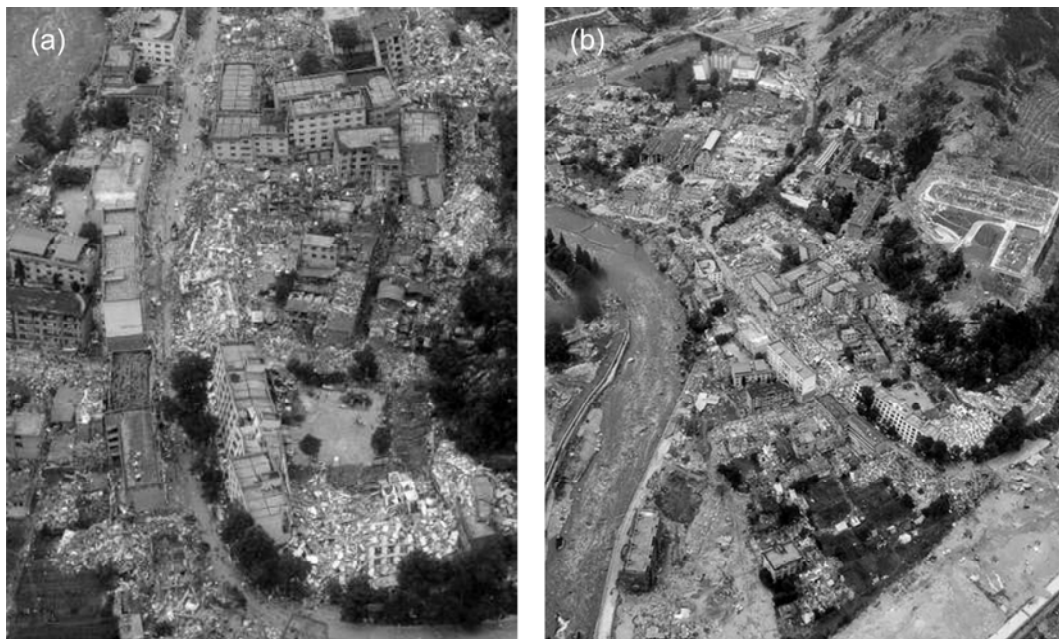
Fig. 4: Oblique aerial view of residential constructions in the Wenchuan and Beinchuan towns that suffered total destruction. These towns were founded on river terraces in the mountainous region. Large scale landslides on the surrounding slopes contributed to the destruction of the residential constructions (Xinhua News Agency China 2008, Reuters 2008).

In all settlements, the constructions collapsed or suffered considerable structural damage to an extent that exceeded 50% (Fig. 4). It is indicative that only a small percentage of the constructions, that did not exceed 20%, was left intact. In addition, infrastructures such as bridges, tunnels and dams either collapsed or suffered considerable damage. Finally, in the greater region, landslides and rock falls were recorded due to the high energy relief and the unconsolidated lithologies, that caused additional damage in settlements and infrastructure. The general estimated intensity for this region is $X_{EMS-1998}$ and locally approaches $XI_{EMS-1998}$.

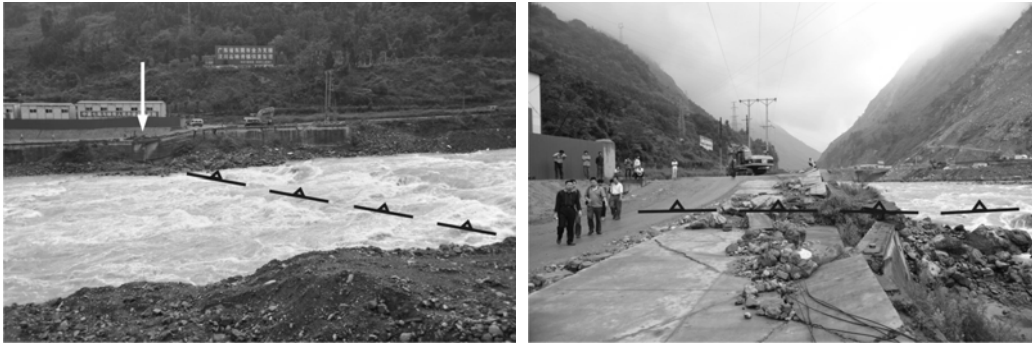
Fig 5: Views of the Yingxiu-Beinchuan seismic fault at the outskirts of Yingxiu town.

C1. As reported above, this earthquake generated a 220 km surface rupture along the Yingxiu-Beinchuan fault and a 72 km surface rupture along the Guanxian-Anxian fault (Figs 1, 5). Maximum vertical and horizontal displacements of 6.2 m and 4.9 m, respectively, were observed along the Yingxiu-Beinchuan fault, whereas a maximum vertical displacement of 3.5 m occurred along the Guanxian-Anxian fault (Hao et al., 2008).

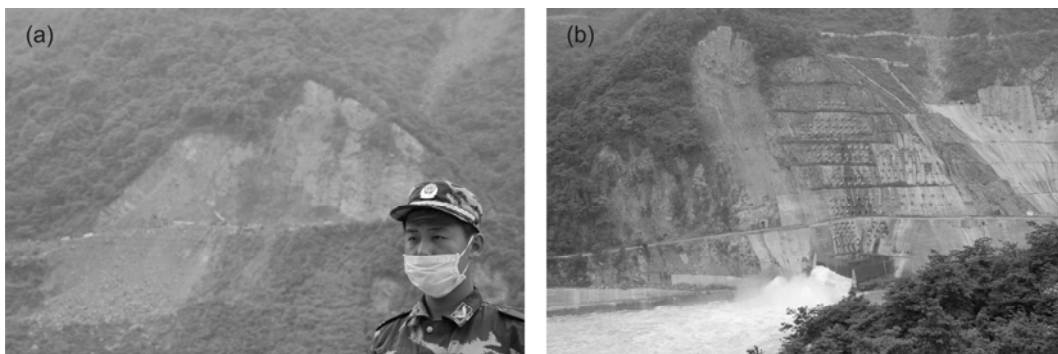
Fig. 6: View of large-scale landslides that were triggered in the mountainous region along river Min (a) and view of the Zipingpu Dam (b).

C5. Large landslides and rock-falls ($>10^5\text{-}10^6 \text{ m}^3$) were frequently recorded, practically regardless of equilibrium state of slopes (Figs 6, 7), causing many temporary or permanent barrier lakes. River banks, artificial embankments, and sides of excavations collapsed. Levees and earth dams incurred serious damages (Lekkas 2008b, Zhao et al. 2008, Xu et al. 2009).

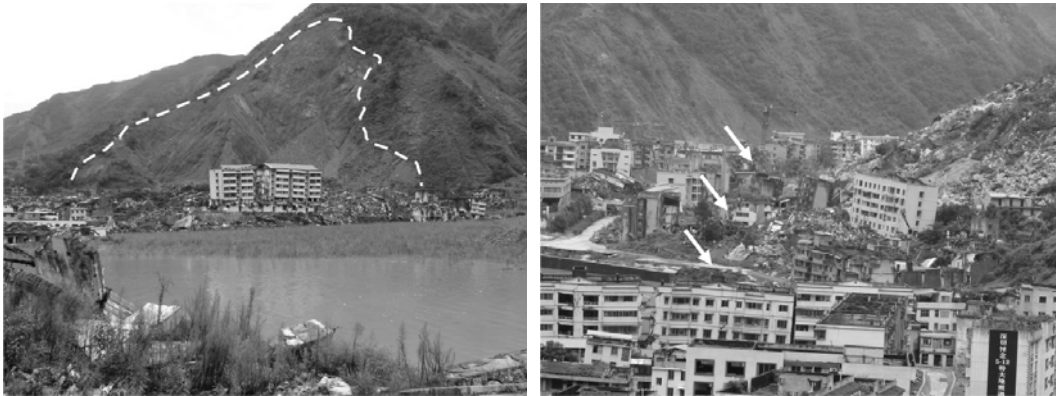
Fig. 7: Views of Beinchuan town which was almost totally destroyed ($ESI_{2007} = XI, XII$) due to the combined action of the seismic fault Yingxiu-Beinchuan (arrows) and the huge landslides.

The estimated intensity values for Area C range from X to $\text{XII}_{\text{ESI-2007}}$ (Fig. 7).

Intensity values could be estimated for a broad area around the epicentre based on EMS_{1998} and ESI_{2007} (Figs 7, 8).

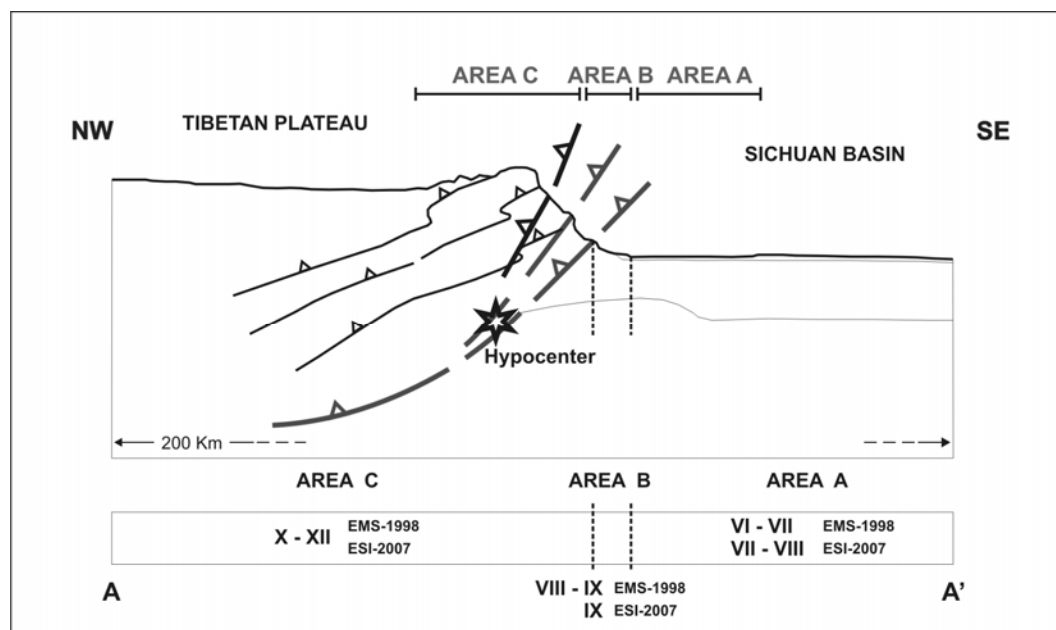
Fig. 8: Schematic cross-section NW-SE trending with the location of areas A, B and C and the estimated values according to EMS₁₉₉₈ and ESI₂₀₀₇ intensity scales.

Summarizing, by the application of both EMS₁₉₉₈ and ESI₂₀₀₇ and the comparison of the results based on the geodynamic, seismotectonic, geomorphological and geotechnical frame of the region affected by the 12th of May, 2008 earthquake, the following conclusions can be drawn (Fig. 8):

No significant variations on the values of both intensity scales were recorded during their application for the areas A, B and C, that correspond to three clearly distinct areas: (i) the flat lowland area of Sichuan Basin, located southeast of the trace of the seismic fault, (ii) the elongated area of a general northeast – southwest direction with special morphological characteristics, located to the southeast of the seismic fault trace and (iii) the region that includes the occurrence of extensive surface faulting to the west and corresponds to the Tibetan Plateau.

The value variations in both scales that were estimated between the footwall (area A) and the hanging wall (area C) are of the order of 2 to 4 degrees. At the elongated zone (area B) to the southeast of the activated fault zone intermediate values were estimated.
