THE JANUARY-FEBRUARY 2014 CEPHALONIA (IONIAN SEA, WESTERN GREECE) EARTHQUAKE SEQUENCE: DAMAGE PATTERN ON BUILDINGS

Abstract

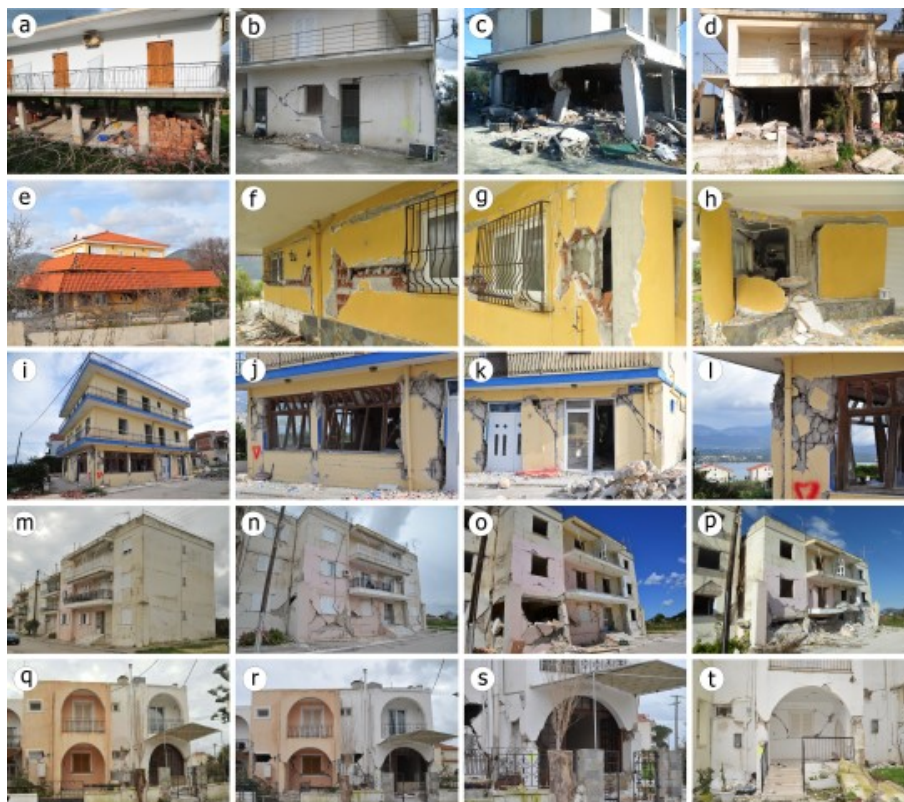
However, several exceptions were observed along the road extending from the Lixouri town to the villages of Agios Dimitrios and Livadi located north of Lixouri and along the southeastern coastal part of Paliki peninsula (Fig. 6). Several RC buildings designed under older anti-seismic codes and RC buildings with a soft storey at the ground level and stiffness considerably lower than the upper floors suffered severe structural damage to RC elements comprising concrete disorganization, flexural cracks and buckling of the longitudinal and transversal rods of the columns on the verge of collapse. Indicatively for this region, a two-storey RC building in the Agios Dimitrios village without infill walls in the first floor suffered soft-storey failure on the verge of collapse including buckling of steel bars and disorganization of concrete, while the second storey remained intact (Fig. 6a). Another two-storey RC building in the Agios Dimitrios village suffered diagonal cracks and detachment of infill walls of the first floor from the surrounding RC frame by the first earthquake (Fig. 6b) and failure of columns and joints by the second earthquake (Fig. 6c,6d). A three-storey building sustained severe structural and non-structural damage due to poor and inadequate construction. The structural damage include total collapse of the second floor due to absence of a column (Fig. 6e) and the non-structural damage comprised detachment of the infill walls from the surrounding RC frame due to vertically perforated bricks in the infill walls of the first floor (Fig. 6f, 6g, 6h). A three-storey building in Lixouri probably built before 1984 without infill walls in the first floor sustained soft-storey failure, while the two upper floors remained also intact (Fig. 6i-6l). Buildings in the Lixouri public housing complex sustained non-structural and structural damage including detachment of large pieces of plasters from the infill walls, extensive cracks of infill walls and failure of columns (Fig. 6m-6t). In conclusion, the abovementioned damage to RC buildings was induced due to open ground storey, asymmetric building construction, and heavy loads on the upper floors, short columns and inappropriate foundation on poor soils.

Fig. 6 – Damage to RC buildings. (a) A two-storey RC building in the Agios Dimitrios village suffered soft-storey failure on the verge of collapse, while the second storey remained intact. (b – d) A two-storey RC building in the Agios Dimitrios village suffered diagonal cracks and detachment of infill walls of the first floor from the surrounding RC frame by the first earthquake (b) and failure of columns and joints by the second earthquake (c, d). (e – h) A three-storey building sustained total collapse of the second floor due to absence of columns (e) and detachment of the infill walls from the surrounding RC frame due to vertically perforated bricks in the infill walls of the first floor (f, g, h). (i – l) A three-storey building in Lixouri probably built before 1984 sustained soft-storey failure, while the two upper floors remained also intact. (m – p) A three-storey building in the Lixouri public housing complex. The first earthquake caused moderate damage (m), while the second earthquake aggravated damage (n). (o, p) The same building on the verge of collapse in July 2015 and in November 2015

immediately after the Mw 6.4 Lefkas (Ionian Sea, Western Greece) earthquake. (q – p) Another two-storey building in the Lixouri public housing complex suffered moderate damage due to the first earthquake (q) and severed damage due to the second earthquake (r, s, t).

The majority of RC buildings in the affected area showed satisfactory seismic response and structural performance during both earthquakes since none of them collapsed and no resident was killed or seriously injured. This was due to the good quality of construction materials and concrete with comprehensive strength higher than the expected, seismic detailing and presence of earthquake resistant features such as the reinforced infill walls at the ground level. This fact takes on even greater significance when considering that (a) the peak ground acceleration values recorded during both earthquakes are among the largest measured so far in Greece [10, 11] and (b) all buildings in Cephalonia must be designed and constructed on the basis of a PGA equal to 0.36 g, which corresponds to the greatest seismic strength demand according to the Greek code for Seismic Resistant Structures [27].

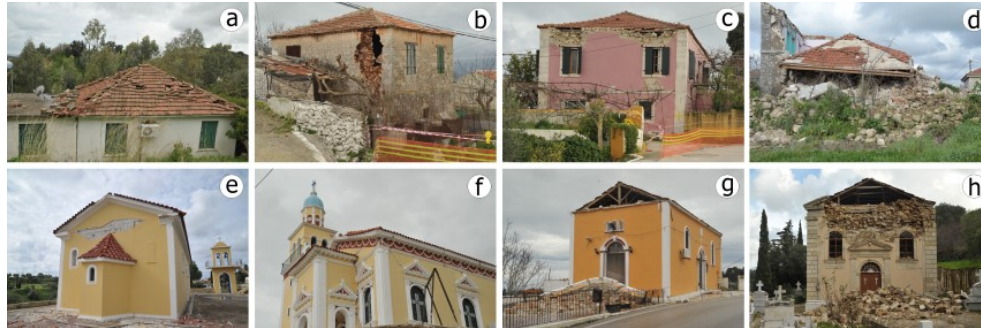
Masonry buildings suffered dislocation of several roof tiles (Fig. 7a), diagonal cracks in the masonry load-bearing walls, damage at the corners of longitudinal and transversal masonry walls (Fig. 7b) and detachment of large pieces of plaster from the masonry walls and of the roof from the rest of the building. Heavy damage included partial collapse of walls (Fig. 7c, 7d). After the second earthquake, many of these structures suffered destruction comprising total or near total collapse.

The RC churches suffered non-structural damage comprising light cracks in the brick infill walls, detachment of large pieces of plaster applied on the interior walls and damage occurred on bell towers (Fig. 7e-7h). The masonry churches suffered dislocation of several roof tiles and detachment of large pieces of plaster (Fig. 7e), light diagonal and vertical cracks in the masonry load-bearing walls (Fig. 7f) as well as fall of the church riser and gables at the edge of double-pitched roofs (Fig. 7g, 7h). Heavy damage included heavy diagonal and vertical cracks in the masonry load-carrying walls resulting in masonry disorganization and partial or total collapse of the structure. Damage in cemeteries includes partial or total collapse of retaining and perimeter walls and destruction of grave monuments. The ancient monuments of the affected area suffered no damage by the early 2014 Cephalonia earthquakes. On the contrary, the post-Byzantine monuments of the island including castles and churches suffered damage induced mainly by the first earthquake.

Fig. 7 – Damage to masonry buildings included (a) detachment of roof tiles, (b) partial collapse of the load bearing wall, (c) destruction of the upper corners of the buildings and (d) near total collapse of the building. Masonry churches suffered damage including (e) detachment of roof tiles and pieces of plaster, (f) cracks in masonry load bearing walls and in the upper corners of the structure and (g, h) fall of gables at the edge of double-pitched roofs.
