The Emilia Romagna, May 2012 earthquake sequence. The influence of the vertical earthquake component and related geoscientific and engineering aspects

Panayotis Carydis*, Carlo Castiglioni**, Efthymis Lekkas***, Irene Kostaki****, Nikolaos Lebesis*****, Alberto Drei******

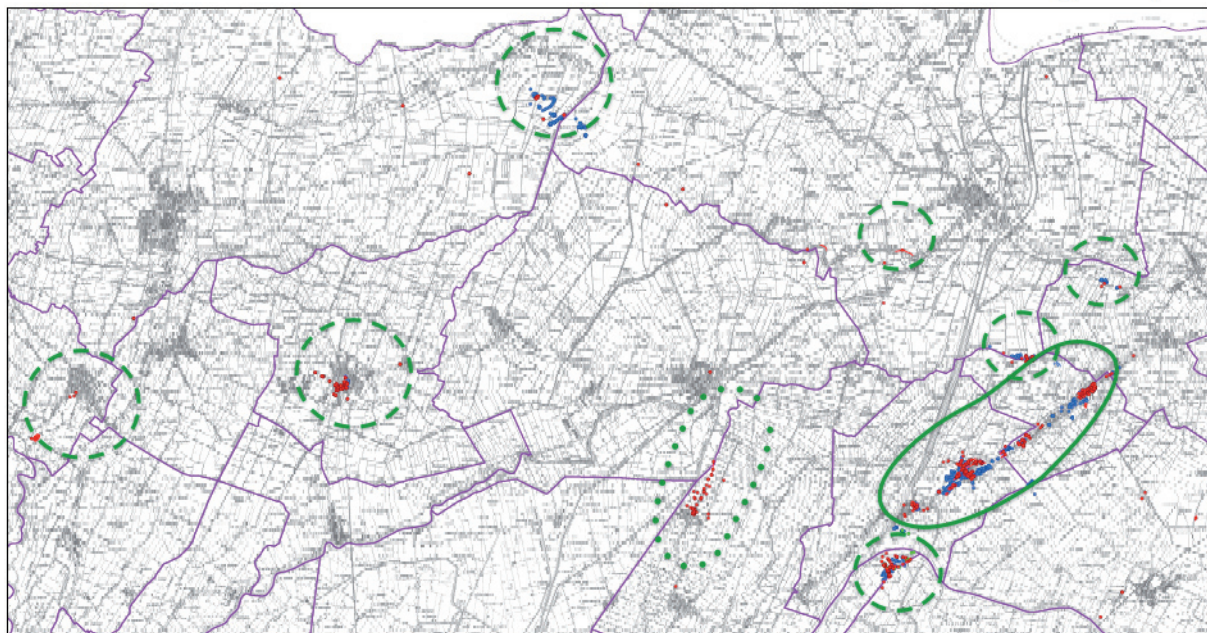
Fig. 10. *Main location of secondary environmental effects from May – June 2012 seismic sequence, as surveyed by /21/. Dashed lines locate isolated individual liquefaction locations of category (i), dotted line locates strictly oriented liquefactions of category (ii) and continuous line locates liquefactions of category (iii) corresponding to the WSW-ENE zone that was surveyed (combined observations map) by /24/.*
Distribuzione di effetti ambientali secondari causati dagli eventi del Maggio-Giugno 2012, come da rilevamenti riportati in /21/. Le linee tratteggiate indicano zone isolate di liquefazione del suolo di classe (i), quelle punteggiate individuano liquefazioni di classe (ii) con un preciso orientamento, mentre la linea continua (iii) indica la zona OSO-ENE sottoposta a indagine (mappa cumulativa di rilevamenti) da /24/.

Spatial distribution of the secondary phenomena of liquefaction and lateral spreading, can be categorized by means of density and trend, as it is evident in the liquefaction location map (Fig. 10).

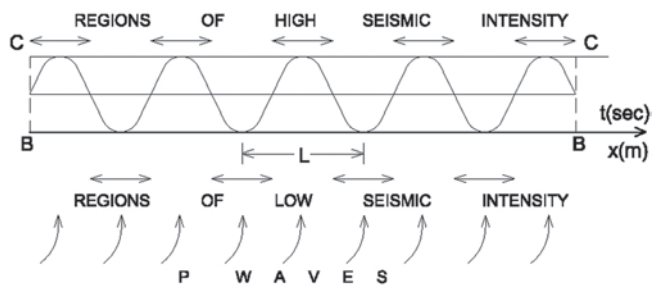
There are regions within the epicentral area that might be quite close one to the other, among which a considerable difference of the seismic intensity might be observed. As it is shown in Fig. 17, the final motion along the vertical direction is a superposition of the P waves and of the vertical projection of the particle motion of the surface or Rayleigh (R) waves. Therefore according to the wave length of the surface waves we might have regions of low and regions of high seismic intensity.

As it is shown in Fig. 17 the distance among those two regions is half wave length of surface waves which, according to the quality of the ground, might be from 50 to 150 m. This alternative variation of ground intensity is rhythmic and may cause a great variation in the earthquake response of structures, /9/ and /27/. According to that evidence, we might have regions in which we observe either not any motion and not any earthquake effect, or extreme damage and even collapse of structures. This peculiarity is repeated in a rhythmic way.

Fig. 17. *Ground motion in the epicentral regions (where the vertical earthquake motion dominates): in B-B is the surface of the ground at its initial position; in C-C is the extreme position of the ground due to P waves and the vertical projection of R wave particle motion; B- C compressional field is the vertical projection of the final motion of the ground particles; L is the wave length of surface waves.*
Moto del terreno nelle zone epicentrali (dove la componente verticale è dominante): in B-B la superficie del terreno è nella situazione iniziale; in C-C il terreno è nella sua posizione estrema a causa delle onde P e della componente verticale del moto del terreno dovuto alle onde R; lo stato di compressione B-C è la componente verticale del moto risultante delle particelle di terreno; L è la lunghezza d'onda delle onde di superficie.

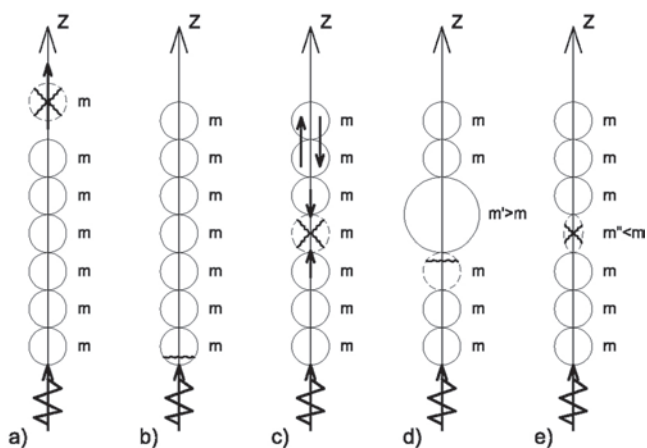
Fig. 20. *Impact phenomenon along the height of a structure; a) a fully elastic impact with regularity and continuity along the height. The top particles are ejected. The lesser is the top mass, the stronger is its ejecting; b) in a plastic impact at the base, the seismic energy is absorbed at that point and the rest of the structure remains intact; c) due to interference of incident and reflected waves, damage may occur at any point along the height of the structure. Nevertheless, there are frequent cases in which this point coincides with the middle point of it; d) and e) if a discontinuity of mass or stiffness intervenes along the direction of the wave propagation, high concentration of stresses may be created resulting in damage.*

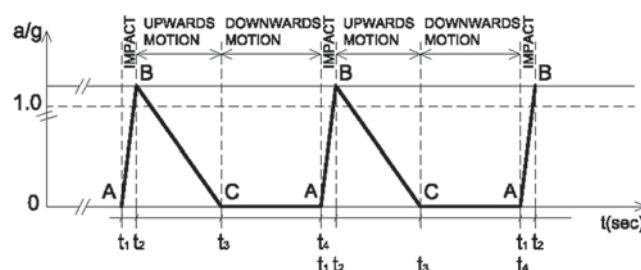
Fig. 21. *Accelerations created on the center of mass of a structure elastically jumping on the ground due to the vertical earthquake component: A-B, $\Delta t1 = t2-t1$ impact phase; B, t2 detachment from the ground; B-C, $\Delta t2 = t3-t2$ upwards motion, up to the highest position at C; C-A, $\Delta t3 = \Delta t2 = t4-t3$, zero acceleration during its downwards motion (the structure is in a space without gravity!).*

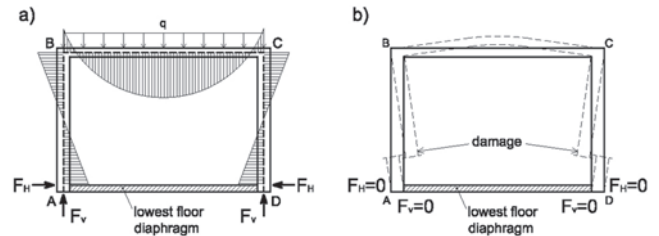
Fig. 23. *During the downwards motion phase, the structure, designed to carry mainly gravitational loads, is suddenly in a space condition without gravity; a) the case with gravity; b) the existing frame is without gravity.* Durante la fase di moto verso il basso, la struttura, progettata per sostenere principalmente carichi verticali di tipo gravitazionale, si trova improvvisamente in una condizione in assenza di gravità; a) situazione con gravità b) struttura in assenza di gravità.

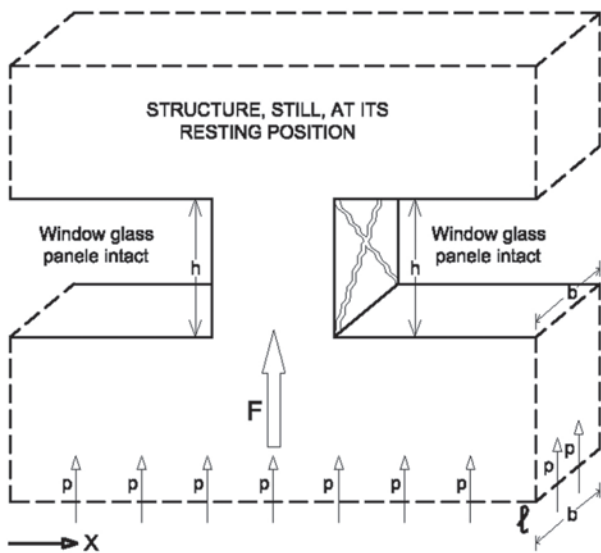
As a practical example of the structural behaviour described in Fig. 20, case e), hereafter the behaviour of a "short column" (shown in Fig. 28) under vertical acceleration component is presented and discussed.

Fig. 28. *A part of a wall with a "short column". The pressure p (kPa) due to vertically propagated body waves, integrated along the length (l) produces a force F of an impact character. The residual shortening of height (h) is relatively extremely small.*
Una porzione di muro con una "colonna tozza". La pressione p (kPa) dovuta alla propagazione verticale delle onde di volume, per tutta la lunghezza (l), produce una forza F a carattere impulsivo. L'accorciamento residuo sull'altezza (h) è relativamente molto piccolo.

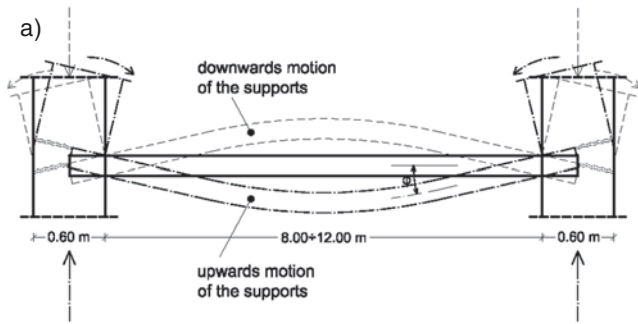
This fact explains the causes of horizontal cracks observed in many buildings (e.g. in L'Aquila after the 2009 earthquake as shown in Figs 30b and c), at the lower floor levels, eventually at the interface between r/c beams and masonry infills. A probable explanation is based on: a) the dynamic difference between a r/c beam (and as we can see of a considerable length) and a brick wall and b) the impact phenomenon on this type of structures, seems to be stronger at their lower floors. At the building of Fig. 30c, the damaged façade

Fig. 30. *a) Additional vibrational effects on floors and roofs from the vertical earthquake component. Usually in most cases, the walls above the floor or roof level are toppling inside the building. This means that the fall is due to upwards motion of the supports (perimetric walls); b) and c) Damages observed in Pettino (L'Aquila) after the 2009 Earthquake*

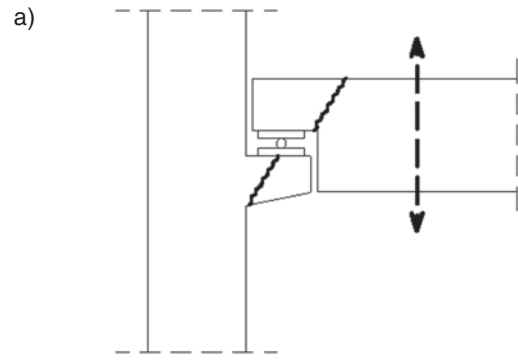
The lack of those provisions in the supports might be the basic reason for the numerous damages and collapses of industrial buildings' roofs made with prefabricated beams as it is shown in Figs. 32a to f. On the other hand, if any kind of beam to column joint was provided the response of the vertical element would be ameliorated. After that, we may conclude that structures, as the prefabricated ones, that are going to be applied in great numbers, must be designed for a higher degree of importance, than the one presently considered in Seismic Design Codes.

Fig. 31. *a) Due to the vertical seismic component, the beam is jumping up an down on its supports if it is not sufficiently anchored; b) the corber or the beam, or both are broken. In this case a vertical bolt is provided but it was too short and the beam jumped over; c) if there is a horizontal motion too, the results are worsened.*
a) A causa della componente verticale del sisma, la trave "salta" su e giù sugli appoggi se non è adeguatamente ancorata; b) la mensola d'appoggio o la trave, o entrambi, risultano danneggiate. In questo caso, era stato previsto uno spinotto verticale metallico di collegamento troppo corto, e la trave si è sfilata; c) i risultati sono ancor più gravi [catastrofici] nel caso si sovrapponga una componente di moto orizzontale

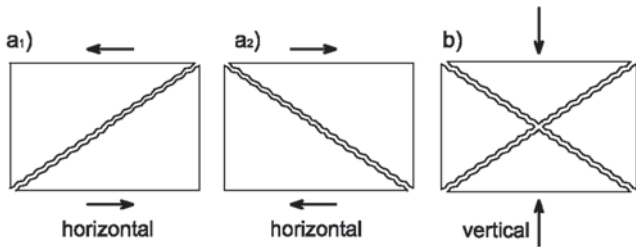
Fig. 34. *It is difficult to distinguish the damage pattern between the effects of: a1) + a2) horizontal and b) strong vertical earthquake components, after /4/.*
È difficile distinguere il meccanismo di danno causato: a1) + a2) dalla componente orizzontale del terremoto, b) dalla forte componente verticale; tratto da /4/.

motions /4/. On the other hand, it is quite difficult to distinguish the effects of alternative sign horizontal and strong vertical earthquake actions, as it is schematically shown in Figs. 34 a$_1$, a$_2$ and b.

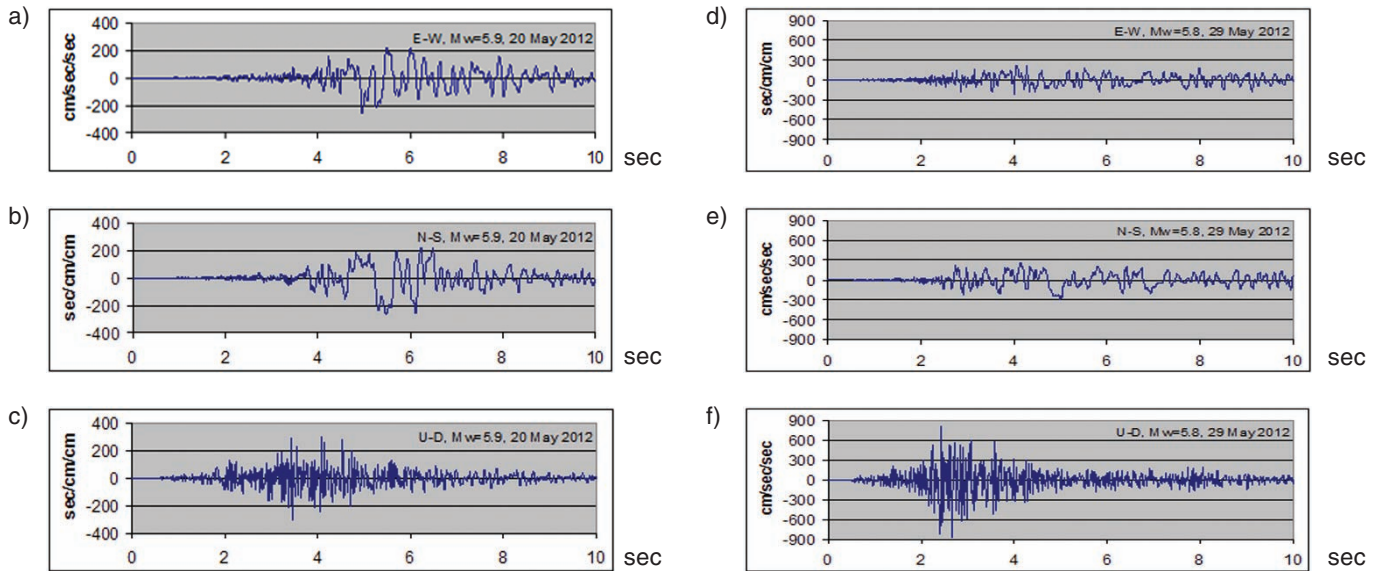
Fig. 37. *Strong phase of the acceleration time histories recorded at Mirandola station; a), b) and c) for the first event, epicentral distance 14 km; d), e) and f) for the second event, epicentral distance 2.0 km, /17/, /18/, /19/, /24/ and links. The starting of time is arbitrary.*

After having integrated the present communication, the acceleration time history of the vertical component of the second main event of 29th May 2012 was released /17/, /18/ and /24/. The available set of records for the two main events are show in Fig. 37, while the respective response spectra for $\zeta = 5\%$ are shown in Fig. 38. The peak value is around 0.9 g, while its acceleration response spectrum has a peak value of 3.2 g at around 0.065 sec period. Those extremely interesting new data comes in full agreement with our findings and arguments exposed in the present communication. This record is really extremely important since it will be a reference for researchers designers and code mak-

Comparing the time lag of the starting of the strong phase between horizontal and vertical ground motions, we can estimate that for the first event is about 2.0 sec while for the second one is about 0.5 to 0.7 sec. Therefore the coincidence in time of the three component is much more pronounced for the second event than for the first one. Also, comparing Figs. 37c and f) and Figs 38c and f) we could conclude that the characteristics of the vertical wave forms are almost independent of the epicentral distance and intensity of the motion (based on the filters and damping used).

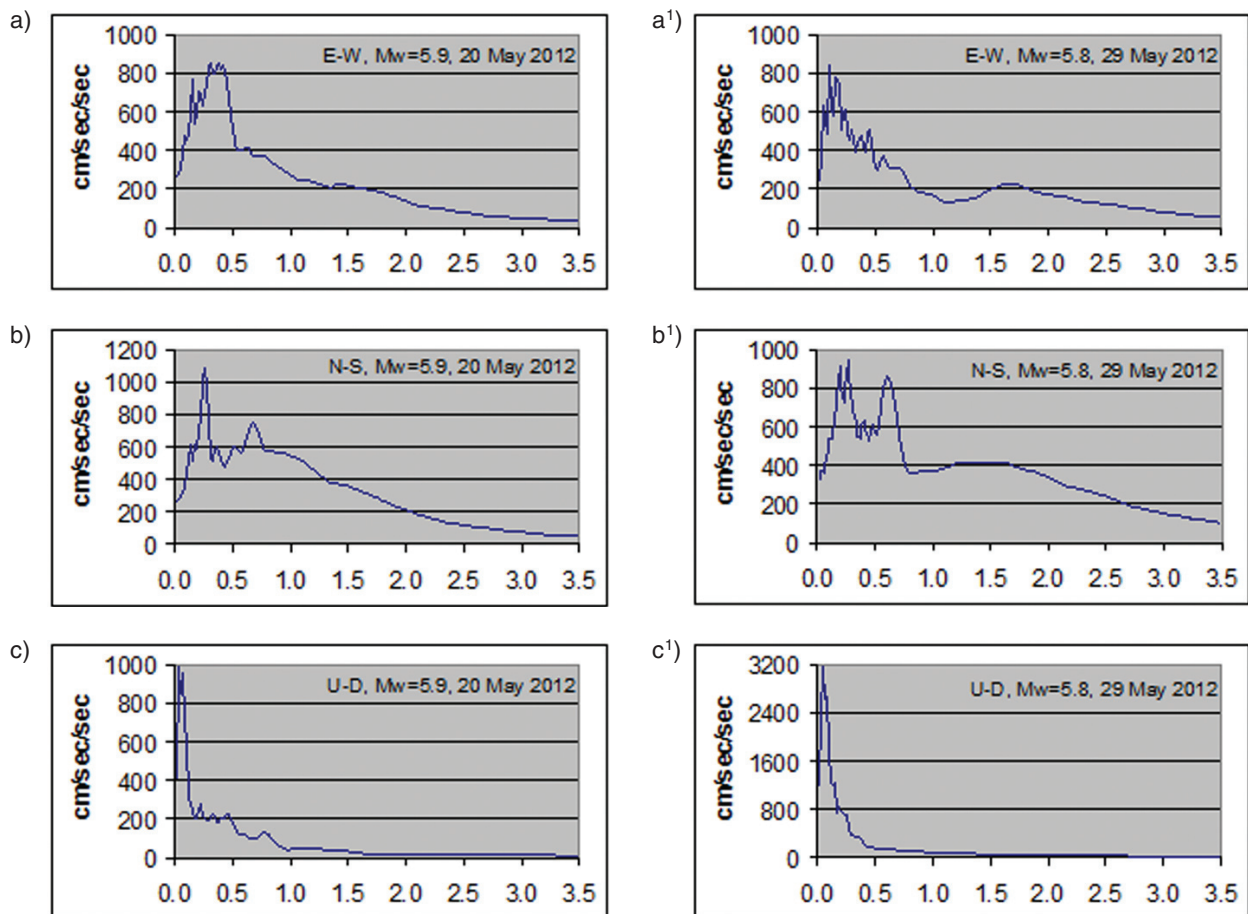
Fig. 38. *Acceleration response spectra for the records presented in Fig. 37 and for ζ = 5%, a), b) and c) for the first event and a'), b') and c') for the second event, after /17/, /18/, /19, /24/ and links.*
Spettri di risposta in termini di accelerazione per gli eventi presentati in Fig. 37 per ζ = 5%, a), b) e c) per il primo evento e a'), b') e c') per il secondo evento, da /17/, /18/, /19, /24/ e links vari.
