Albania earthquake of November 26, 2019

Report on Structural and Geotechnical Damage

November 2020

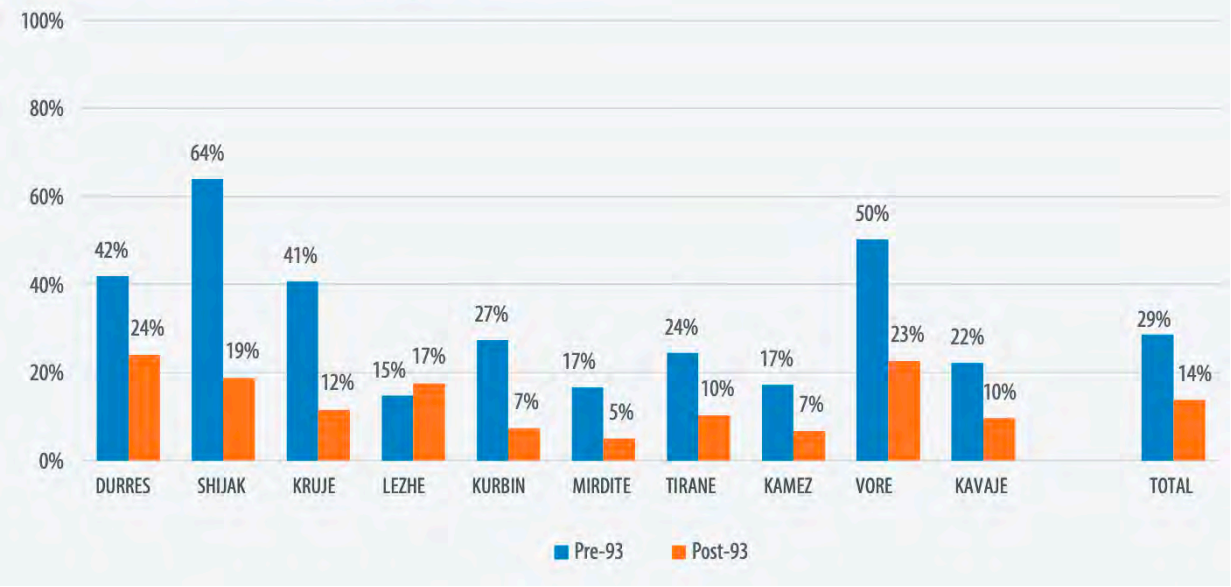
Figure 12. Distribution of damaged housing units per year of construction (Republic of Albania et al., 2020).

Figure 12 presents the percentage of buildings that have experienced a degree of damage in 10 different municipalities in Albania classified per year of construction, with the threshold being in 1993 (Republic of Albania et al., 2020). It is shown that the extent of damage was twice as high (29% for pre-1993 versus 14% for post-1993) for the entire building stock. The same analogy holds for Durrës, where 42% of the pre-1993 buildings and 24% of the post-1993 buildings were damaged.

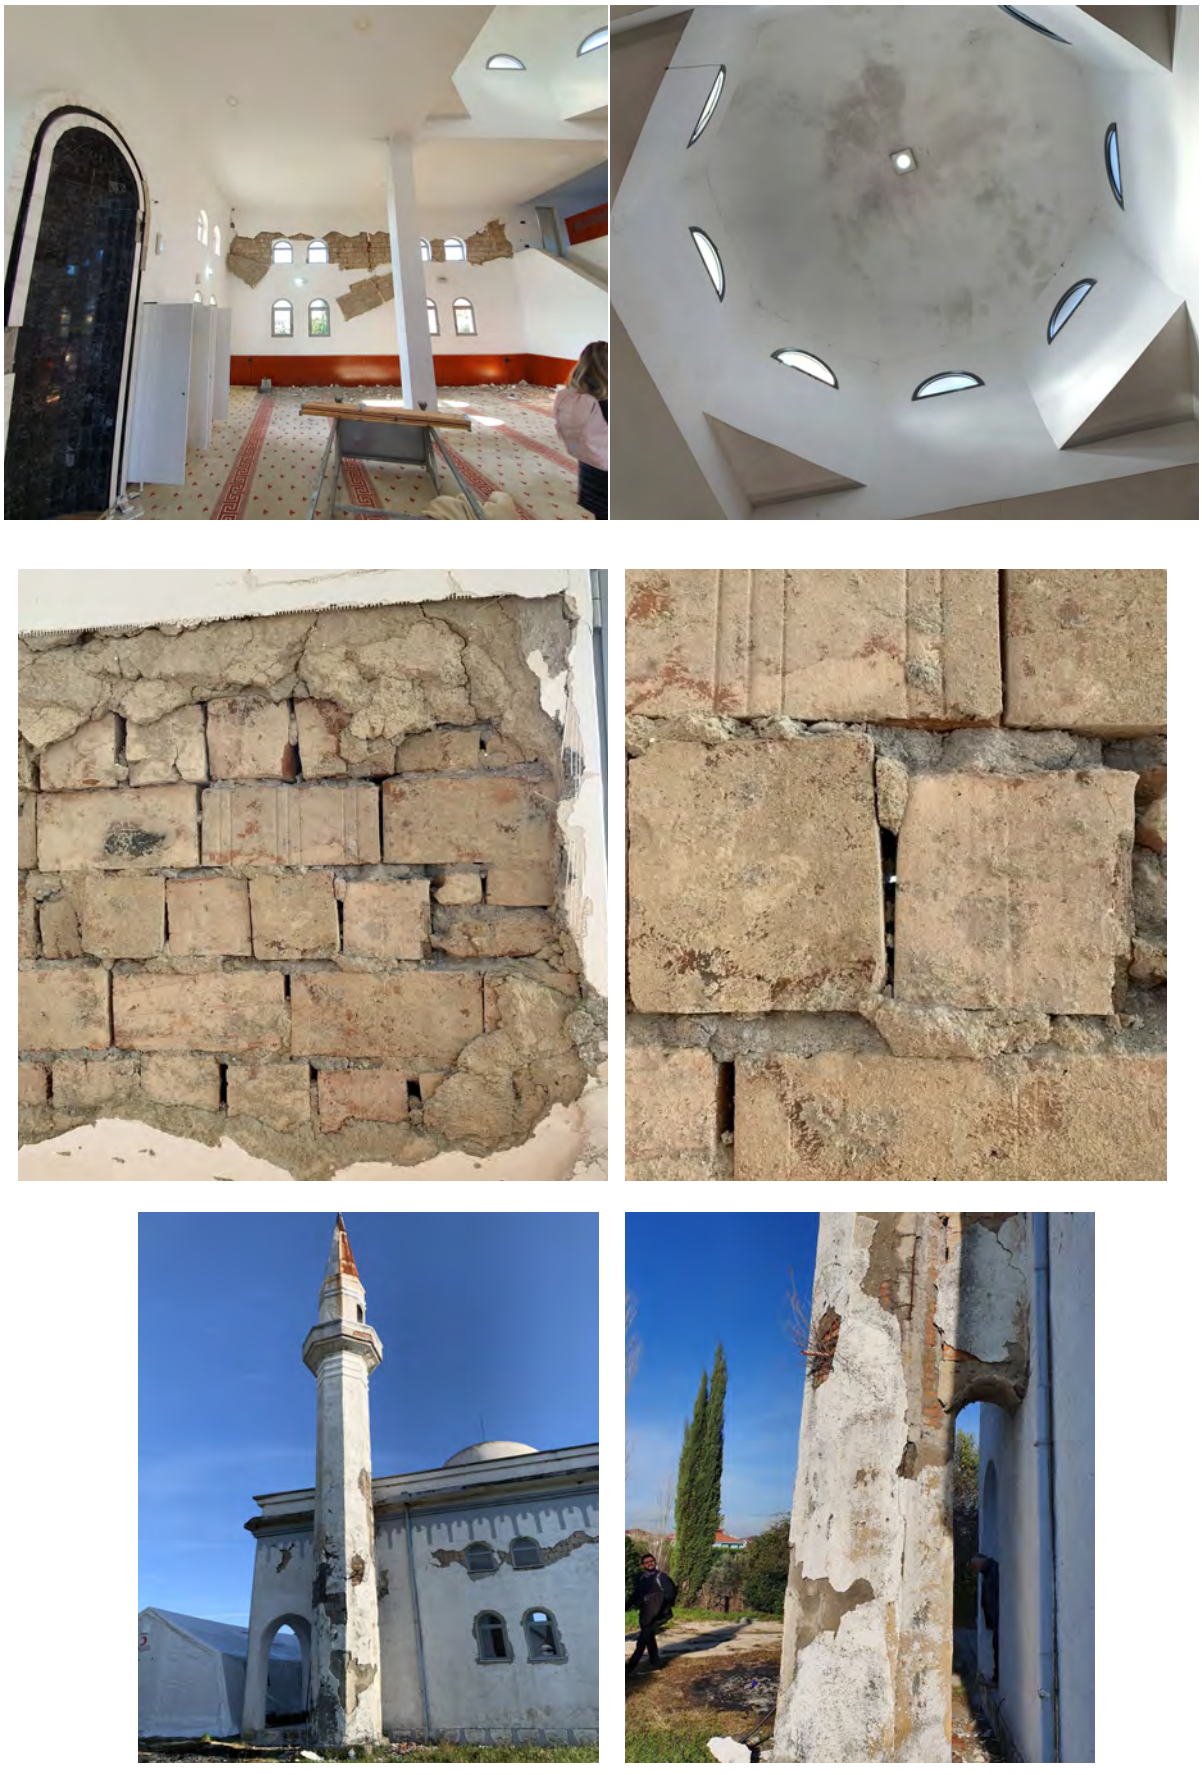
Slight to moderate damage was observed at the mosque of Thumanë (Fig. 26-27). The structural system of the mosque is mainly masonry with RC frames at the interior. The horizontal and vertical joints are irregular (in terms of shape and thickness), while the mortar thickness varies. Wide "X"-shaped cracks due to diagonal tension were observed at the exterior infill walls together with cover spalling at the interior. Small cracks were also observed at the dome as well as along the dome ring due to excessive horizontal stresses. No significant damage was observed on the interior RC frame elements. This is the result of their small stiffness compared to the stiffness of the masonry walls at the perimeter of the structure that provided the main seismic resistance. The minaret appears to have suffered moderate damage. Minarets in general exhibit seismic behavior not similar to other known structures, because of their unique characteristics in terms of slenderness and shape. The minaret has a hexagonal cross-section and it is constructed with RC columns of approximately 10x10 cm2 at every vertice of the hexagon and tie-beams every 3m along its height. Extended cracking and spalling were observed, at the base and along the shaft. Cracks are also present at the connection of the minaret to the main mosque structure. These cracks are very common when minarets are contiguous and integral with the main mosque structure. They come as result of the out-of-phase vibration of the two parts of the structure due to the difference of their dynamic properties.

Figure 27: Damage of the mosque in Thumanë

- Major damage was also observed at the mosque located in Thumanë. Extended cracking and spalling at the masonry minaret, at the base and along its height.

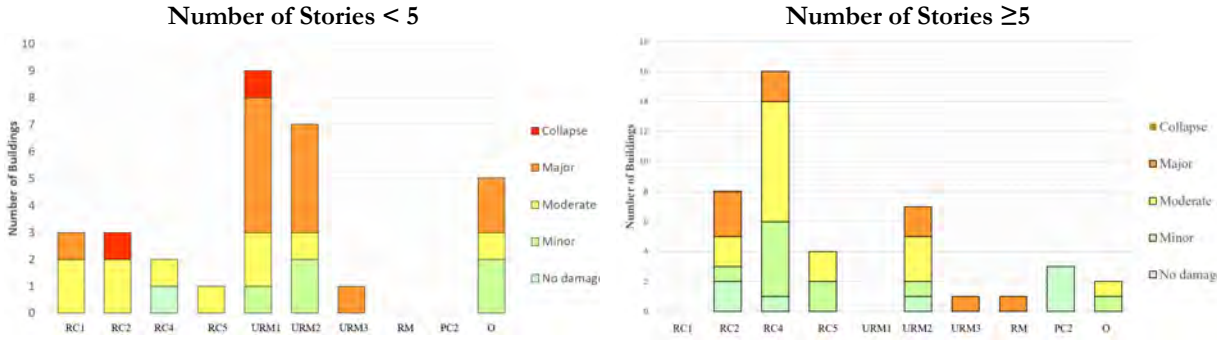
Figure 42: Structural typologies of inspected buildings classified by damage level.

The distribution of damage level per structural typology of the inspected sample of buildings is depicted in Fig. 42. Most RC buildings designed with old codes (RC2) and unreinforced brick masonry (URM1) suffered severe damage. Buildings with designed to modern codes (RC4) and unreinforced (confined) masonry with RC slabs (URM2), perform better, yet there were cases where they experienced light-to-moderate damage. When building height (number of storeys n) is introduced as a classification criterion, with a threshold of n=5), it is evident that for low- to mid-rise buildings (n<5) the damage extend is higher for URM buildings with the majority of URM1 and URM2 developing major damage or collapse. The latter were mainly unreinforced brick masonry (URM1) and RC buildings designed with old codes (RC2), whereas RC buildings designed with modern codes (RC4) experienced a lower level of damage. For the case of mid- to-high-rise buildings (n ≥5), the majority of RC buildings designed with modern codes (RC4) experienced only minor to moderate damage, with most of the older RC buildings (RC2) and unreinforced brick masonry with RC slabs (URM2), suffering moderate to major. Based on the same figure, the damage extend is higher for lower buildings (n <5 , T~0.5sec) in accordance with the response spectra presented in Fig. 5, where for both cases (i.e., earthquake records at the Tirana (TIR) and Durres (DURR) station), the spectral amplification is higher for a period range T=0,2~0,5sec.

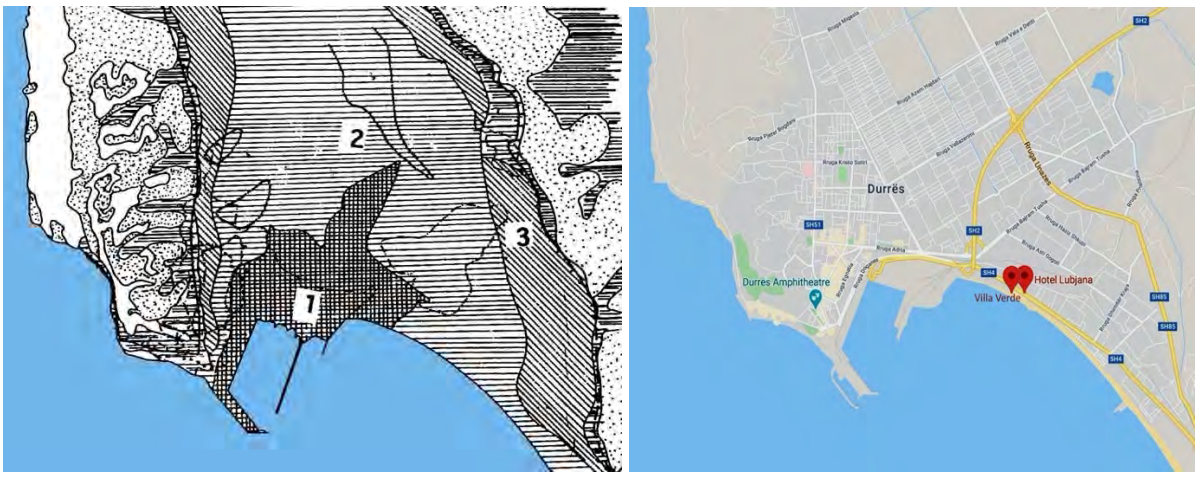
Figure 45: Liquefaction potential map of Durrës (Kociu, 2004) and map showing the location of Hotels Lubjana and Villa Verde Beach.

Based on field observations, the M6.4 earthquake that struck Albania on 26 November 2019, resulted mainly in structural damage, whereas geotechnical damage was not explicitly reported. However, there are areas in Durrës, known for their soft soil conditions, which might have contributed to the observed extent and localization of building damage. The main types of geotechnical phenomena observed, were soil liquefaction, settlements and permanent ground displacements. They developed at the coastal area of Durrës, where a number of damaged hotels are located. The map in Fig. 45 (left) shows the liquefaction potential map of the city (Kociu, 2004) with numbers 1, 2 and 3 denoting areas highly, moderately and high susceptibility to liquefaction, respectively. On the right, it is evident the location of the hotel buildings that suffered extensive settlement and titling.

The Hotel Lubjana situated at the seafront of Durrës, was one of the structures that experienced such extensive tilt due to soil liquefaction as shown in Fig. 46. The damage was beyond repair and it was demolished during the first weeks after the seismic event. The Villa Verde Beach Hotel was also located in the high risk for liquefaction area. Although the main cause of its collapse seems to be the development of a soft-storey mechanism, the soil conditions may have contributed to the failure.

Figure 46: Tilting of Hotel Lubjana due to soil liquefaction and resulting settlement (left). Collapse of the Villa Verde Beach Hotel (photos courtesy of J. Psaropoulos)
