# The October 23 ( $M_w = 7.2$ ) and November 9 ( $M_w = 5.7$ ), 2011 Van, Turkey earthquakes. A geoscientific and engineering report

Panayotis Carydis\*, Efthymis Lekkas\*\*, Christos Papaioannou\*\*\*, Andreas Tsokos\*\*\*\*, John Delakouridis\*\*\*\*\*

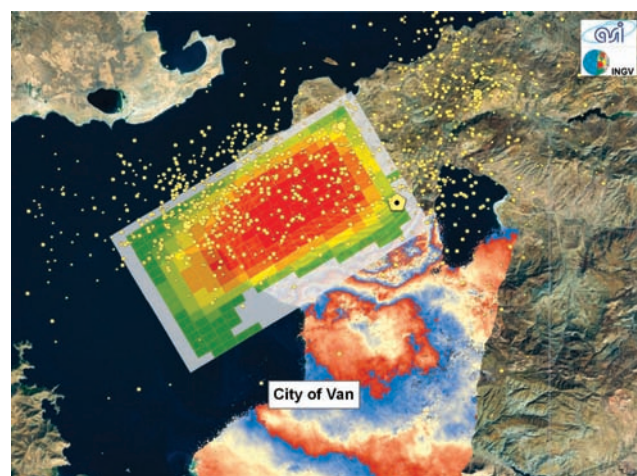
Fig. 3. Surface projection of the North-dipping source modeled from the COSMO InSAR ground displacements. Also shown: seismicity and wrapped interferogram, after /10/.

The seismic activity of October 23<sup>rd</sup> 2011 ( $M_w = 7.2$ ), based on seismological and interferometry data, /10/, resulted from a fault of NEE-SWW direction, located 25-30 km north of Van and 35-40 km south of Ercis city. The outcrop of the fault, based on field observations, had a visible length of approximately 300 m and it crossed the main road of Van-Ercis. After consideration of all the data it can be concluded that this fault is a reverse fault of N80E direction and 70° dip, with the north block being the hanging wall, Fig. 3.

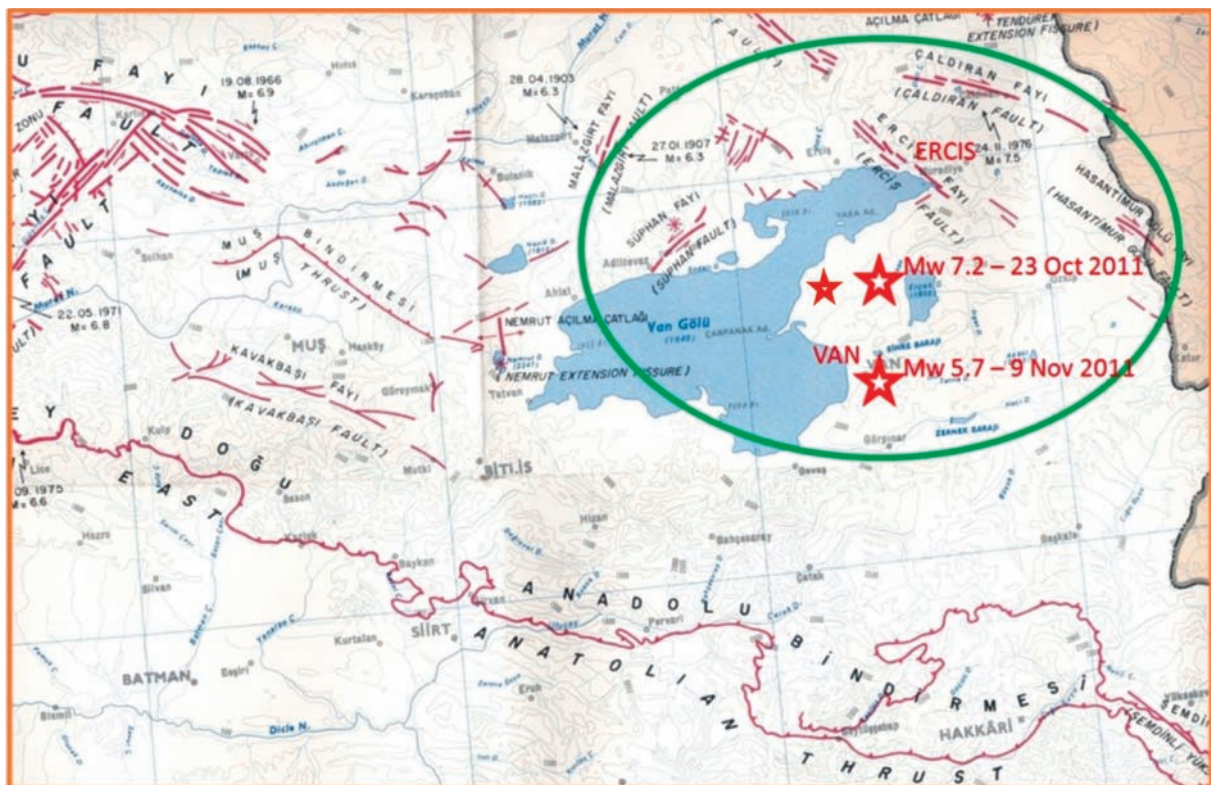
Fig. 5. The wider area of Van-Ercis and the epicenters of the two recent catastrophic earthquakes. With a smaller asterisk an aftershock of  $M_L = 4.6$ , 21 November 2011 is also shown. Respectively ground motion records are commented in section 3.

The second major seismic event of November 9<sup>th</sup> 2011 ( $M_w = 5.7$ ), took place after the activation of the strike slip fault between the city of Van and Erçek Lake. This fault has a general NE-SW direction, along which characteristic pop-up and pop-down structures occur and crosses under the city of Van. The activation of the fault resulted in damage that was observed only in the city of Van and not further north, in contrast to the earthquake of October 23<sup>rd</sup> 2011, Fig. 5.

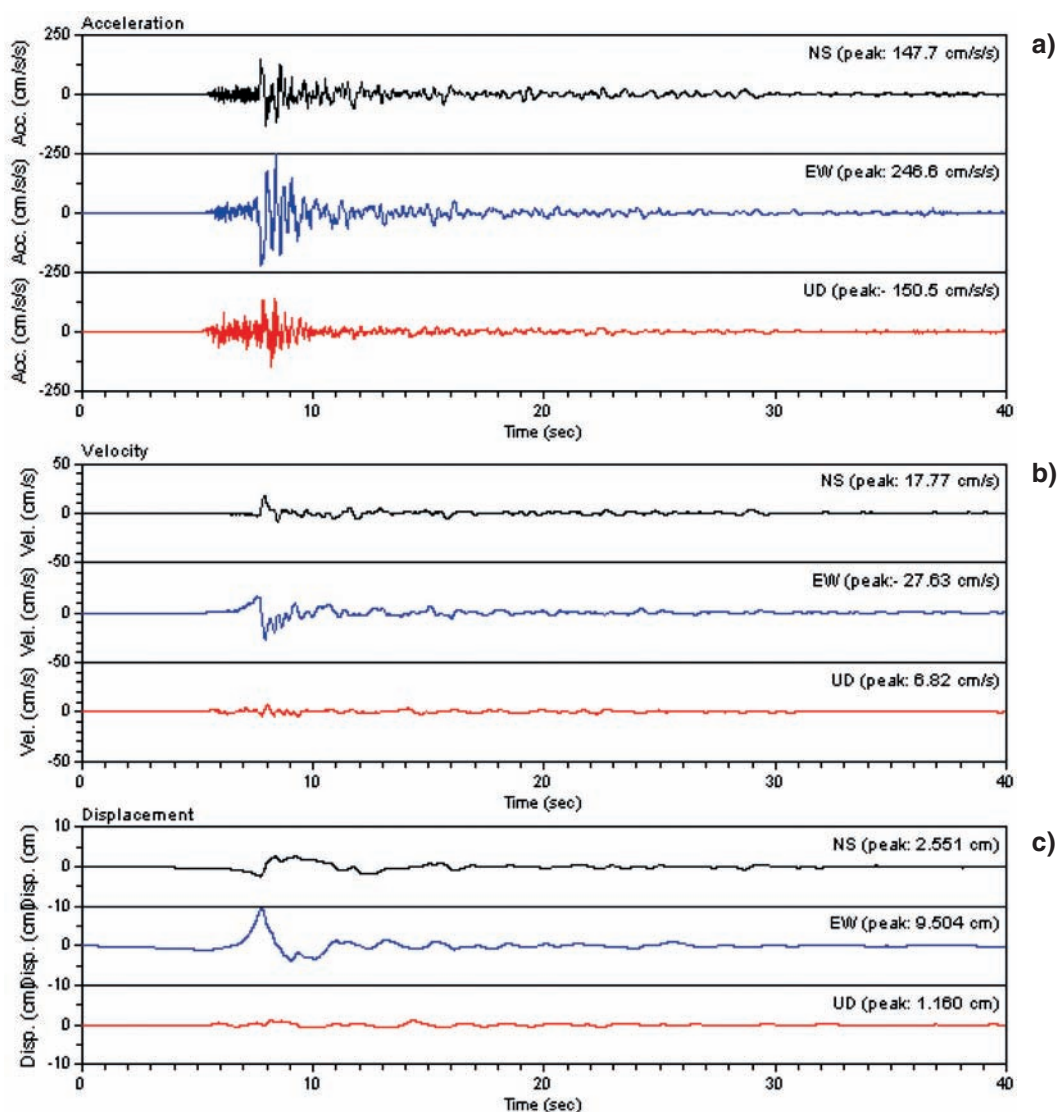
It is interesting to mention here that the peak acceleration of NS component reaches the value of 147.7 cmsec<sup>-2</sup>, that of EW component 246.6 cmsec<sup>-2</sup> and that of the vertical component 150.5 cmsec<sup>-2</sup>. The duration

Fig. 6. Corrected acceleration (a), velocity (b) and displacement (c), time histories for the  $M_w = 5.7$ , 9 November 2011, 21.23, LT event recorded in Van.

of the strong phase is of the order of 2.5 sec. The ratio of the peak acceleration values along NS is:  $V/A = 1.02$  and along EW is:  $V/A = 0.61$ . Both values differ from the commonly accepted  $V/A = 0.7$ , recommended by many codes. Nevertheless, one would expect much higher acceleration values of the ground motion and especially along the vertical component since the accelerometer is installed in the epicentral region of this specific earthquake.

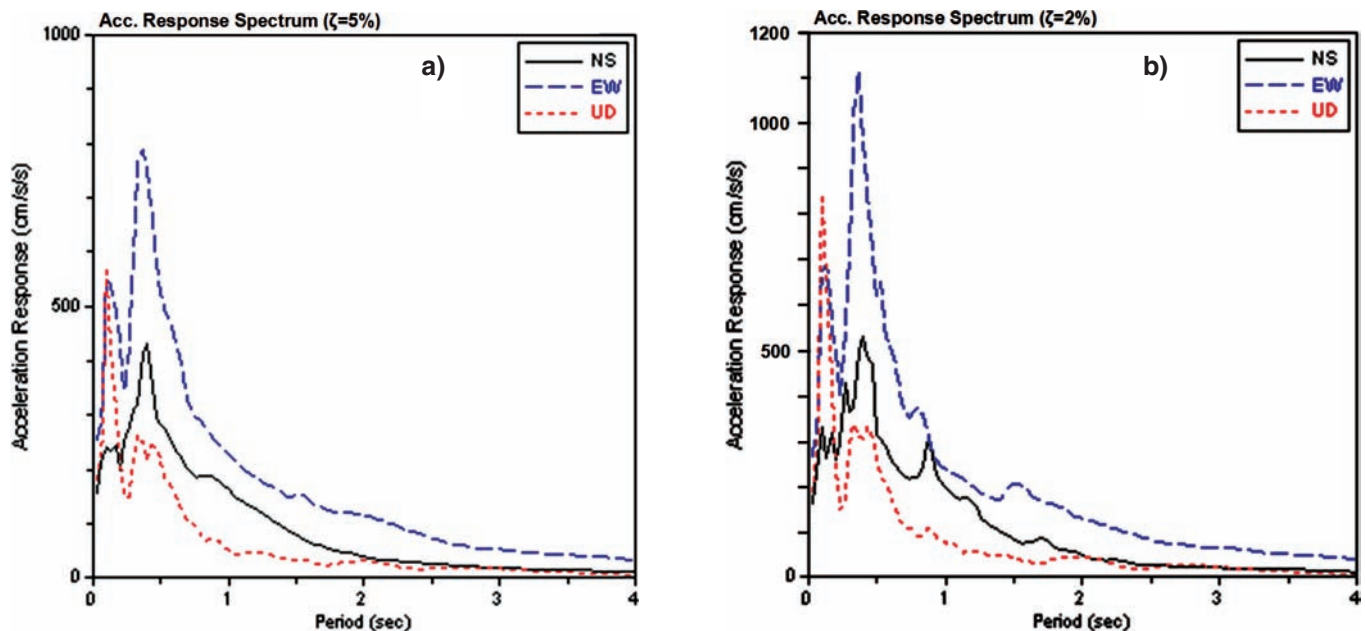
Fig. 7. Acceleration response spectra for the  $M_w = 5.7$ , 9 November 2011 event recorded in Van, for  $\zeta$ : (a) 5% and (b) 2%.

comparing the respective peak values in Figs 7a,b. For NS component  $\eta = SA_{0.02}/SA_{0.05} = 525/440 = 1.19$ ; For EW,  $\eta = SA_{0.02}/SA_{0.05} = 1100/800 = 1.38$ ; For UD,  $\eta = SA_{0.02}/SA_{0.05} = 840/570 = 1.47$ , while the EC-8 code formula for  $\zeta = 0.02$  gives damping correction factor  $\eta = \sqrt{10/(5+2)} = 1.20$ . The higher value of  $\eta$  for the vertical is in agreement with the general opinion that the damping is more efficient for the vertical response of structures rather than for the horizontal one, since the vertical response is rich in higher frequencies.

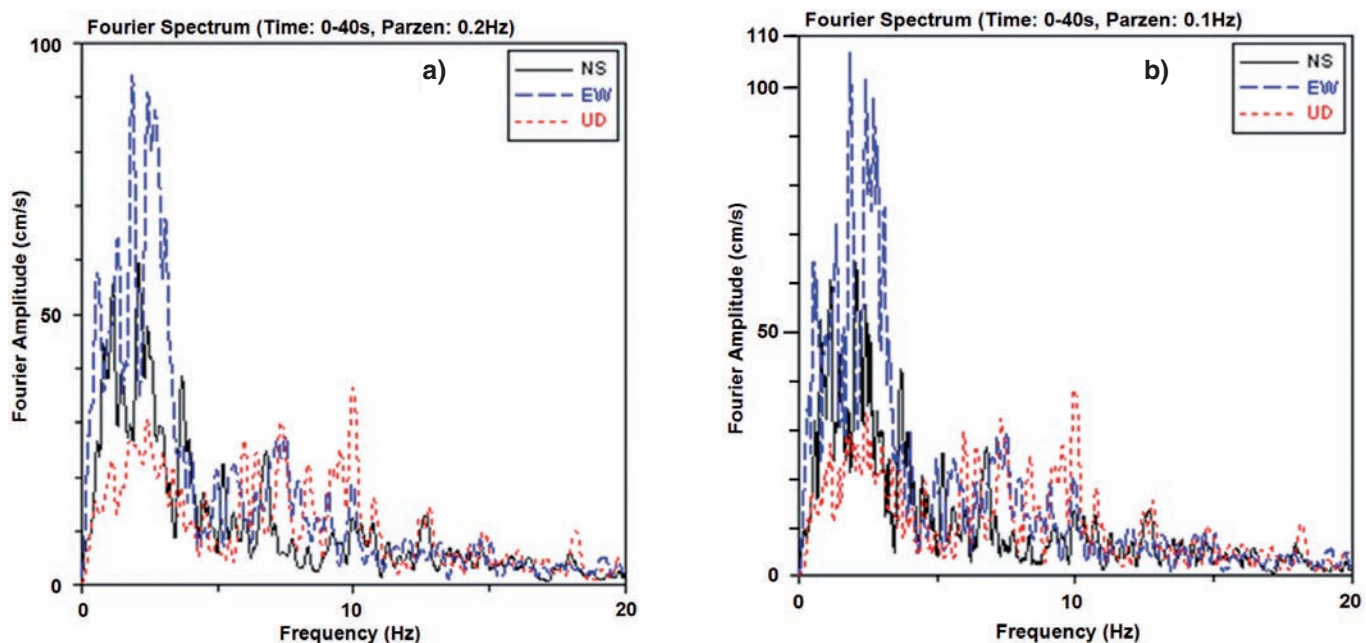
Fig. 8. Fourier velocity spectra for the  $M_w = 5.7$ , 9 November 2011 event, corresponding to running windows smoothing process with width  $n$ : (a) 0.2 Hz and (b) 0.1 Hz.

a period of about 0.10 sec. This may be justified from Fourier amplitude spectra, shown in Fig. 8, where the peak values for the two horizontal components are at around 2.5 Hz and for the vertical one at 10 Hz. It is worth mentioning that for the vertical component, the richer in information Fourier spectrum is almost flat for frequencies from low values up to 10-12 Hz. It is thus confirmed the impact character of the vertical seismic component, which possesses the potential of affecting a wide range of structures and, practically, independently from their natural periods.

By comparing Figs. 8a and 8b, almost similar conclusions can be drawn. More specifically, with the decrease of the width of the running window smoothing process from 0.2 Hz (Fig. 8a) to 0.1 Hz (Fig. 8b) the Fourier spectrum of the vertical component is approaching or exceeding that of the two horizontal ones.

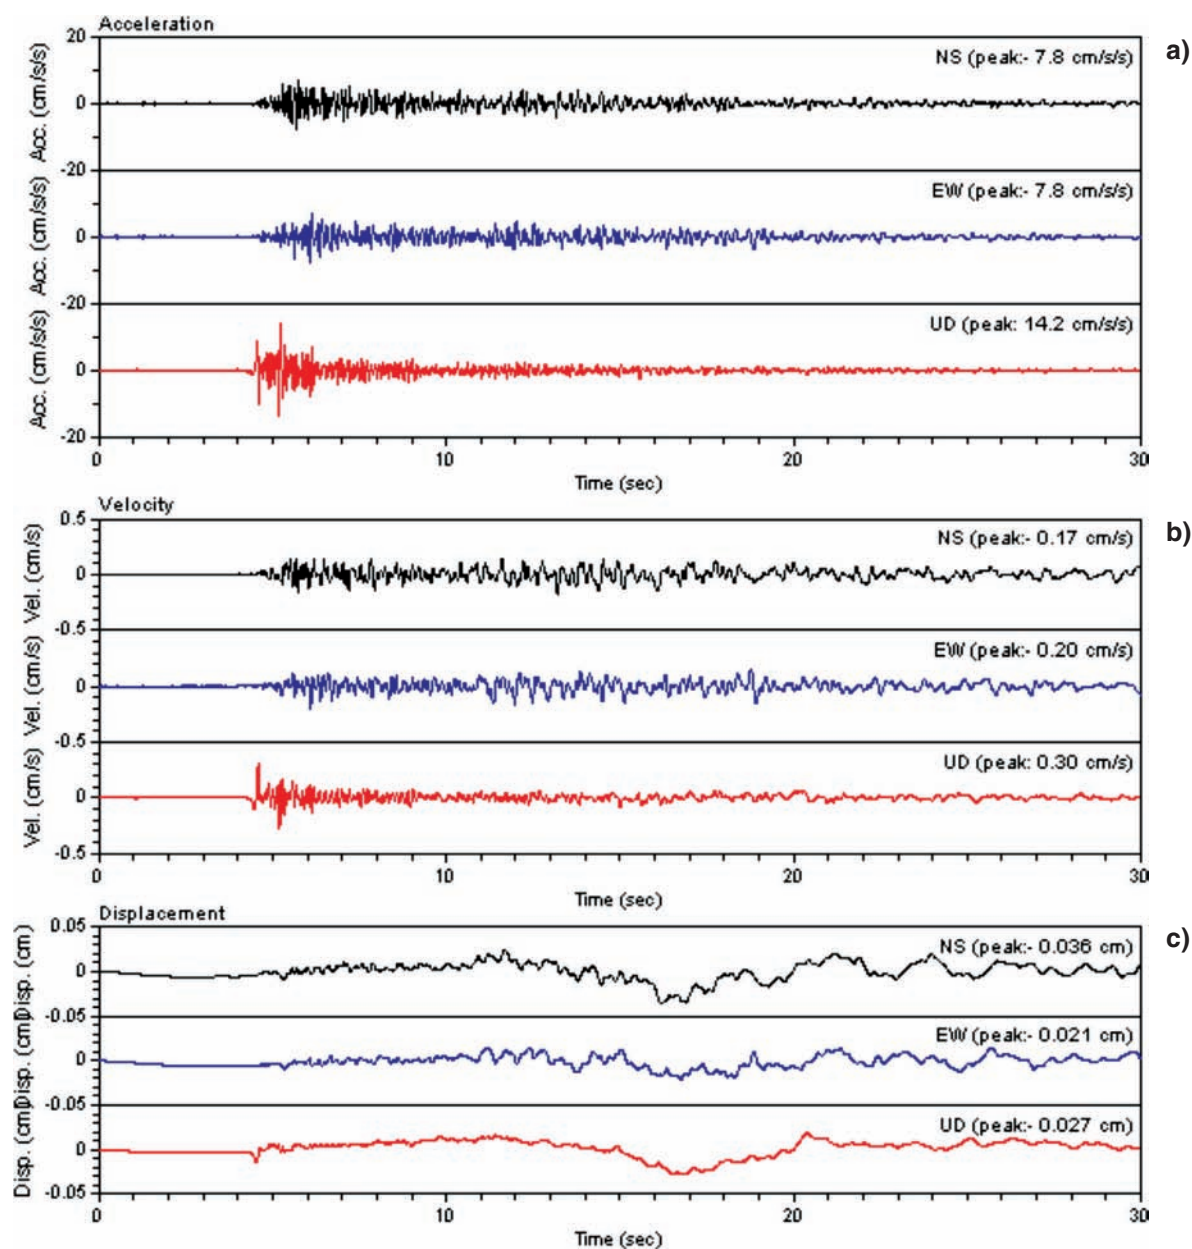
Fig. 9. Corrected acceleration (a), velocity (b) and displacement (c), time histories for the  $M_L = 4.6$ , 21 November 2011 aftershock, recorded in Ercis. Soil conditions are still unknown. The epicenter is shown in Fig. 5. The epicentral distance is about 39 km.

higher than that of the horizontal ones. An example is given in the corrected records in Fig. 9, at Ercis, located at epicentral distance of about 39 km, the peak acceleration value of the vertical component is  $14.2 \text{ cmsec}^{-2}$  while that of both horizontal components are equal to about the half of it, namely  $7.8 \text{ cmsec}^{-2}$ . The peak values for the records at Van (epicentral distance of about 25 km) are 3.0, 3.2 and  $2.5 \text{ cmsec}^{-2}$  for the UD, NS and EW components respectively. The respective corrected waveforms in Van city are shown in Fig. 12. In Figs 10 and 13 the acceleration response spectra and in Figs 11

Nevertheless, considering the waveform pattern in Ercis one may conclude that a possible interpretation of the heavy damage, due to the main shock, may be related to high amplitudes along the vertical component of the ground motion. A possible explanation could be the location of Ercis if we consider as the earthquake fault the one with strike 241 degrees which dips under Ercis. The town is located on the hanging wall, where shaking damage is generally greater and at fault-

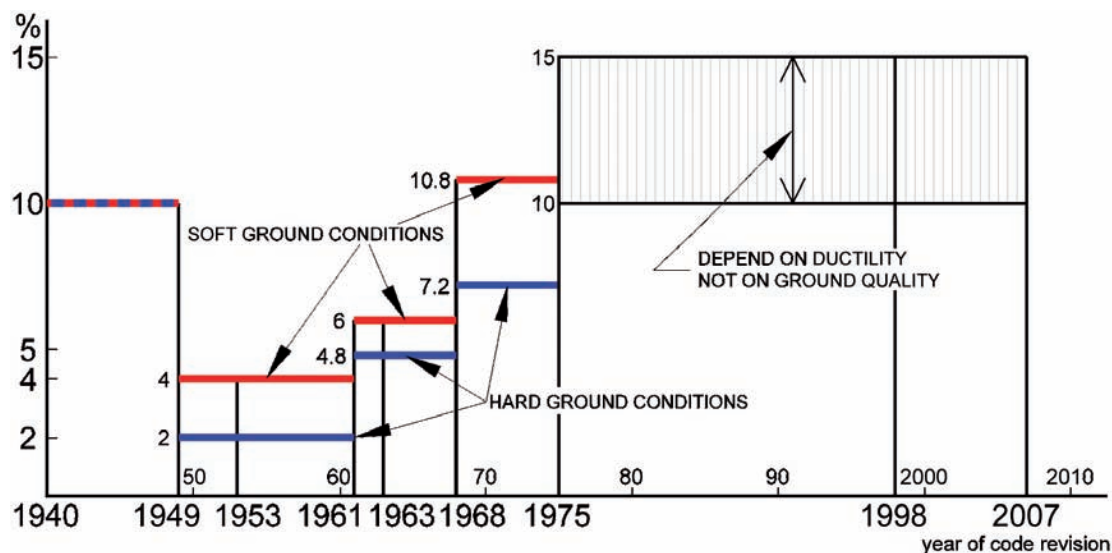
Fig. 15. Evolution of base shear design coefficients for a 5-storey hotel building in the city of Van (in the highest seismic zone).

In Fig. 15 the base shear design coefficients for the hypothetical hotel building in the city of Van are plotted against time, with all calculations referring to the allowable stresses method.

Based on the diagram of Fig. 15, it is obvious that during the period 1949-1975 quite low seismic coefficients were used. It must be emphasized, also, that those low values of seismic coefficients correspond to the highest seismic zones in which the city of Van belonged before the last two revisions of the seismic code. The abrupt and excessive reduction of the seismic coefficients from 0.10 that were used during the decade 1940-1949, to something around 0.03, as a mean value during the next decade 1950-1960, should also be noted. It must be mentioned here that seismic coefficient values below 0.05 with a parallel increase of the allowable stresses by 50% do not consist any noteworthy earthquake structural resistance, especially in regions of the highest seismic hazard zone in the country. Namely, those buildings can hardly safely withstand an effective peak ground acceleration of more than 0.05 g and under the best structural qualifications 0.15 g. These thresholds are further reduced in the case of buildings with a soft ground storey as this is the case of buildings at the city shopping centers, with ground floors functioning as shops possessing larger show rooms, openings and shop windows. As far as the vertical seismic component is concerned, no provision is
