Adana Earthquake: Peculiar damage distribution and seismotectonic characteristics

Lekkas E. & Vassilakis E.

Abstract

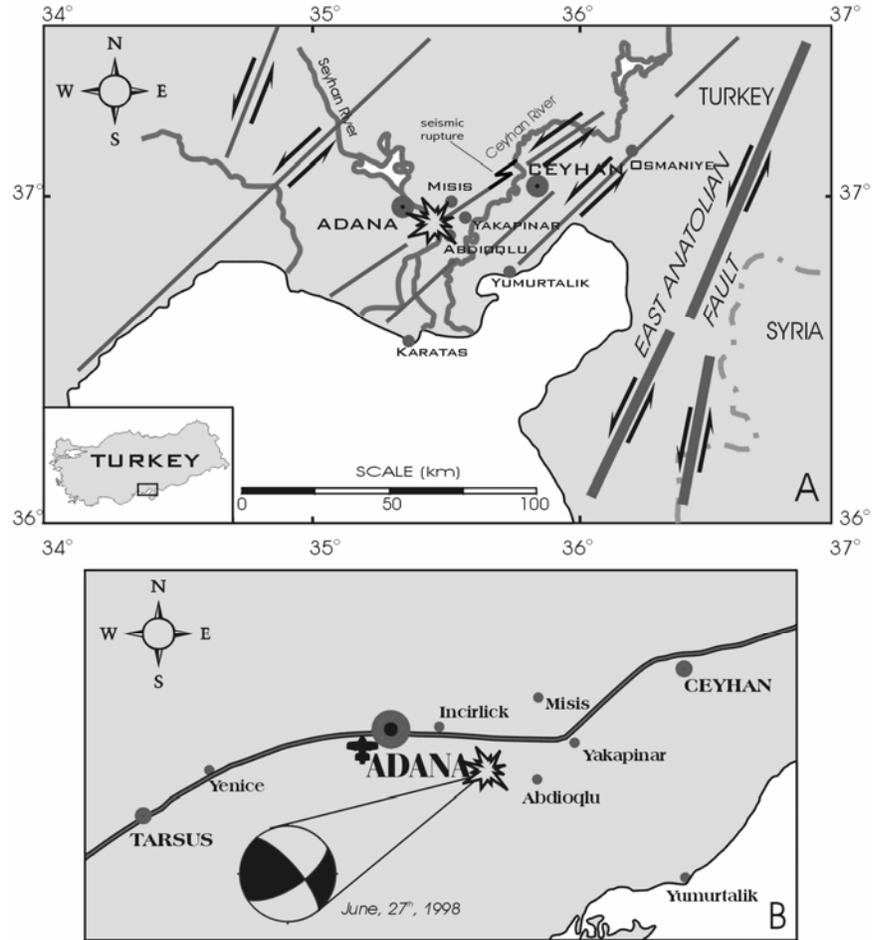
Figure 1. Geotectonic map of the wider meizoseismal area with the location of the epicentre (A) and the focal mechanism (B).

SW direction and sinistral strike-slip movement). In addition, the focal mechanism solution showed that the earthquake originated from a fault of NE-SW direction and sinistral strike-slip movement (Figure 1B).

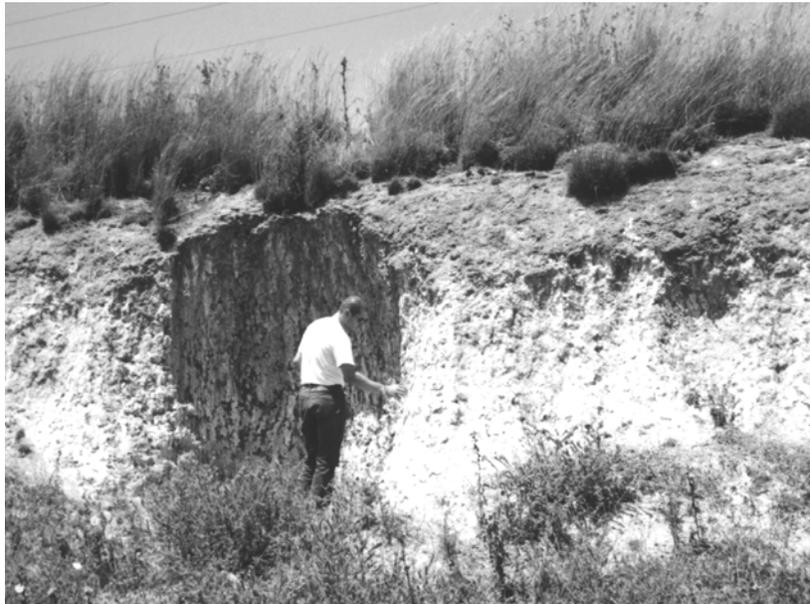
Figure 2. Aspect of the travertine limestones that outcrop at the area between Adana and Ceyhan.

The villages of Yakapinar and Abdioqlu are located midway between Adana and Ceyhan with an approximate population of 5,000 people. They are a residential units that includes older one-story or two-story masonry or brick structures with or without, in some cases, earthquake-design standards and reinforcement mainly by means of concrete pillars or intermediate plates of armed concrete. Relatively modern one-story or two-story buildings existed and suffered significant damages as well. The structures were built on the Pleistocene travertine limestones (Figure 2).
