## THE JANUARY-FEBRUARY 2014 CEPHALONIA (IONIAN SEA, WESTERN GREECE) EARTHQUAKE SEQUENCE: DAMAGE PATTERN ON BUILDINGS

P. Carydis<sup>(1)</sup>, S. Mavroulis<sup>(2)</sup>, V. Alexoudi<sup>(3)</sup>, A. Grambas<sup>(4)</sup>, E. Lekkas<sup>(5)</sup>

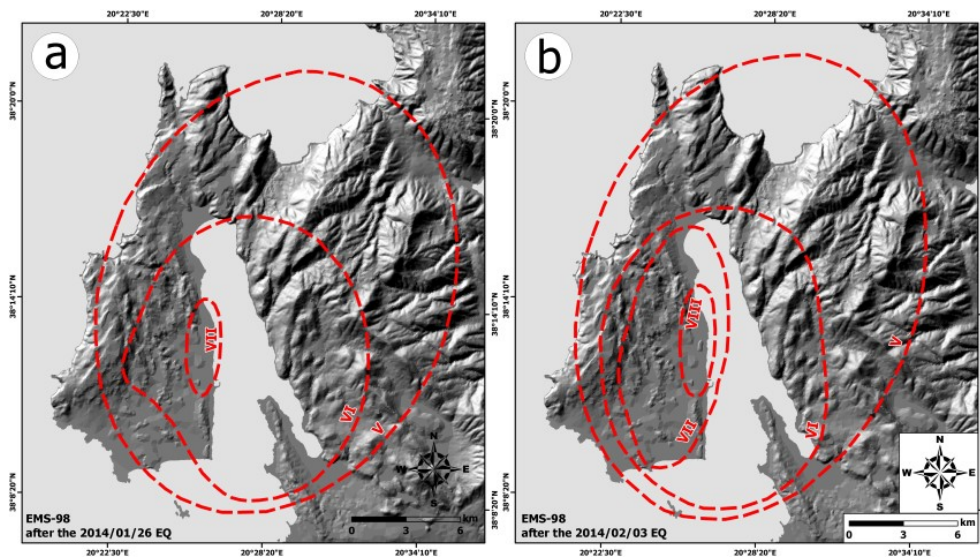
(a) Few unreinforced masonry structures of vulnerability classes A and B in villages located in the northern, western and southern part of the Paliki Peninsula (e.g. Atheras, Zola, Agonas, Nifi, Agia Thekli and Chavriata) suffered damage of grade 1 including negligible to slight non-structural damage, namely light cracks in very few masonry walls and detachment of small plaster pieces from the masonry walls. Thus, intensity  $V_{EMS-98}$  is assigned to the northern, western and southern part of Paliki peninsula.

(b) In villages located in the western part of Aenos Mt (e.g. Kardakata, Kourouklata, Dilinata and Faraklata) and the eastern and central part of the Paliki peninsula (e.g. Livadi and Chavdata respectively), many unreinforced masonry structures of vulnerability classes A and B sustained slight damage of grade 1, while few such buildings suffered moderate damage of grade 2 comprising cracks in many walls, dislocation of roof tiles, detachment of large plaster pieces and partial collapse of chimneys. Thus, intensity  $VI_{EMS-98}$  is assigned to the western part of Aenos Mt and the eastern and central part of the Paliki peninsula.

(c) In the Lixouri town and the Agios Dimitrios village, many buildings of vulnerability classes A and B suffered substantial to heavy damage of grade 3 like large and extensive cracks in walls, detachment of roof tiles and moderate damage of grade 2 like cracks in walls and fall of small pieces of plaster respectively, while few buildings of vulnerability classes A and B suffered very heavy damage of grade 4 like partial collapse of masonry walls and substantial to heavy damage of grade 3 respectively. Moreover, reinforced buildings of vulnerability class D suffered negligible to slight damage of grade 1 like light cracks in infill walls, while reinforced buildings of vulnerability class E suffered no damage at all. Thus, the highest intensity for the first earthquake is  $VII_{EMS-98}$  and is assigned to the Lixouri town and the village of Agios Dimitrios in the eastern coastal part of Paliki peninsula.

(a) Few unreinforced masonry structures of vulnerability classes A and B in villages located in the northern, and western part of the Paliki Peninsula (e.g. Atheras, Zola, Agonas, Nifi and Agia Thekli) suffered damage of grade 1. Thus, intensity  $V_{EMS-98}$  is assigned to the northern and western part of Paliki peninsula.

(b) In villages located in the western part of Aenos Mt (e.g. Kardakata, Kourouklata, Dilinata and Faraklata), many unreinforced masonry structures of vulnerability classes A and B sustained slight damage of grade 1, while few such buildings suffered moderate damage of grade 2. Thus, intensity  $VI_{EMS-98}$  is assigned to the western part of Aenos Mt.

(c) In villages located around the Lixouri town (e.g. Livadi located northwards, Chavdata located westwards and Lepeda located southwards), the second earthquake aggravated building damage induced by the first earthquake. Due to this aggravation, the assigned intensity for the second earthquake ( $VII_{EMS-98}$ ) is one grade larger than that for the first earthquake ( $VI_{EMS-98}$ ).

(d) Building damage aggravation occurred in the Lixouri town and the village of Agios Dimitrios. Thus, the assigned intensity for the second earthquake ( $VIII_{EMS-98}$ ) is one grade larger than that for the first earthquake ( $VII_{EMS-98}$ ).

Fig. 8 – EMS-98 intensities for (a) the first earthquake on January 26, 2014 and (b) the second earthquake on February 3, 2014. The western part of Cephalonia and especially the Paliki peninsula suffered the most from both earthquakes and thus the highest seismic intensities were observed there.
