## **Learning from Earthquakes**

### **Preliminary Observations on the August 14, 2003 Lefkada Island, Western Greece, Earthquake**

*This reconnaissance report was compiled by P. Carydis of the Laboratory for Earthquake Engineering of the National Technical University of Athens (NTUA), A' Vice President of the EAEE and E. Lekkas, S. Lozios, E. Skourtsos and G. Danamos of the Laboratory for Tectonics and Geological Mapping of the University of Athens (UoA) and it is based on their own observations.*

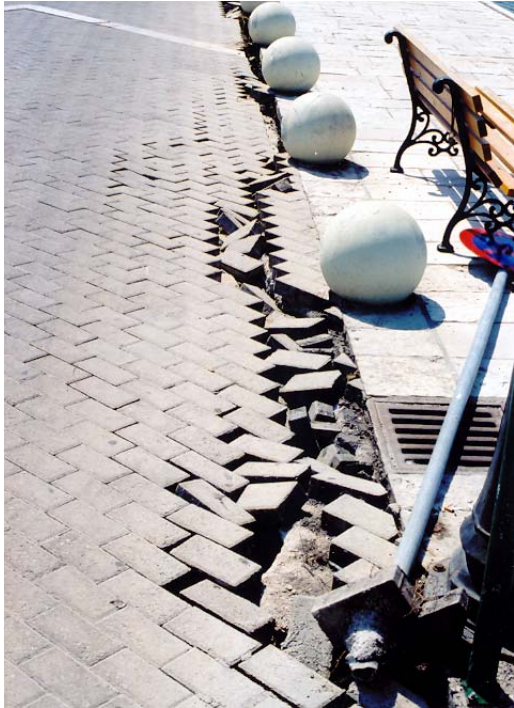
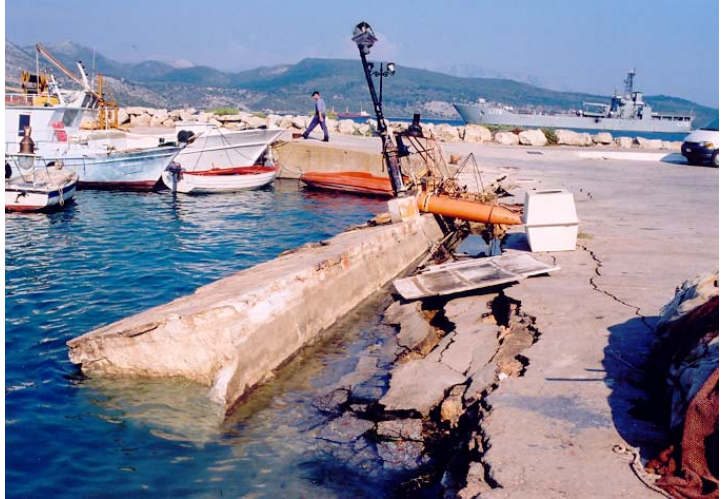
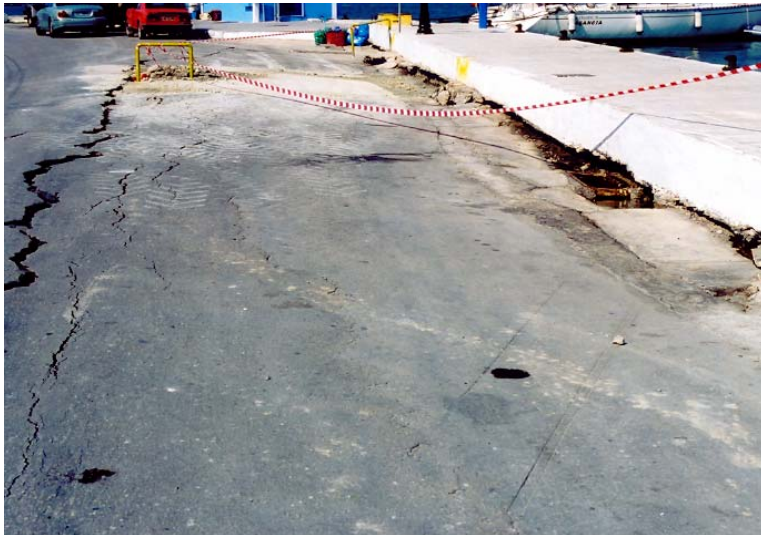
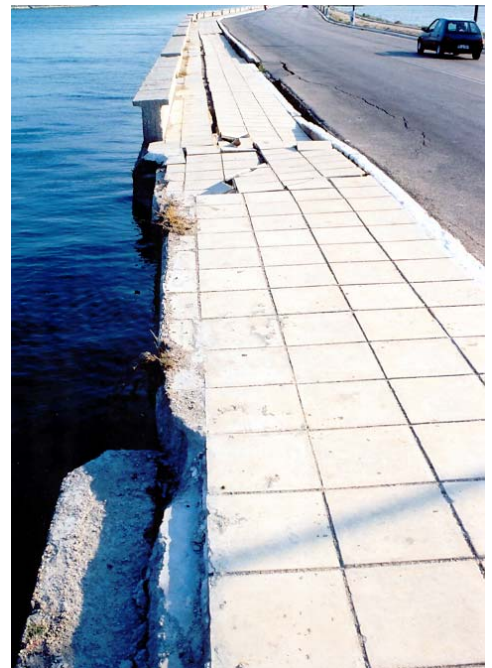
**Fig. 8:** Ground subsidence of about 30 cm, of the fill material.

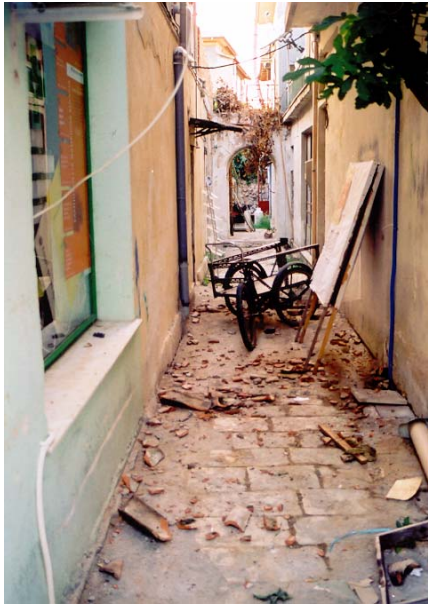
**Fig. 13:** *In the city of Lefkada there are very narrow streets from which rescue teams can not easily proceed.*

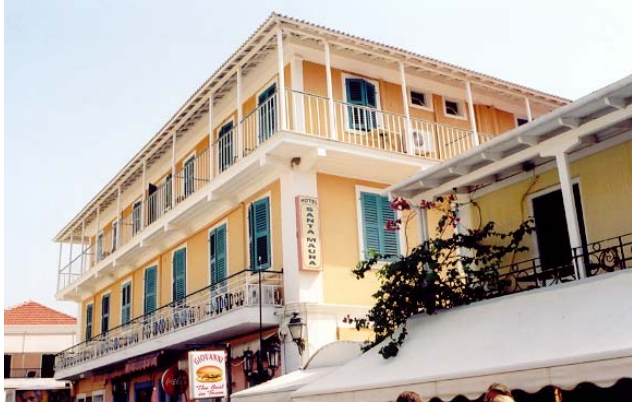
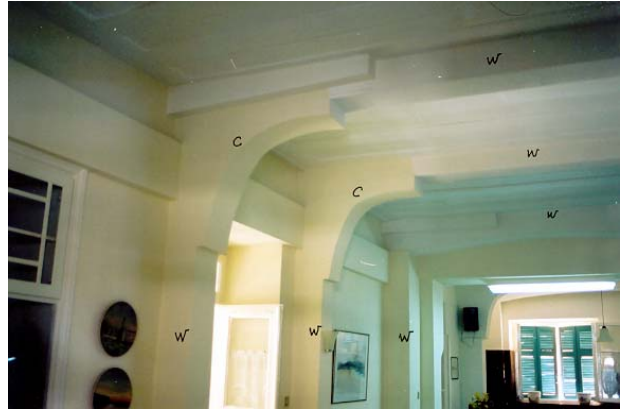
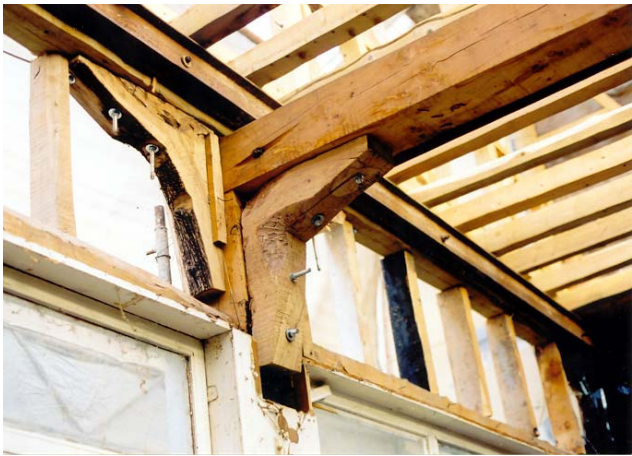
**Fig. 14:** The traditional earthquake resistant system of Lefkada. The building is at the end of the 19<sup>th</sup> century. In Fig. 14b one may see the wooden columns and beams (w) with wooden corners (c). In Fig. 14c the special earthquake system under construction, is shown.

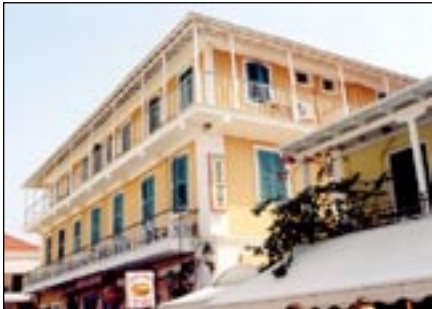
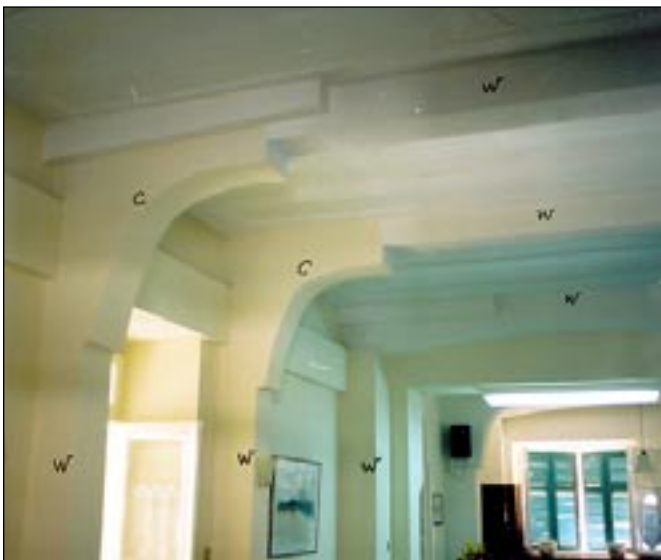
**Figures 17a, b, and c.** The traditional earthquake-resistant system of Lefkada. The undamaged structure in Fig. 17a was built at the end of the 19<sup>th</sup> century. In Fig. 17b the wooden columns and beams (w) with wooden corners (c) are visible. In Fig. 17c the special earthquake system is shown under construction (NTUA-UoA team).

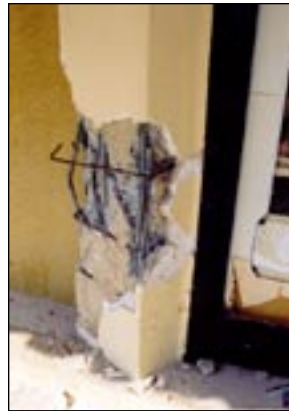
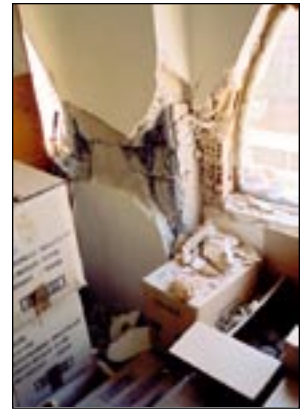
In a building with a market and mezzanine on the ground floor: insufficient stirrups with poor detailing (a).

In the mezzanine: damaged columns on the surface between phases of concrete and the lower part of the arches, formed with brickwalls (b) (NTUA-UoA team).
