Engineering Geology for Society and Territory – Volume 2

Landslide Processes

Lekkas Efthimis, Alexoudi Vasiliki, and Lialiaris Ioannis

23.1 Introduction: Background—Scope

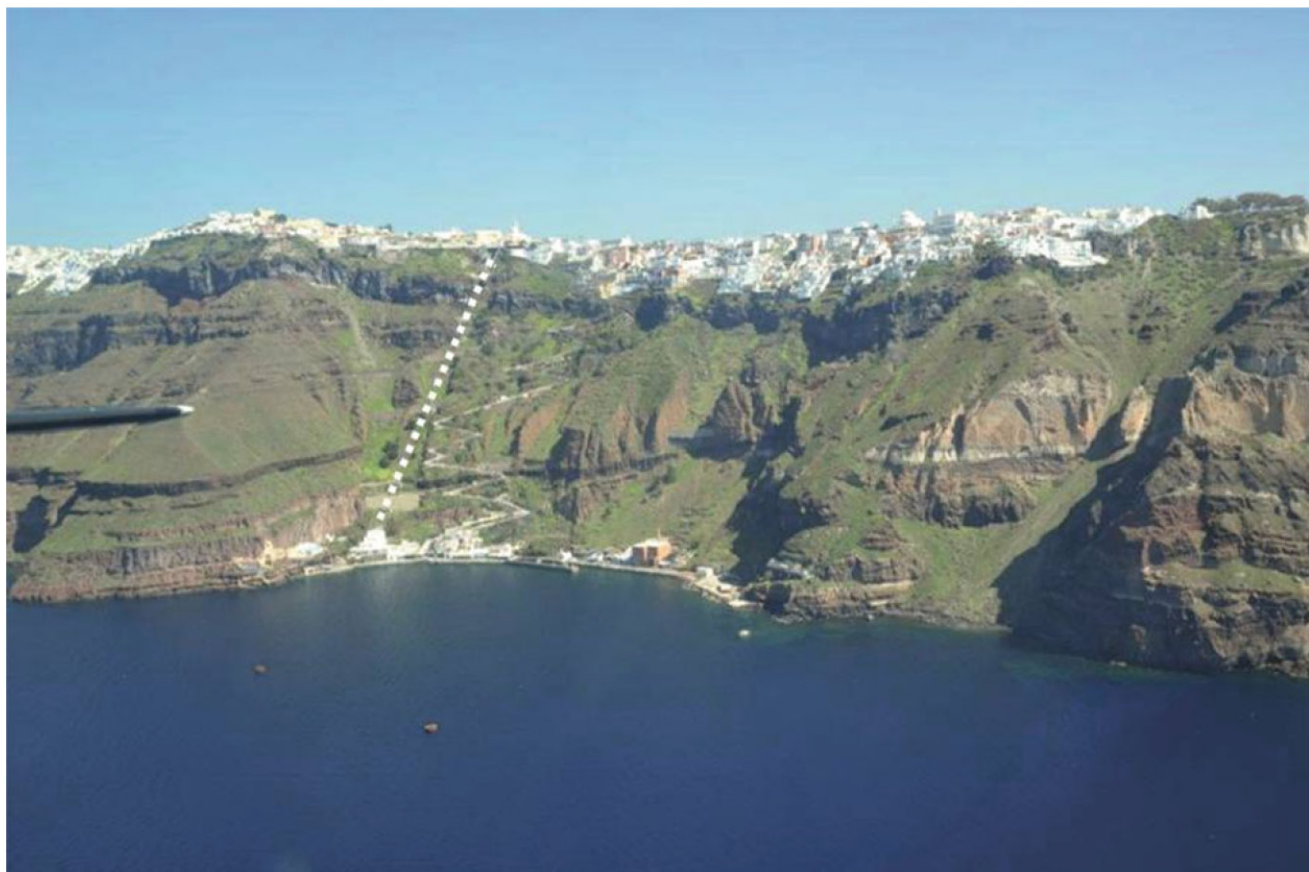
Fig. 23.1 General view of the study area. The Teleferik line is marked with a *dotted line*, Fira appears on the *upper part* of the slope and the Old Port appears at the *Lower part* of the slope

The area of Teleferik—Old Port of the island of Santorini presents an increased rockfall risk, which is expressed by numerous events occurring on the slopes of the caldera (Fig. 23.1).

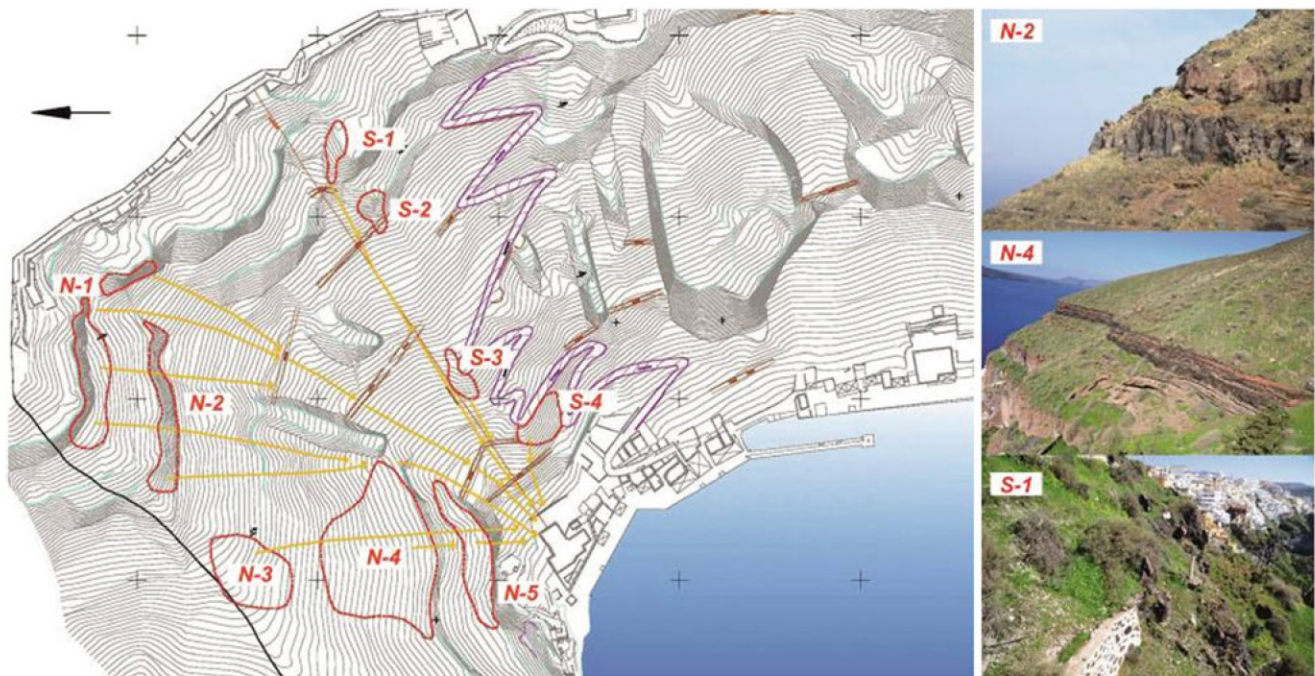
Fig. 23.2 Map with the areas at the North (N-1 to N-5) and South (S-1 to S-4) slopes where it is highly likely that landslide phenomena may occur and view of the hanging boulders corresponding to the areas N-2, N-4 and S-1

Based on data from previous surveys (Druitt et al. 1999; Lekkas 2009; Antoniou and Lekkas 2010), fieldwork and consideration of all the evidence, nine areas have been identified where a rockfall could possibly start (Fig. 23.2). Five of these areas are located on the northern slope (N-1 to N-5) and four in the southern slope (S-1 to S-4). The parameters and design criteria are described below.

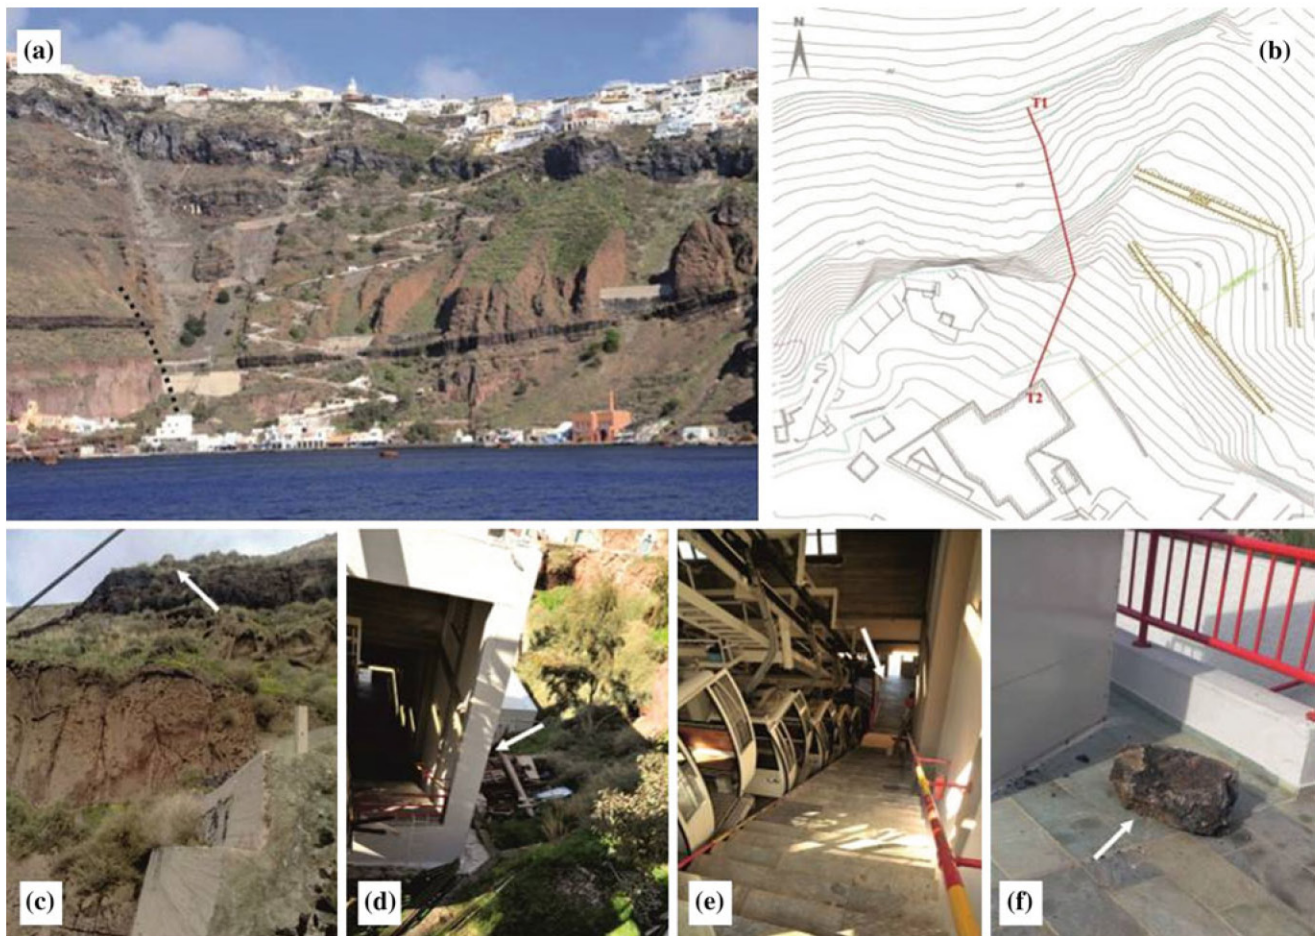
Fig. 23.3 The route of the Black Pumice rock boulder that was detached (a,b) and landed at the Lower Station of the Teleferik (c-f)

In February 2012 a boulder was detached from the North Slope and crashed inside the building of the Lower Station causing material damage to the facilities. The original volume of the boulder which was detached from the Black Pumice formation over the Lower Station is unknown. However, the remaining boulder which landed inside the

Lower Station, after it bounced on various parts of the slope, was estimated at about 0.5 m³ (Fig. 23.3).

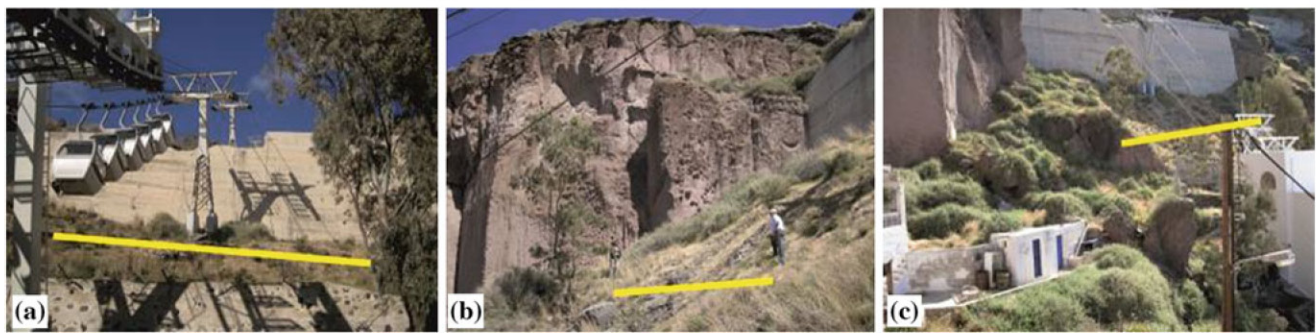
Fig. 23.4 Views of the area showing the rock fall barriers systems (a), (b) and (c)

The layout of the Rock Fall Barriers which was suggested after the onsite investigation of the application areas for the selected systems, is shown in Fig. 23.4.

In total, the installation of three Rock Fall Barriers was suggested as follows:

- Between the Lower Station and pillar No 1, crosswise to the route of the Teleferik with the following features: Length: 20 m, Height: 3 m, Capacity: 1000 kJ.
- On the side of the Lower Station, upwards at a 60° angle relative to the direction of the Teleferik lines with the following features: Length: 10 m, Height: 4 m, Capacity: 2000 kJ.
- On the side of the Lower Station, downwards at 60° angle, relative to the direction of the Teleferik lines with the following features: Length: 10 m, Height: 4 m, Capacity: 2000 kJ.
